**PRELIMINARY ASSESSMENT OF PER- AND  
POLYFLUOROALKYL SUBSTANCES AT THE  
U.S. ARMY RESERVE CENTER,  
RIO VISTA, CALIFORNIA**

**Final  
September 2023**

- Figure 1-1. Installation Location
- Figure 2-1. Site Features
- Figure 2-2. Parcel Transfer Map
- Figure 2-3. Potable Wells Within a 4-Mile Radius
- Figure 4-1. Evaluated Sites
- Figure 4-2. Potential PFAS Sources Within a 5-Mile Radius

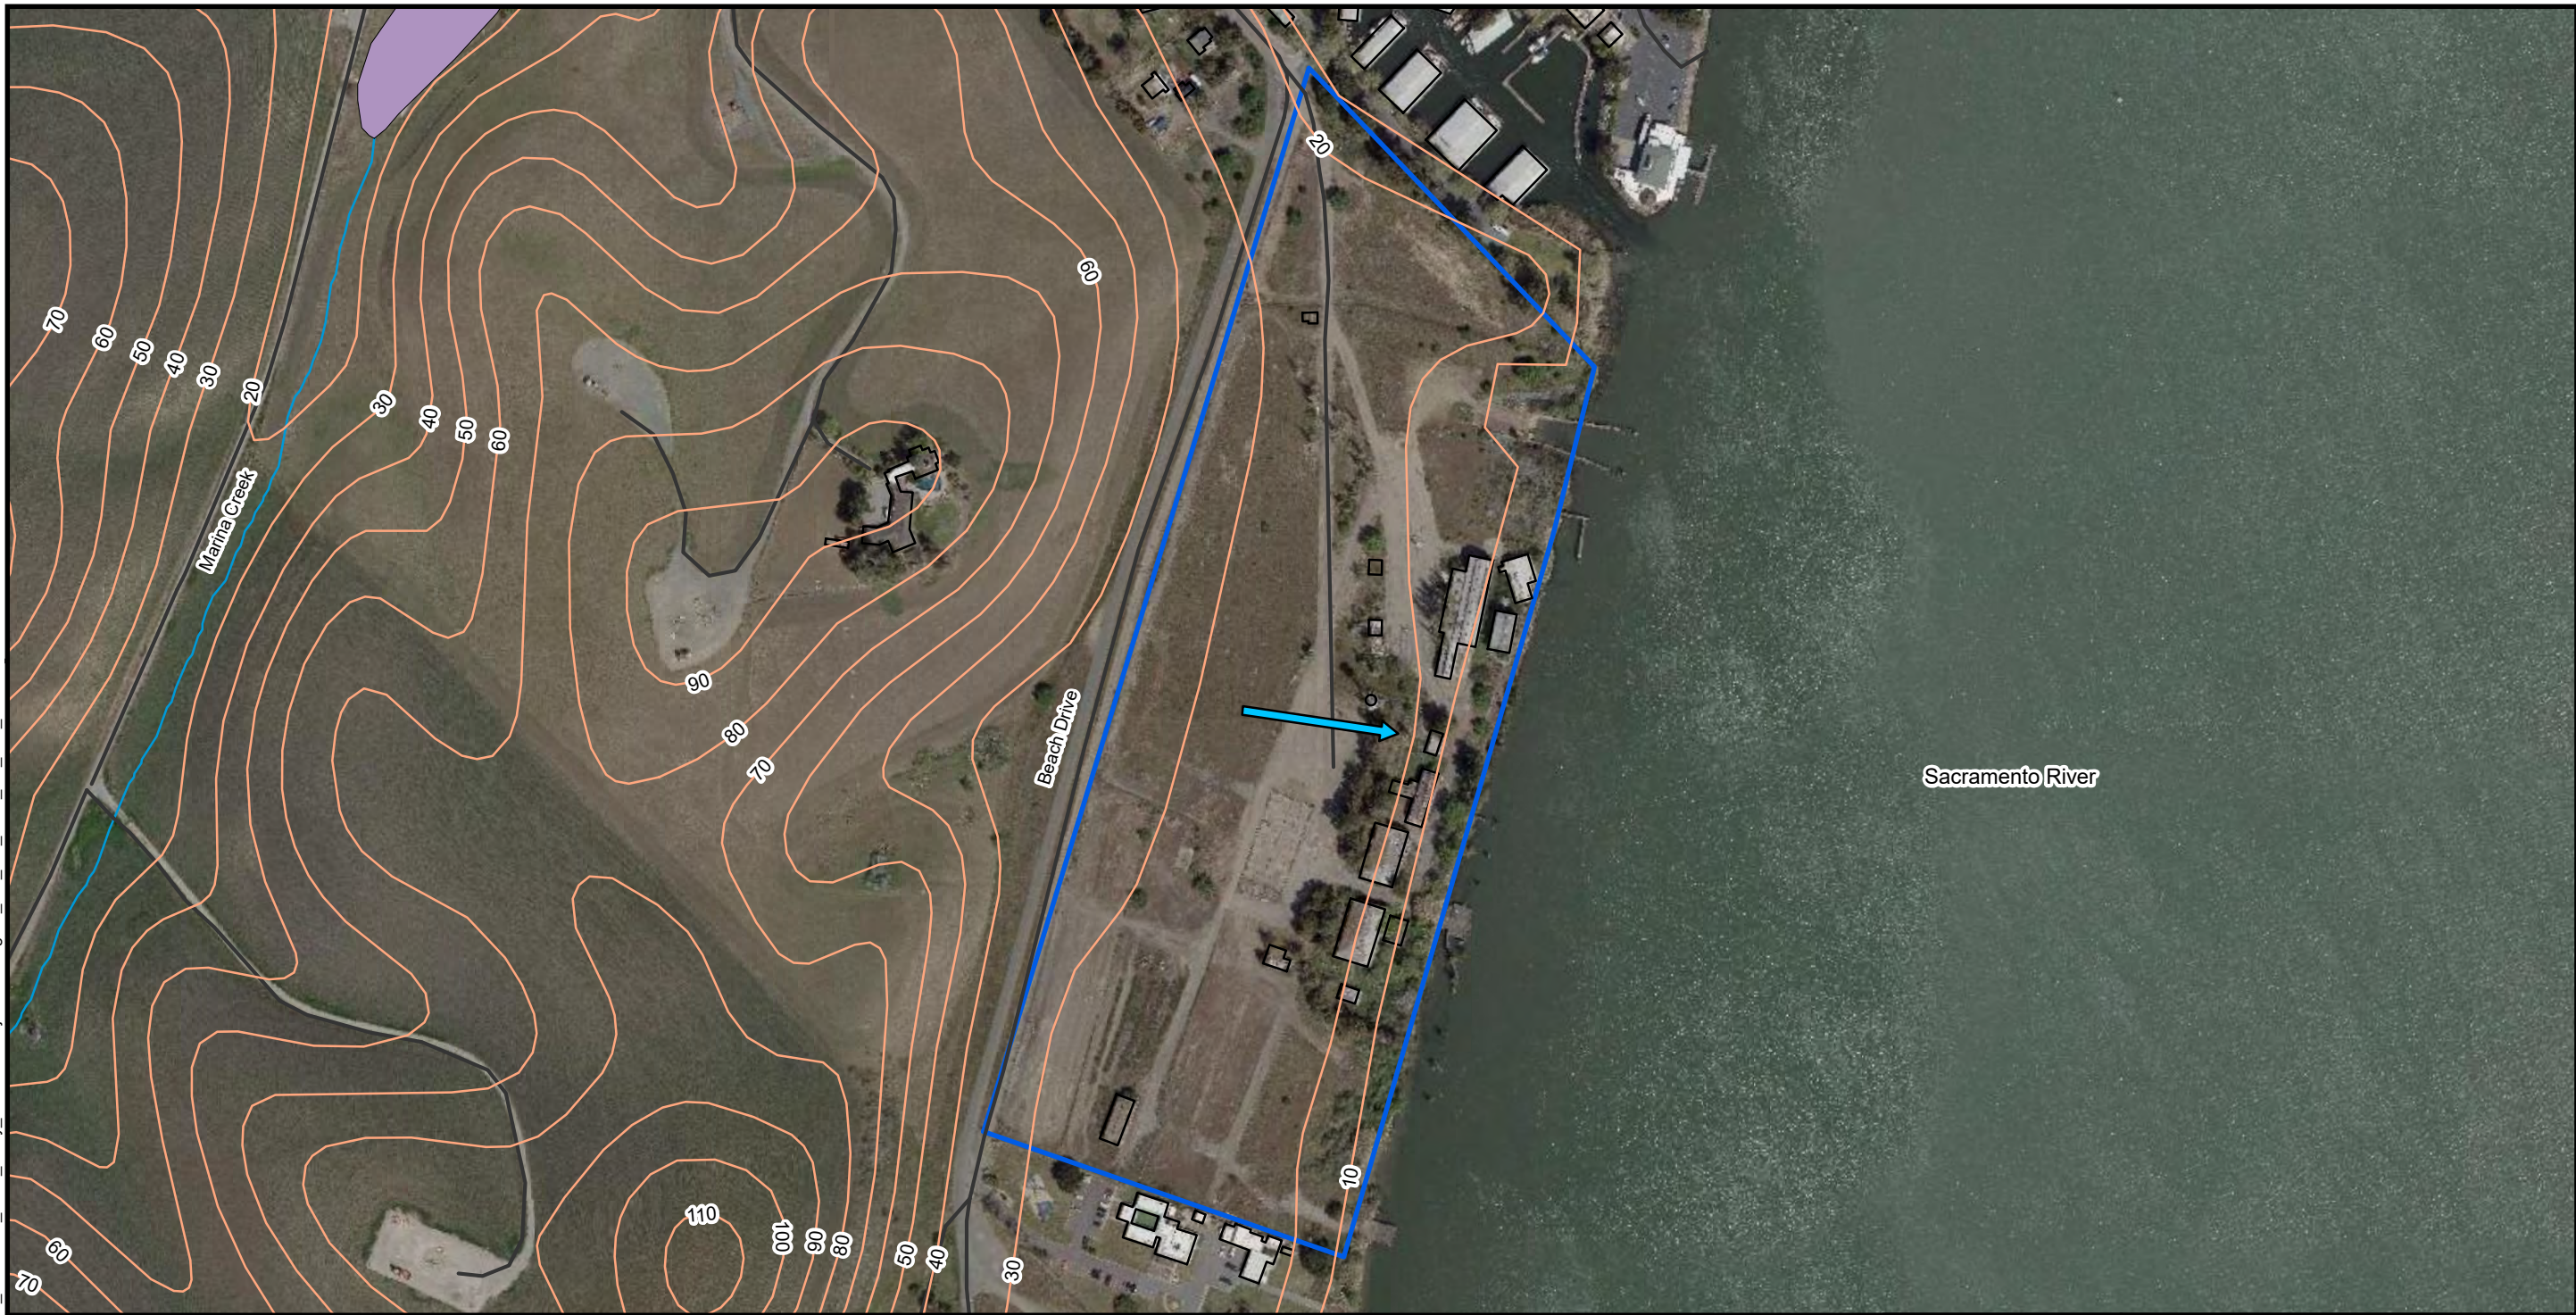
USARC Rio Vista is a former shallow-draft river and harbor craft maintenance, repair, and storage facility that encompassed approximately 28.2 acres at the time of closure (CRV 2010). The installation was activated in 1911 by the U.S. Army Corps of Engineers (USACE) as the U.S. Engineers Dockyard (USED) with a mission to support the work of USACE in dredging, clearing, and surveying the Sacramento River. USACE initially developed the 32-acre site with mooring grounds, a storehouse, and a wharf and by 1929, USED had erected at least seven buildings, marine ways, a wharf, and a derrick. The facility was used for marine storage, engine and hull repair, motor launches, barge mooring, and surface maintenance of steel pontoons used for floating suction dredges. The facility was also used as winter headquarters for floating equipment used on the Sacramento, San Joaquin, and Mokelumne Rivers (CRV 2010).

USARC Rio Vista is located on approximately 28.2 acres of primarily developed or disturbed habitat. The majority of the property contains open areas, some of which are used for storage and testing of highway barrier systems or vacant fields. Several unused, deteriorating buildings (e.g., ship repair shop, storage, barracks) or foundations of former buildings and boat docks are present on the eastern portion of the site.

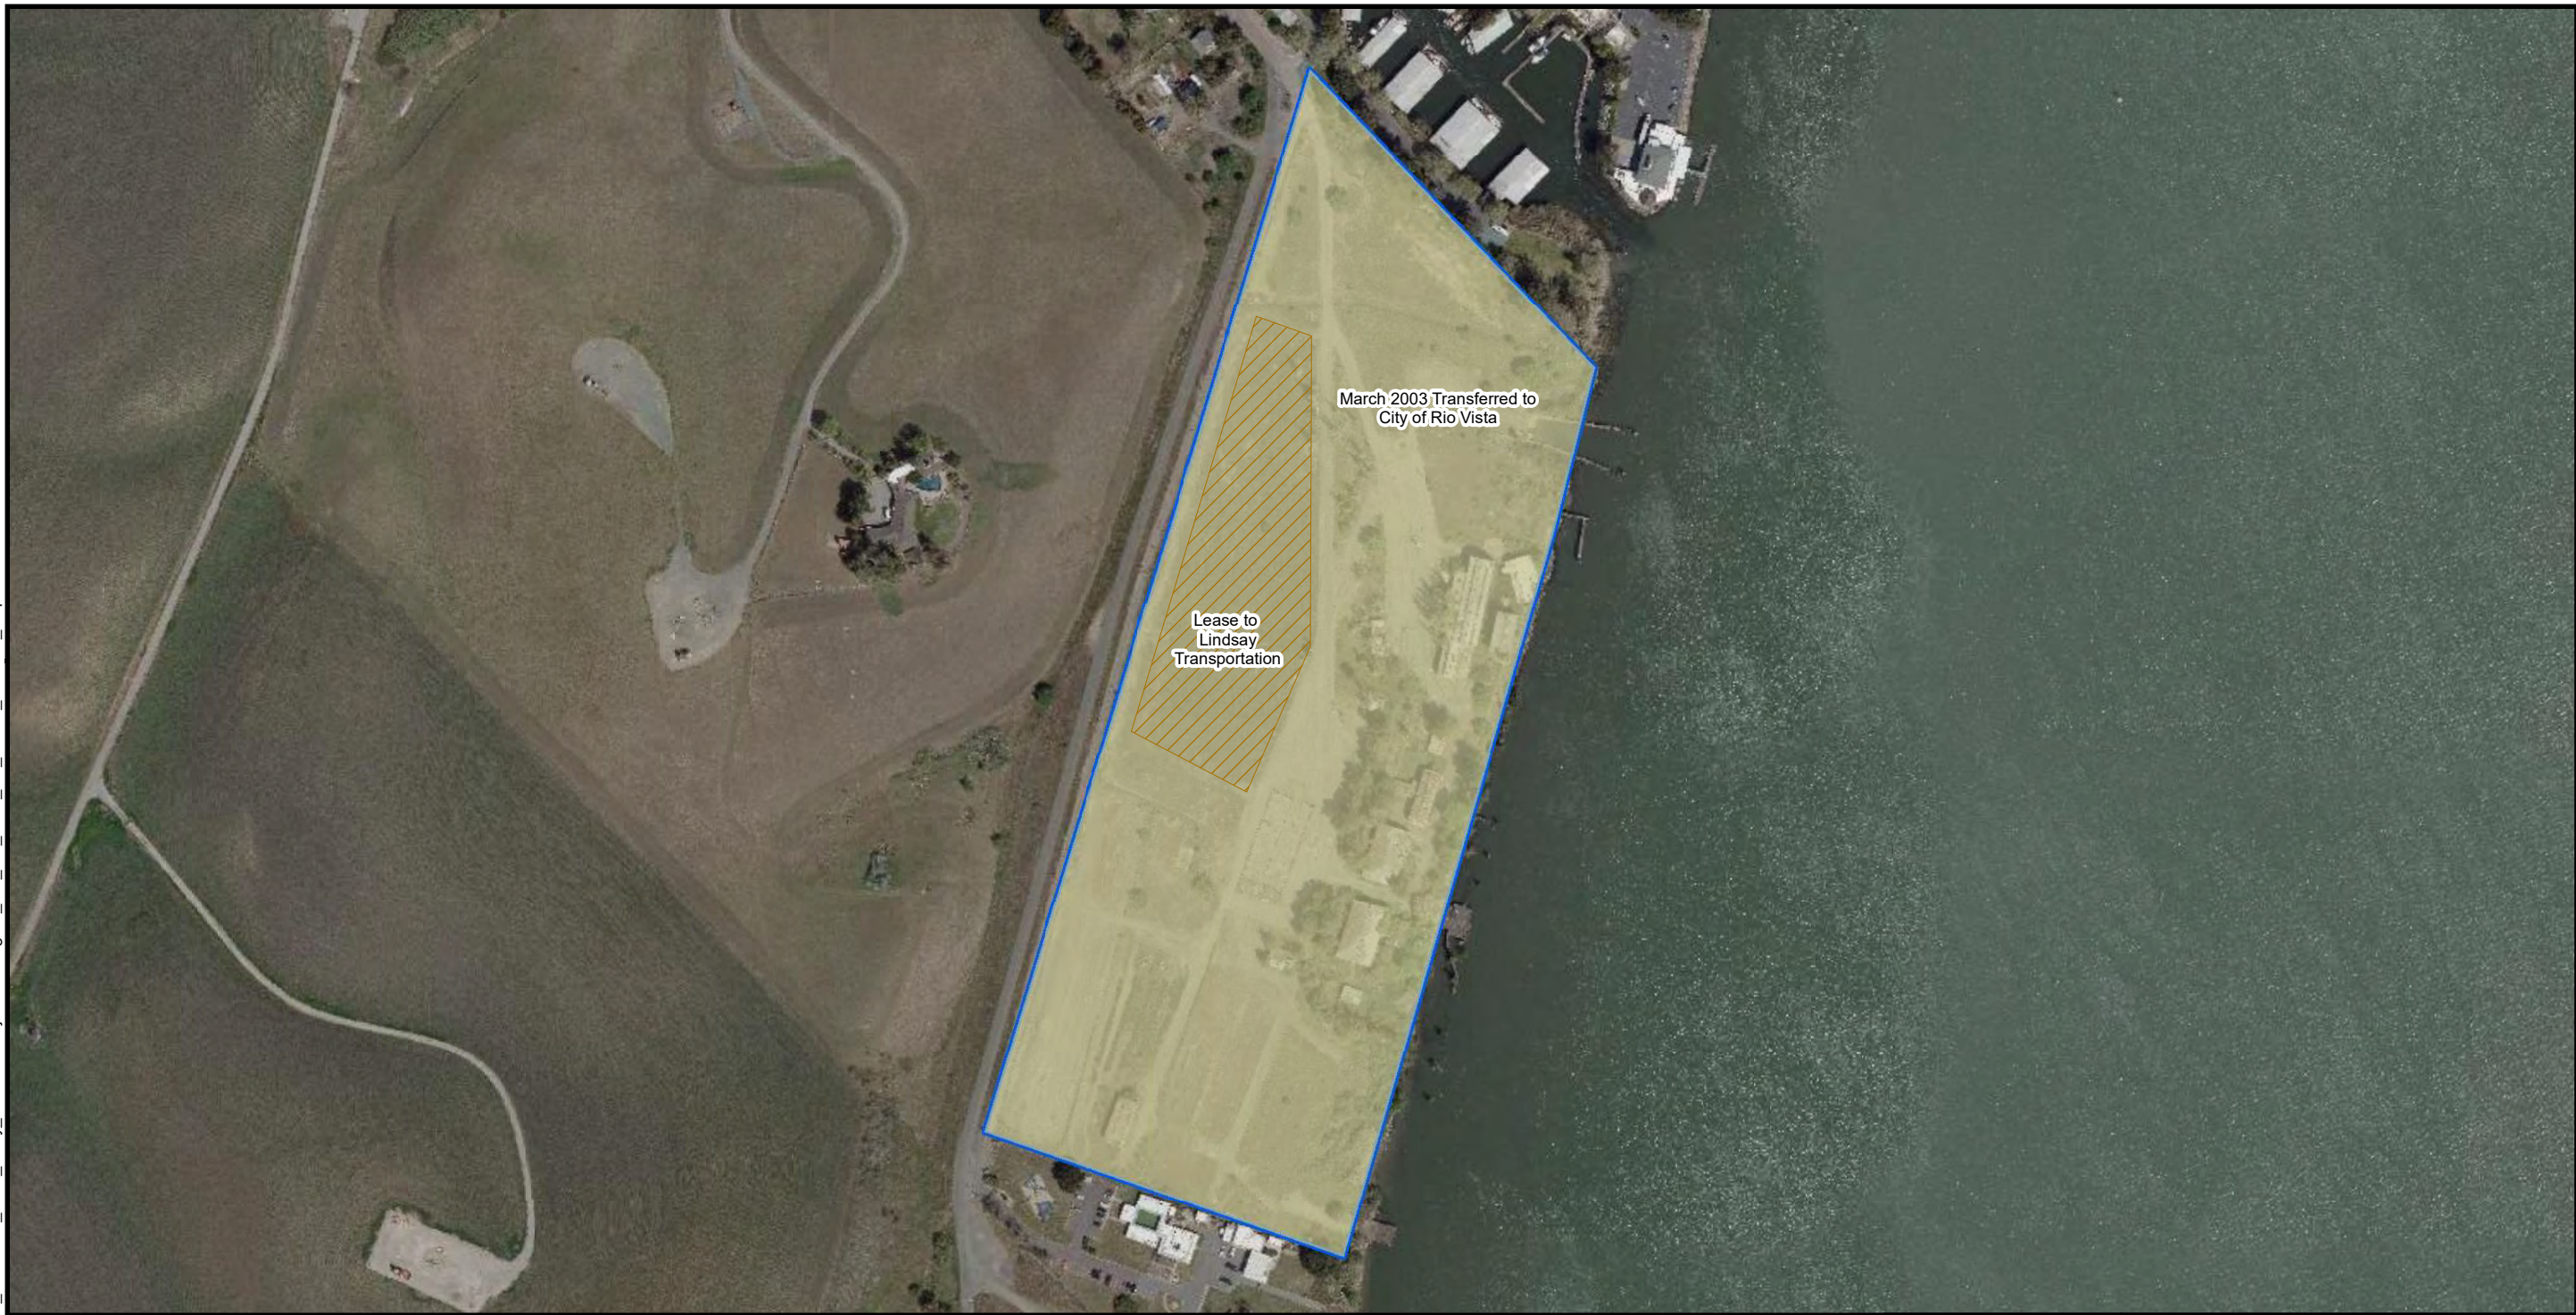
<b>PARCEL TRANSFER MAP</b>	
U.S. ARMY RESERVE CENTER RIO VISTA RIO VISTA, CALIFORNIA	
FIGURE 2-2	DATE: 5/11/2023

In 1989, USARC Rio Vista was deactivated and became a sub-installation of Fort Lewis, Washington in 1993 when it accepted real property accountability for the site from The Presidio of San Francisco. Since deactivation in 1989, the property has seen limited use by reserve units, and the only other notable military activity was a one-time training exercise held by the U.S. Marines in 1996. The 1995 BRAC Commission recommended USARC Rio Vista for closure. Until the 2003 property transfer, the only activity was Army caretaker operations consisting of mowing the grassy open areas of the property every 2 months (CRV 2010, CTC 2002, U.S. Army 2002, USACE 2000).

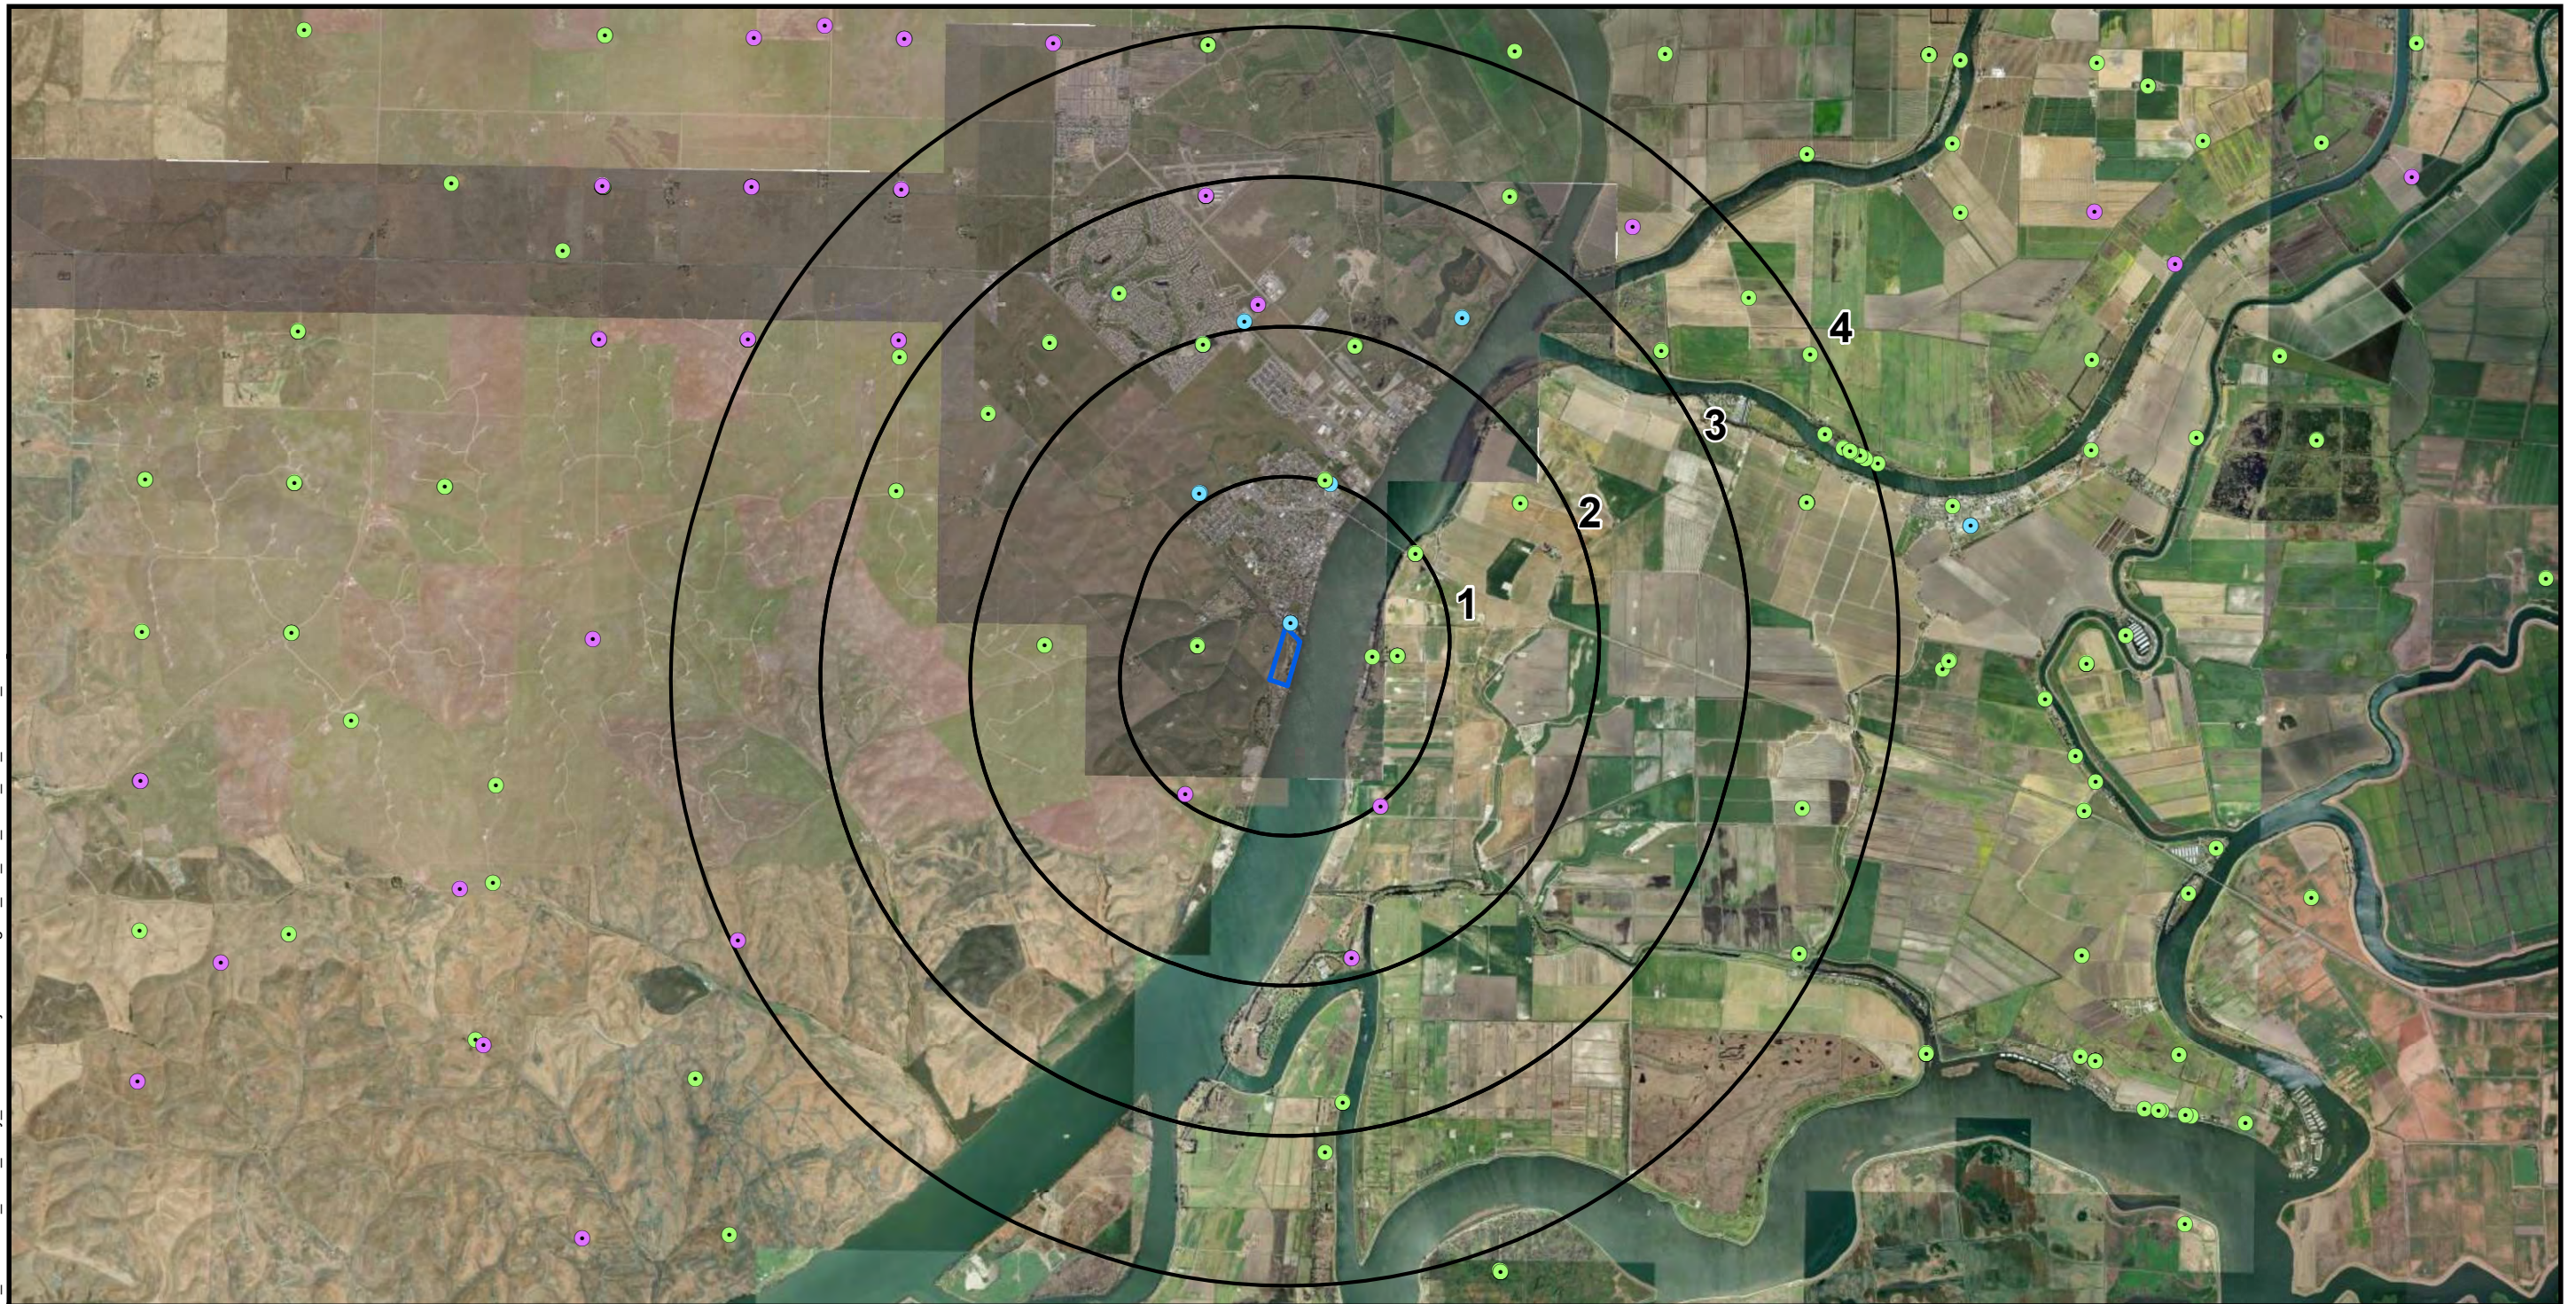
FIGURE 2-3	DATE: 5/11/2023
------------	-----------------

The city of Rio Vista uses groundwater exclusively for its municipal water supply. The city's municipal water system consists of six wells tapping into a deep aquifer, two 2-million-gallon water storage facilities, and a system of pumps and distribution pipes. The city has no central water treatment facility, and treatment instead occurs at the well head using sodium hypochlorite (CRV 2022a, CRVCDD 2002). The groundwater is sourced from the shallow Putah Fan aquifer, and the groundwater conditions in Solano County appear to be stable (SCWA 2021).

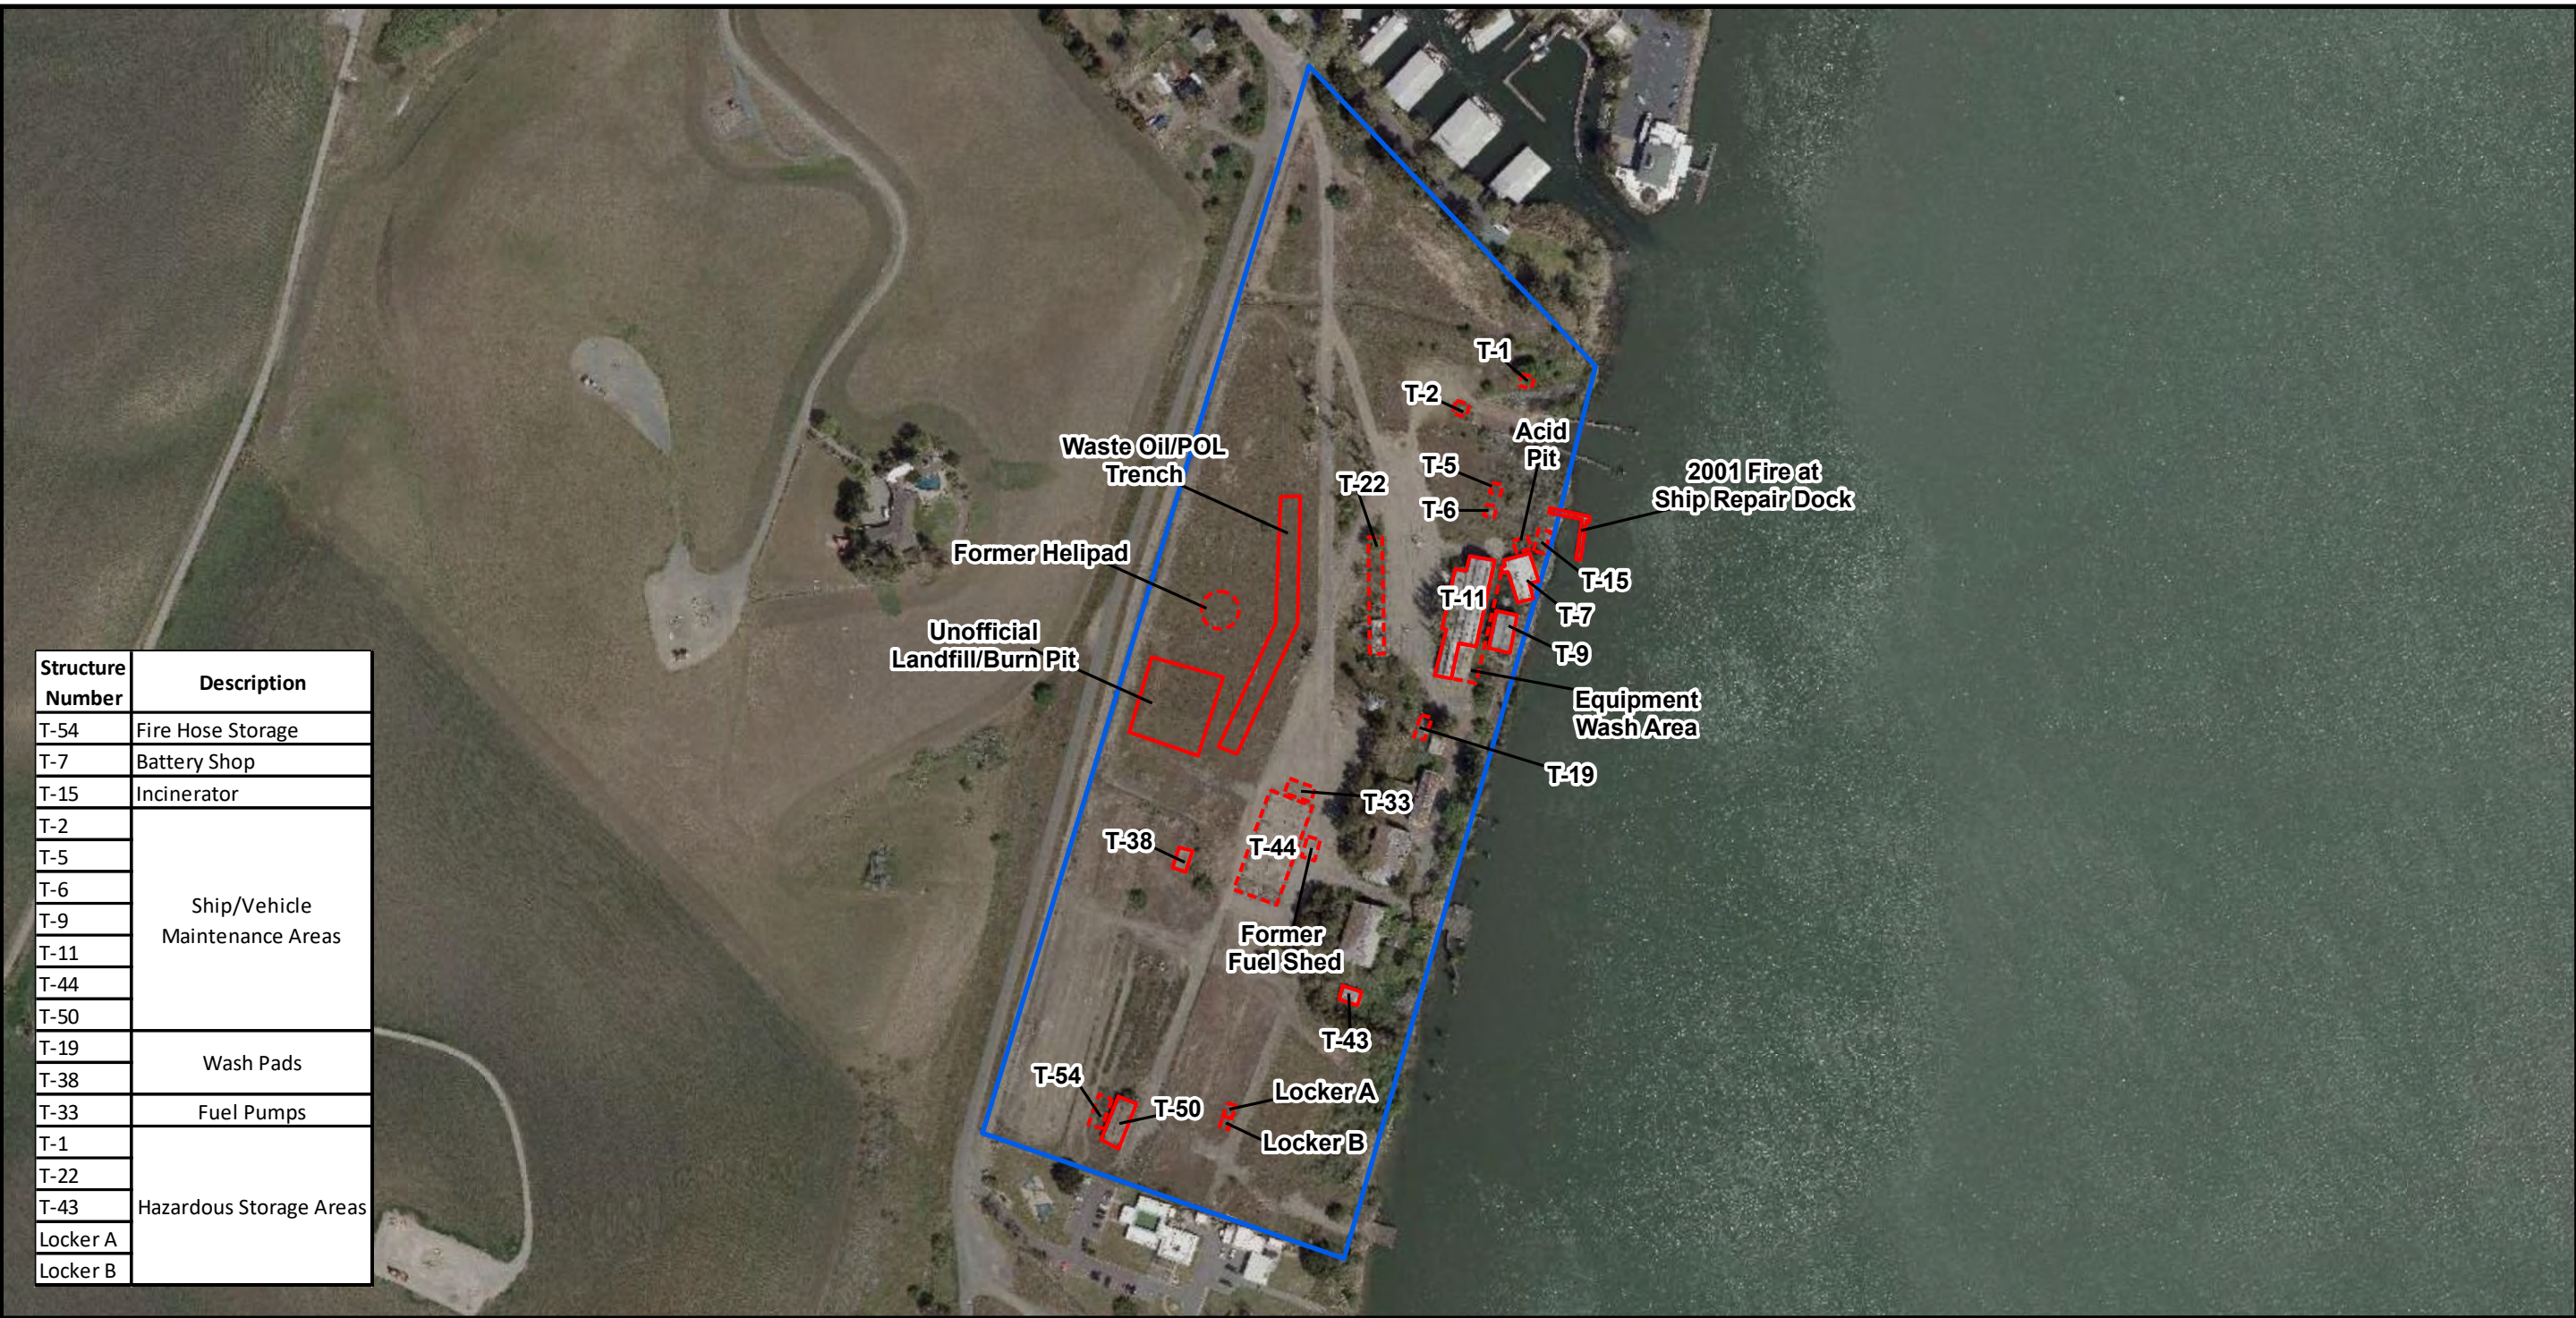
FIGURE 4-1	DATE: 8/15/2023
------------	-----------------

During the PA records reviews, interviews, aerial photographic analysis, and site reconnaissance, available documentation and physical evidence were examined for areas having a potential historical PFAS release. As noted in the 2018 Army Guidance for Addressing PFAS document, "At Army installations, the primary mechanism for releases of PFAS is through the historic use (post-1972) of Aqueous Film Forming Foam (AFFF), a product applied during firefighting and firefighting-related training. AFFF for firefighting was, and is, generally used in areas where fuel- or petroleum-based fires may have occurred, such as in the vicinity of aviation assets, fuel farms, or aircraft crash sites. The Army's current practice is not to use AFFF for petroleum-based training fires. Other known sources of environmental releases of PFAS include mist suppressants for metal plating operations and landfills and wastewater treatment plants that have inadvertently accepted PFAS containing materials" (U.S. Army 2018). For USARC Rio Vista, the areas evaluated include ship and vehicle maintenance shops, wash areas, a former fuel station, dumps and disposal areas, hazardous storage areas, burn areas, fire hose storage, and the area of a 2001 dock fire, as shown in Figure 4-1 and described in the following sections.

In 2001, a fire occurred at the ship repair dock near the marine railway (RSG 2010). USARC Rio Vista was vacant and under Army ownership at the time of the fire. The Rio Vista Fire Department has mutual aid agreements with neighboring departments and other Solano County fire departments; the Rio Vista Fire Department would be the first to respond to a fire at USARC Rio Vista, and the nearest department with a mutual aid agreement is the Montezuma Fire Protection District (Horizon 2017, USACE 2000). According to firefighters employed at the time of the fire and interviewed during this PA, the Rio Vista Fire Department responded to the fire and AFFF was not used. The cause of the fire was not identified.

- ***Unofficial Landfill/Burn Pit – 1970s:*** One unofficial landfill/burn pit was identified at USARC Rio Vista. The landfill was located on a flat, open, grassy areas on the upper terrace, to the southwest of Former Building T-22. Several former employees interviewed during environmental investigations conducted in the 1990s stated that the landfill received demolition debris, treated wood, and woody vegetation debris. They also indicated that wood products were burned in the landfill (CTC 2002, Woodward-Clyde 1997). Disturbance and staining at the unofficial landfill/burn pit is visible in aerial images from 1968, 1972, 1974, 1979, and 1984. During subsequent investigations conducted by the Army between 1997 and 1999, disposed of materials encountered and removed from the landfill area included metal debris, paint cans, and a metal container containing an unidentified oily substance. In addition, the presence of the suspected burn area containing metal debris and wood was confirmed at the eastern end of the landfill (Arcadis 2000, CH2M 2002, CTC 2002).

- ***Waste Oil/POL Trench – Pre-1970:*** A former civilian employee interviewed during the 1997 EBS (Woodward-Clyde 1997) stated that a 600-foot unshored waste oil/POL trench located on the eastern edge of the grassy area adjacent to the unofficial landfill/burn pit was used prior to 1970 to dispose of used engine and transmission oil. Disturbance in the area of the suspected waste oil/POL trench is visible in a 1968 aerial photograph. However, results of Army investigations conducted between 1996 and 2001 did not identify any physical, visual, chemical, or anecdotal evidence of the waste oil/POL trench (Arcadis 2002).

- ***Incinerator (former Structure T-15) – Pre-1968:*** An incinerator was located in the vicinity of the Battery Shop (Building T-7). The incinerator was a cylindrical steel structure approximately 10 feet long and 3.5 feet in diameter that sat on concrete footings. A small opening on the lower east end of the incinerator may have been used to discharge burned materials directly into the river. It is unknown what was burned in the incinerator, and it has not been used since 1967. Multiple metals,

- **Battery Shop Acid Pit – 1958-1989:** An acid pit was located outside the eastern Battery Shop (Building T-7) entrance. Etching on the floor of the battery shop was observed during the 1997 EBS (Woodward-Clyde 1997). Subsequent environmental investigations identified elevated concentrations of lead and the presence of slightly to strongly basic soil in the area outside the battery shop, which is what was considered the acid pit. It is believed that soils were affected by electrolyte solution from the batteries stored in the shop, but no evidence of disposal, such as lead debris or battery casings, was identified. In 2000, soil was removed as part of the Interim Removal Action to 5 feet bgs at the Battery Shop Acid Pit (Arcadis 2002, CH2M 2002, CTC 2002). Additional details or documentation on the acid pit were not identified during this PA.

- **Maintenance Activities** – Ship and vehicle maintenance activities were conducted at former Buildings T-2, T-5, T-6, and T-44, and Buildings T-9, T-11, and T-50. Typical maintenance activities conducted at USARC Rio Vista included the removal of water, fuel, and debris from vessels going into storage; propeller and rudder maintenance; painting; and the installation and testing of navigational and electronic equipment. Former Buildings T-2, T-5, and T-6 were winch sheds used to remove ships from the water for repair, scraping, sandblasting, painting, and storage. The area between these three buildings was used for painting operations. Former Building T-44 and Buildings T-9 and T-11 were major ship repair shops, with Building T-11 containing a sump and an oil/water separator (OWS) that were cleaned out in 2000 (Arcadis 2002, CH2M 2002, CTC 2002). Building T-50 served as the Vehicle Maintenance Shop. The precise operational period of these facilities is unknown, but peak use likely occurred between 1952 and 1974, with reduced use in the 1970s and 1980s as USARC Rio Vista transitioned to a training-focused facility. No known PFAS-containing materials were used at these facilities.

- **Hazardous Storage Areas** – Hazardous materials at USARC Rio Vista were stored at former Building T-1, Building T-43, and Paint Lockers A and B. Hazardous materials stored in these locations primarily consisted of flammable materials and paint. The northern end of former Building T-22 contained a wood-framed, plastic-lined box filled with sand and was used to contain petroleum products and other unknown hazardous waste prior to disposal (CTC 2002, Woodward-Clyde 1997). No known PFAS-containing materials were stored at these buildings.

Structure Number	Description
T-54	Fire Hose Storage
T-7	Battery Shop
T-15	Incinerator
T-2	Ship/Vehicle Maintenance Areas
T-5	
T-6	
T-9	
T-11	
T-44	
T-50	Wash Pads
T-19	
T-38	Fuel Pumps
T-33	
T-1	Hazardous Storage Areas
T-22	
T-43	
Locker A	
Locker B
