**PRELIMINARY ASSESSMENT OF PER- AND
POLYFLUOROALKYL SUBSTANCES AT
RIVERBANK ARMY AMMUNITION PLANT
RIVERBANK, CALIFORNIA**

Final
August 2023

**Leidos
1750 Presidents Street
Reston, Virginia 20190**

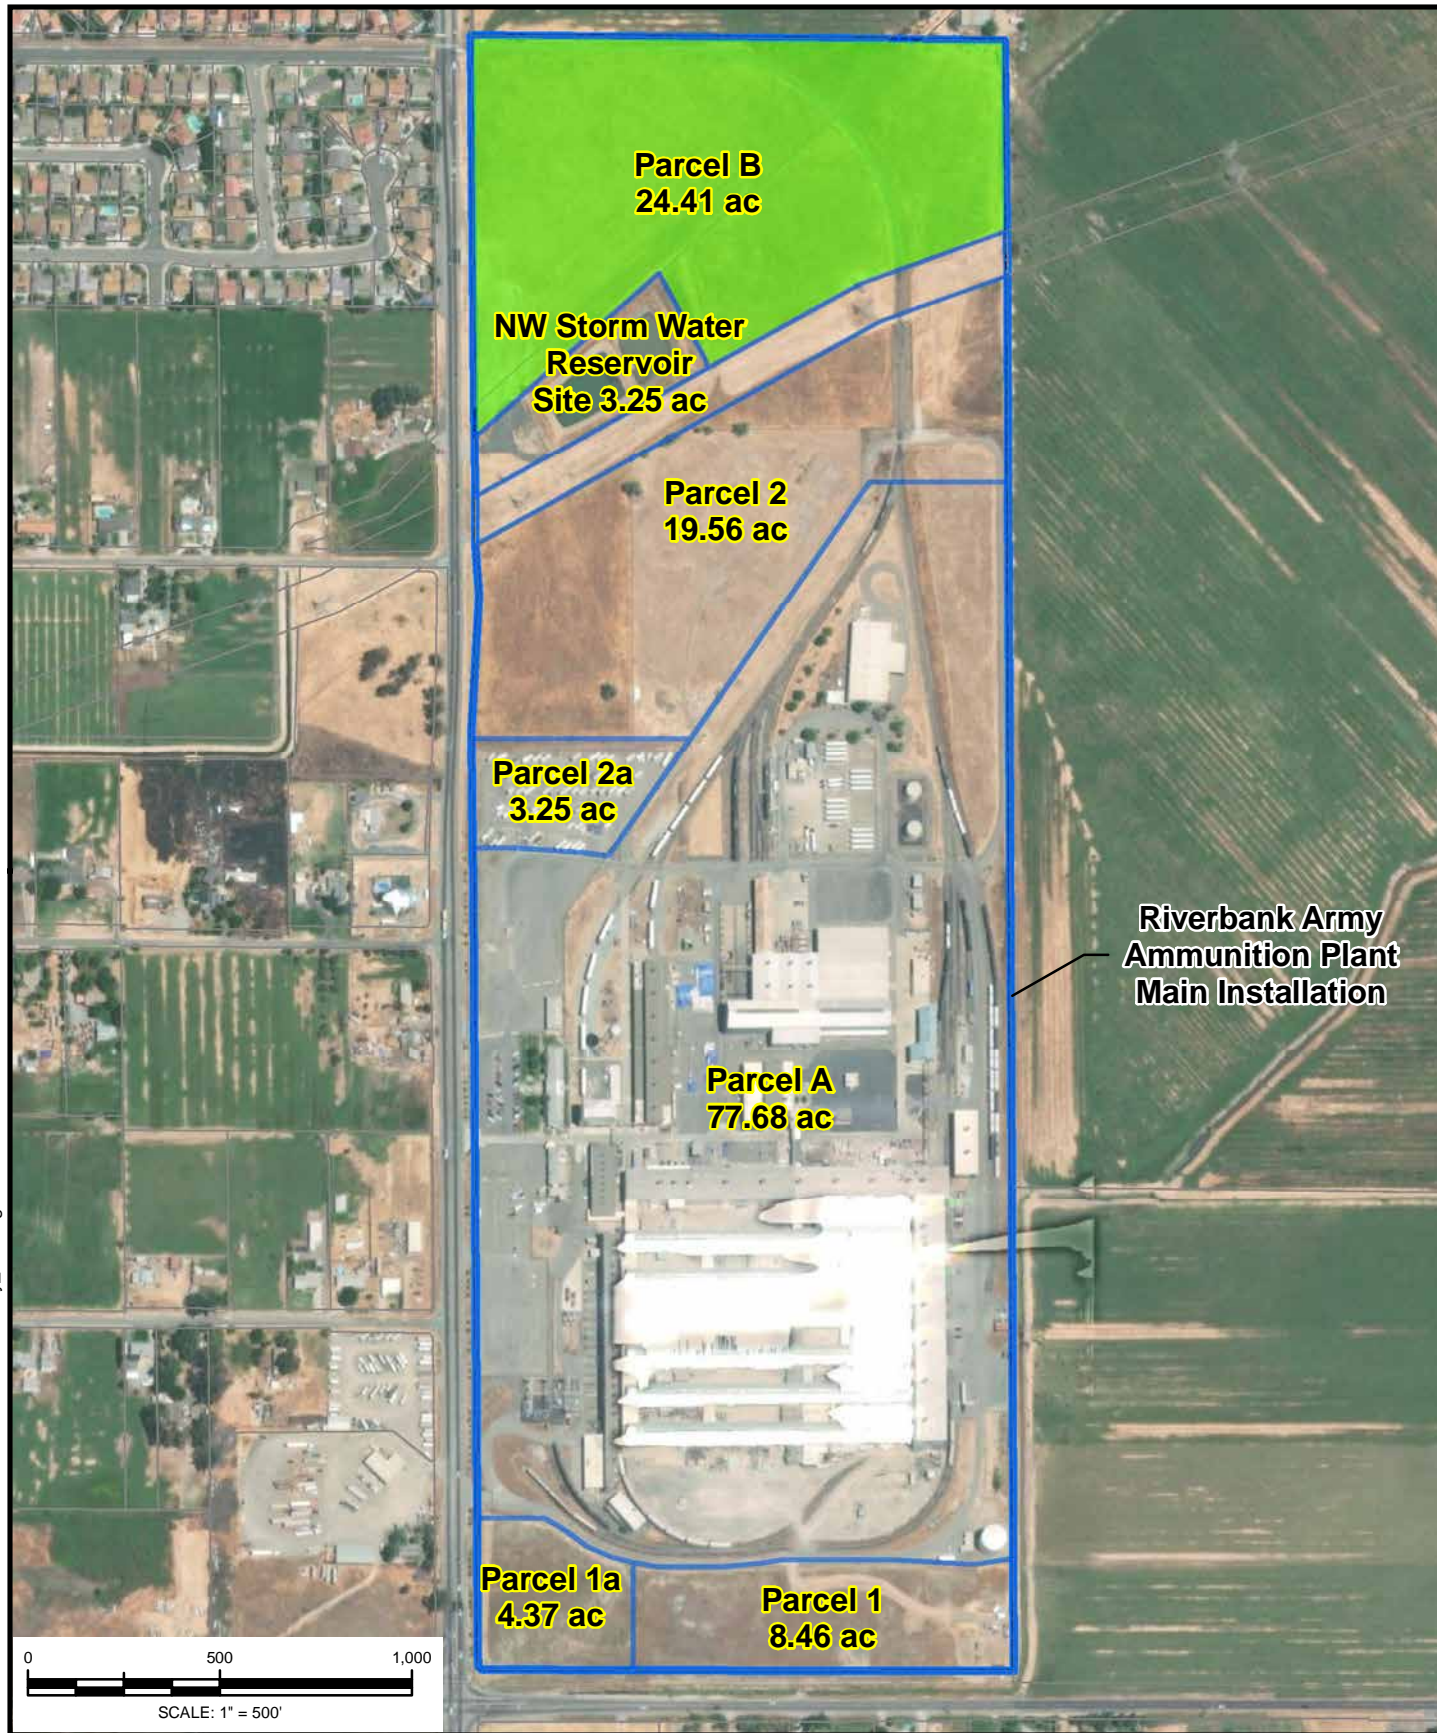
FIGURE 2-2 DATE: 5/1/2023

RBAAP is broken into the following six parcels on the main installation (A, B, 1, 1a, 2, and 2a) and Parcel 4 (E/P ponds), as shown in Figure 2-2. On October 17, 2017, Parcel B (24.42 acres) was transferred to the Riverbank Local Redevelopment Authority (RLRA) for use as a new green industry park via a no-cost Economic Development Conveyance (EDC). The remaining acreage on the main installation is leased by RLRA, which then subleases the facilities for manufacturing, light industrial use, storage, and repair facilities (U.S. Army 2020). The Army plans to transfer Parcel A (77.8 acres) and the Northwest Stormwater Reservoir (3.3 acres) via a no-cost EDC to RLRA. The remaining parcels will be put up for sale (U.S. Army 2020).

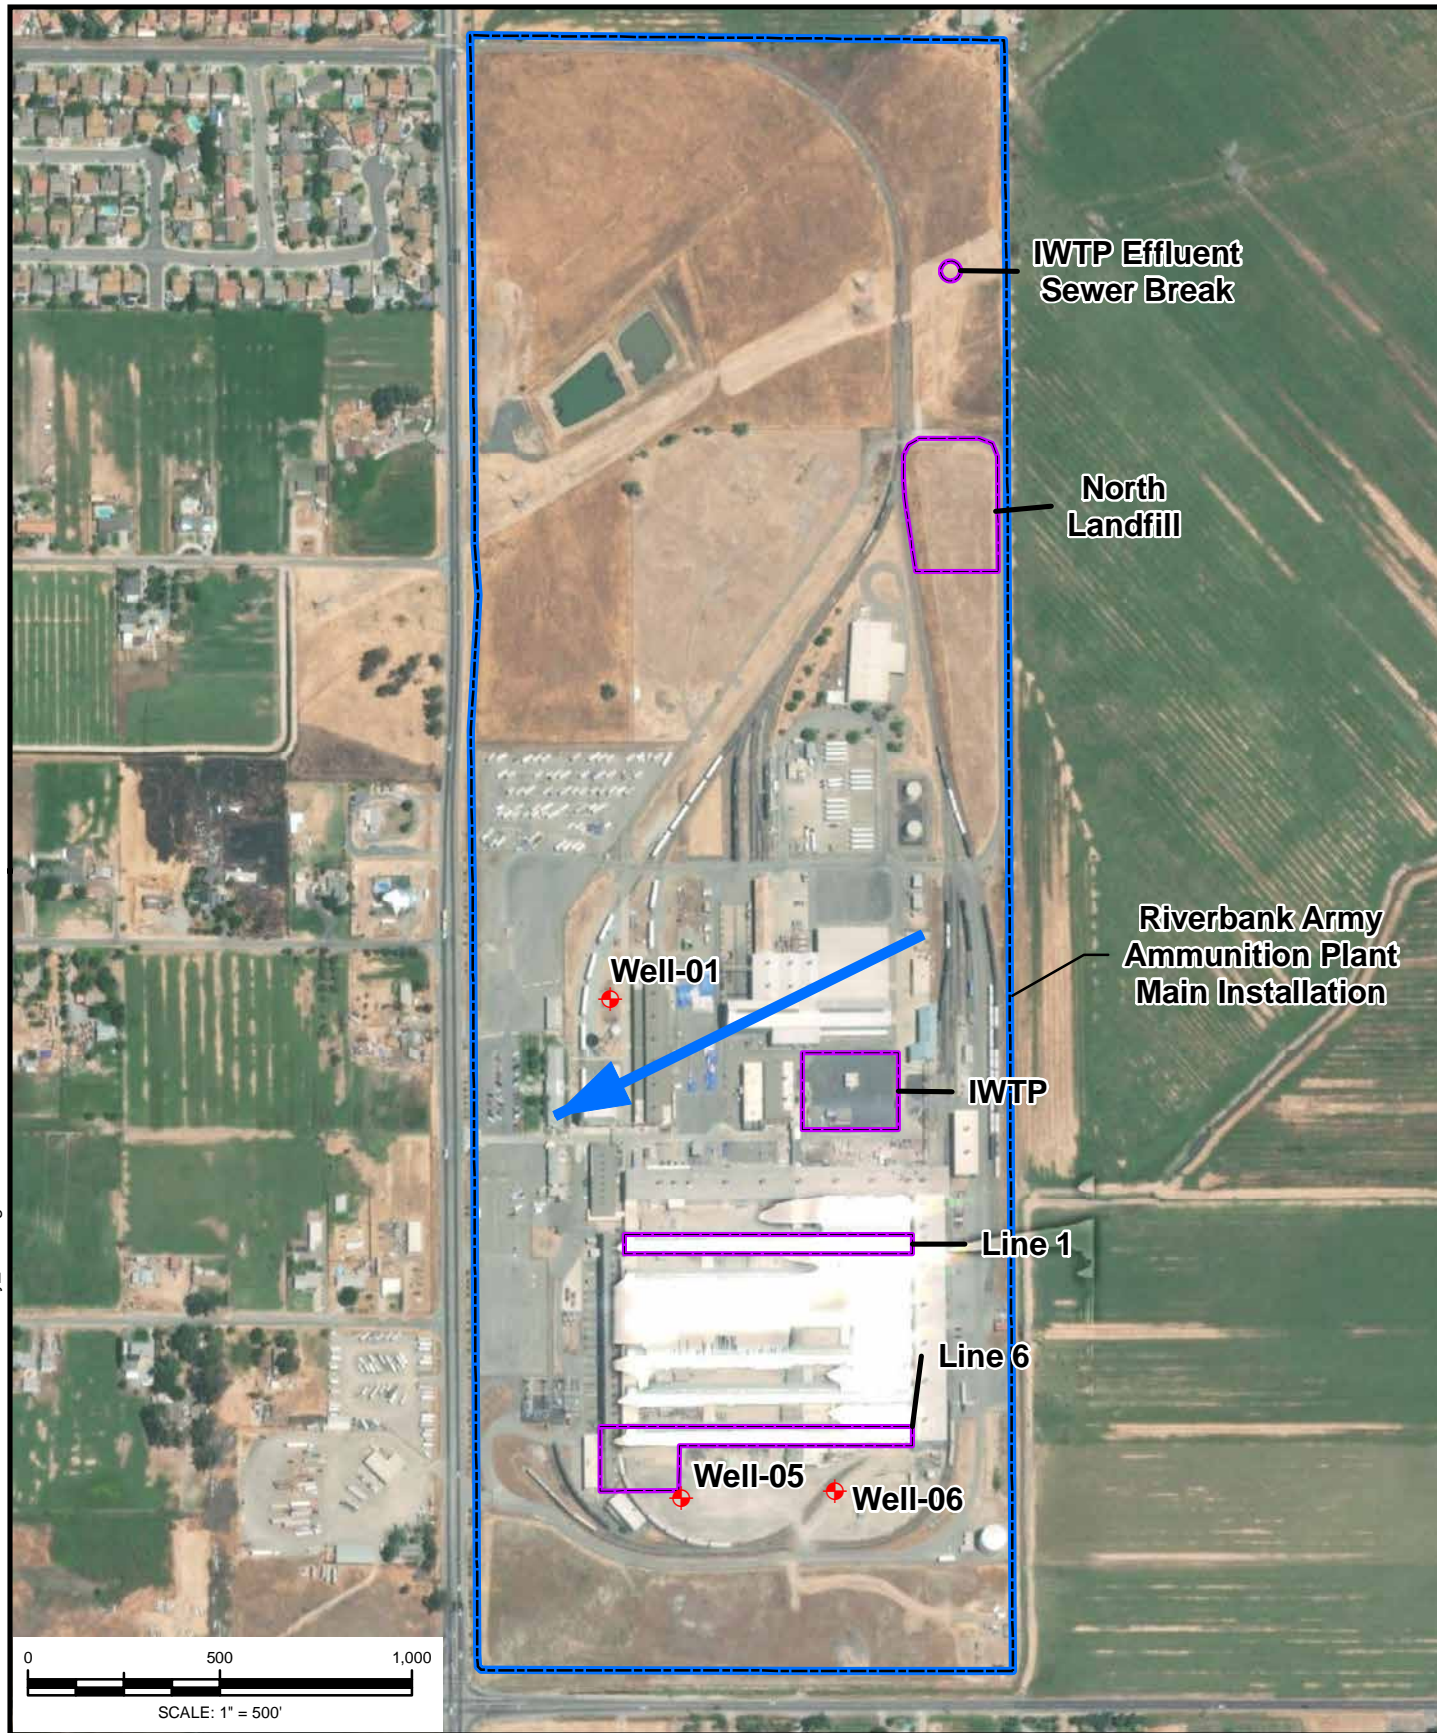
- Legend**
- ◆ RBAAP Water Supply Wells
 - Groundwater Flow Direction
 - Areas of Potential Interest (AOPI)
 - Installation Boundary

Notes:
Groundwater flow direction as presented in the Fourth Quarter 2020 Status Report, In Situ Treatment Phase IB, Ahna Global, LLC, July 2021.
