FINAL PRELIMINARY ASSESSMENT AND SITE INSPECTION OF PER- AND POLYFLUOROALKYL SUBSTANCES

Sierra Army Depot, California

February 2022

Arcadis U.S., Inc.

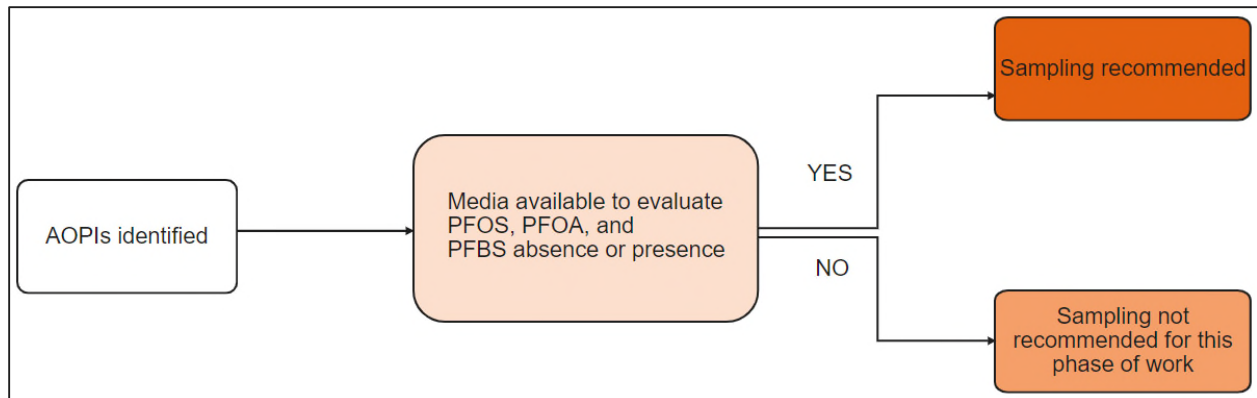
Figure 6-1: AOPI Sampling Decision Tree

The rationale for sampling at each AOPI is illustrated on **Figure 6-1** below.

The sampling design for SI sampling activities at SIAD is detailed in Worksheet #17 of the SIAD QAPP Addendum (Arcadis 2020). Briefly, groundwater, soil, surface water, and sediment samples were collected from on-post production wells, existing monitoring wells, and soil borings at and downgradient of areas with a known or suspected AFFF use, AFFF storage areas, and areas that historically received potentially PFAS-containing materials. Soil samples were collected to inform the interpretation of PFOA, PFOS, and PFBS distribution, evaluate the potential for those areas to be sources of PFOS, PFOA and PFBS to surface water and groundwater as an influence to drinking water, and update the individual AOPI CSMs. Groundwater, surface water, soil and sediment samples were analyzed for PFOS, PFOA, and PFBS by Liquid Chromatography with tandem mass spectrometry Compliant with Table B-15 of DOD QSM 5.3, and one soil sample from each AOPI was also analyzed for total organic carbon (TOC), pH, and grain size.

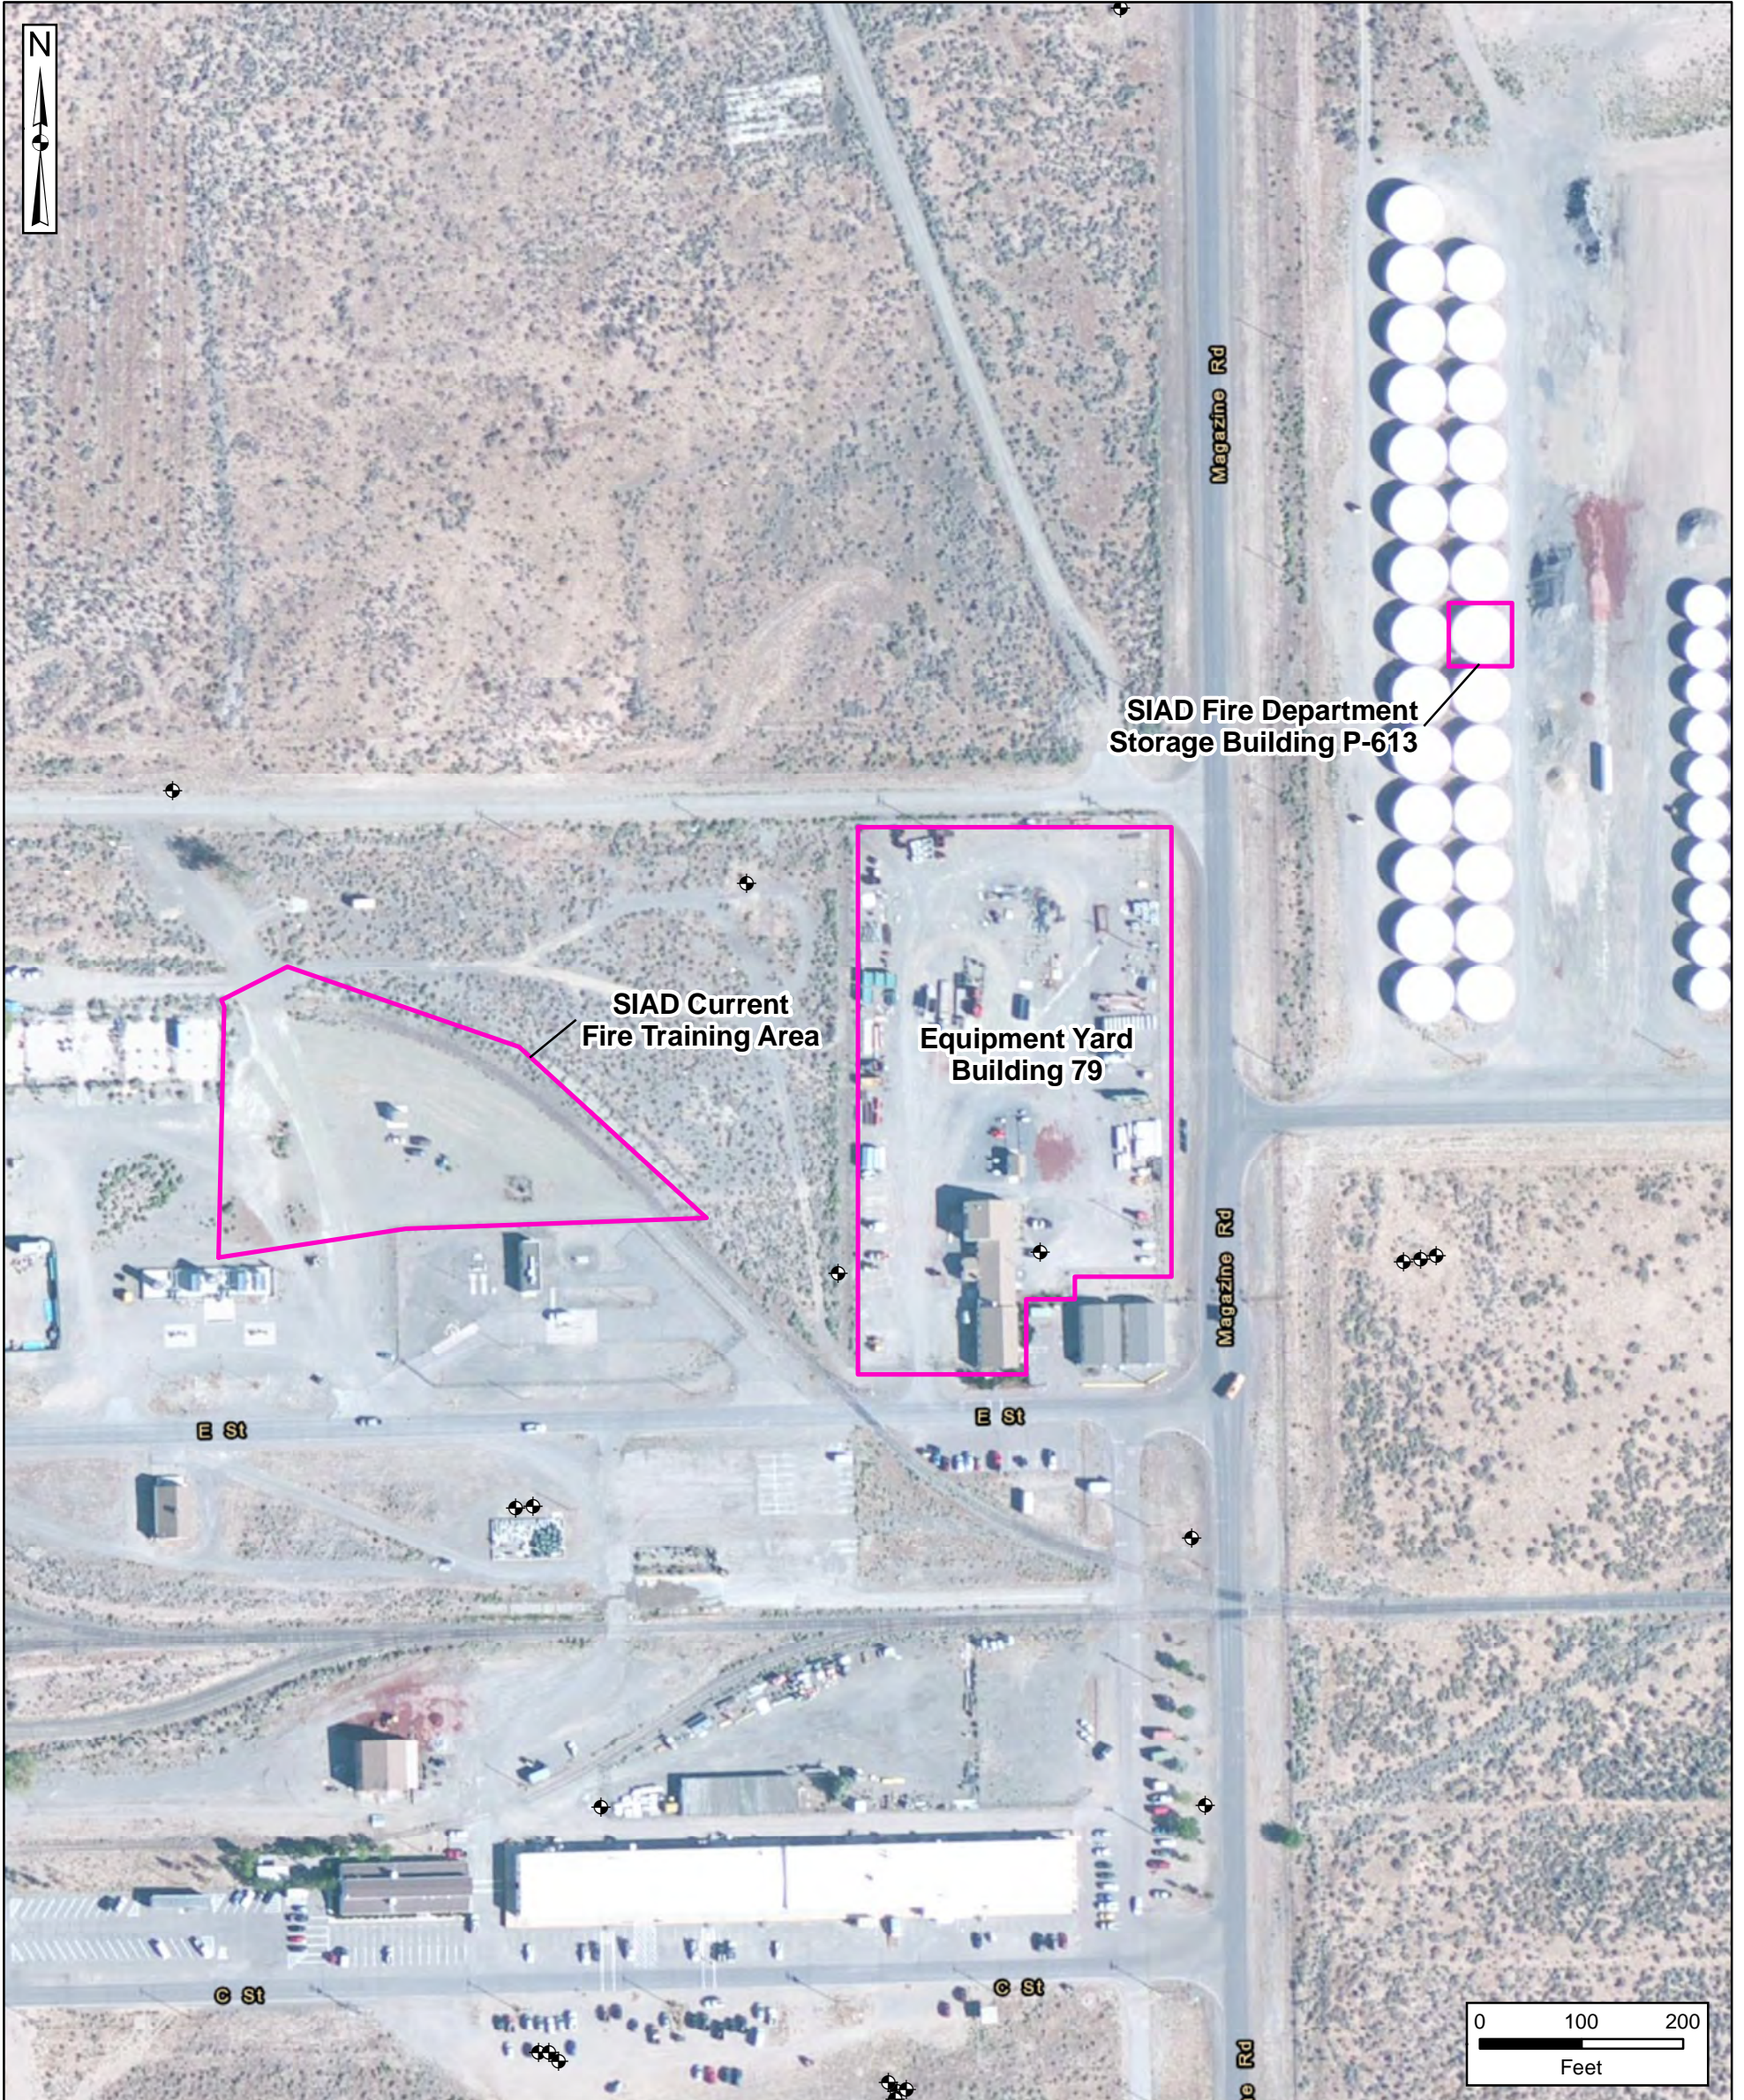
Figure 5-3
Aerial Photo of SIAD Current Fire Training Area,
Equipment Yard - Building 79, and
SIAD Fire Department Storage Building P-613

The SIAD Fire Department Storage Building P-613 is identified as an AOPI following records research, personnel interviews, and site reconnaissance due to historical AFFF storage. Five-gallon containers totaling approximately 100 gallons were previously stored here. An interviewee reported that AFFF containers were found (sometime from 2015 to 2018) leaking on a shelf and that liquid had spilled to the floor. PFAS constituents were detected in soil samples collected within this AOPI in 2017 (**Figure 5-3**, **Table 2-2**).

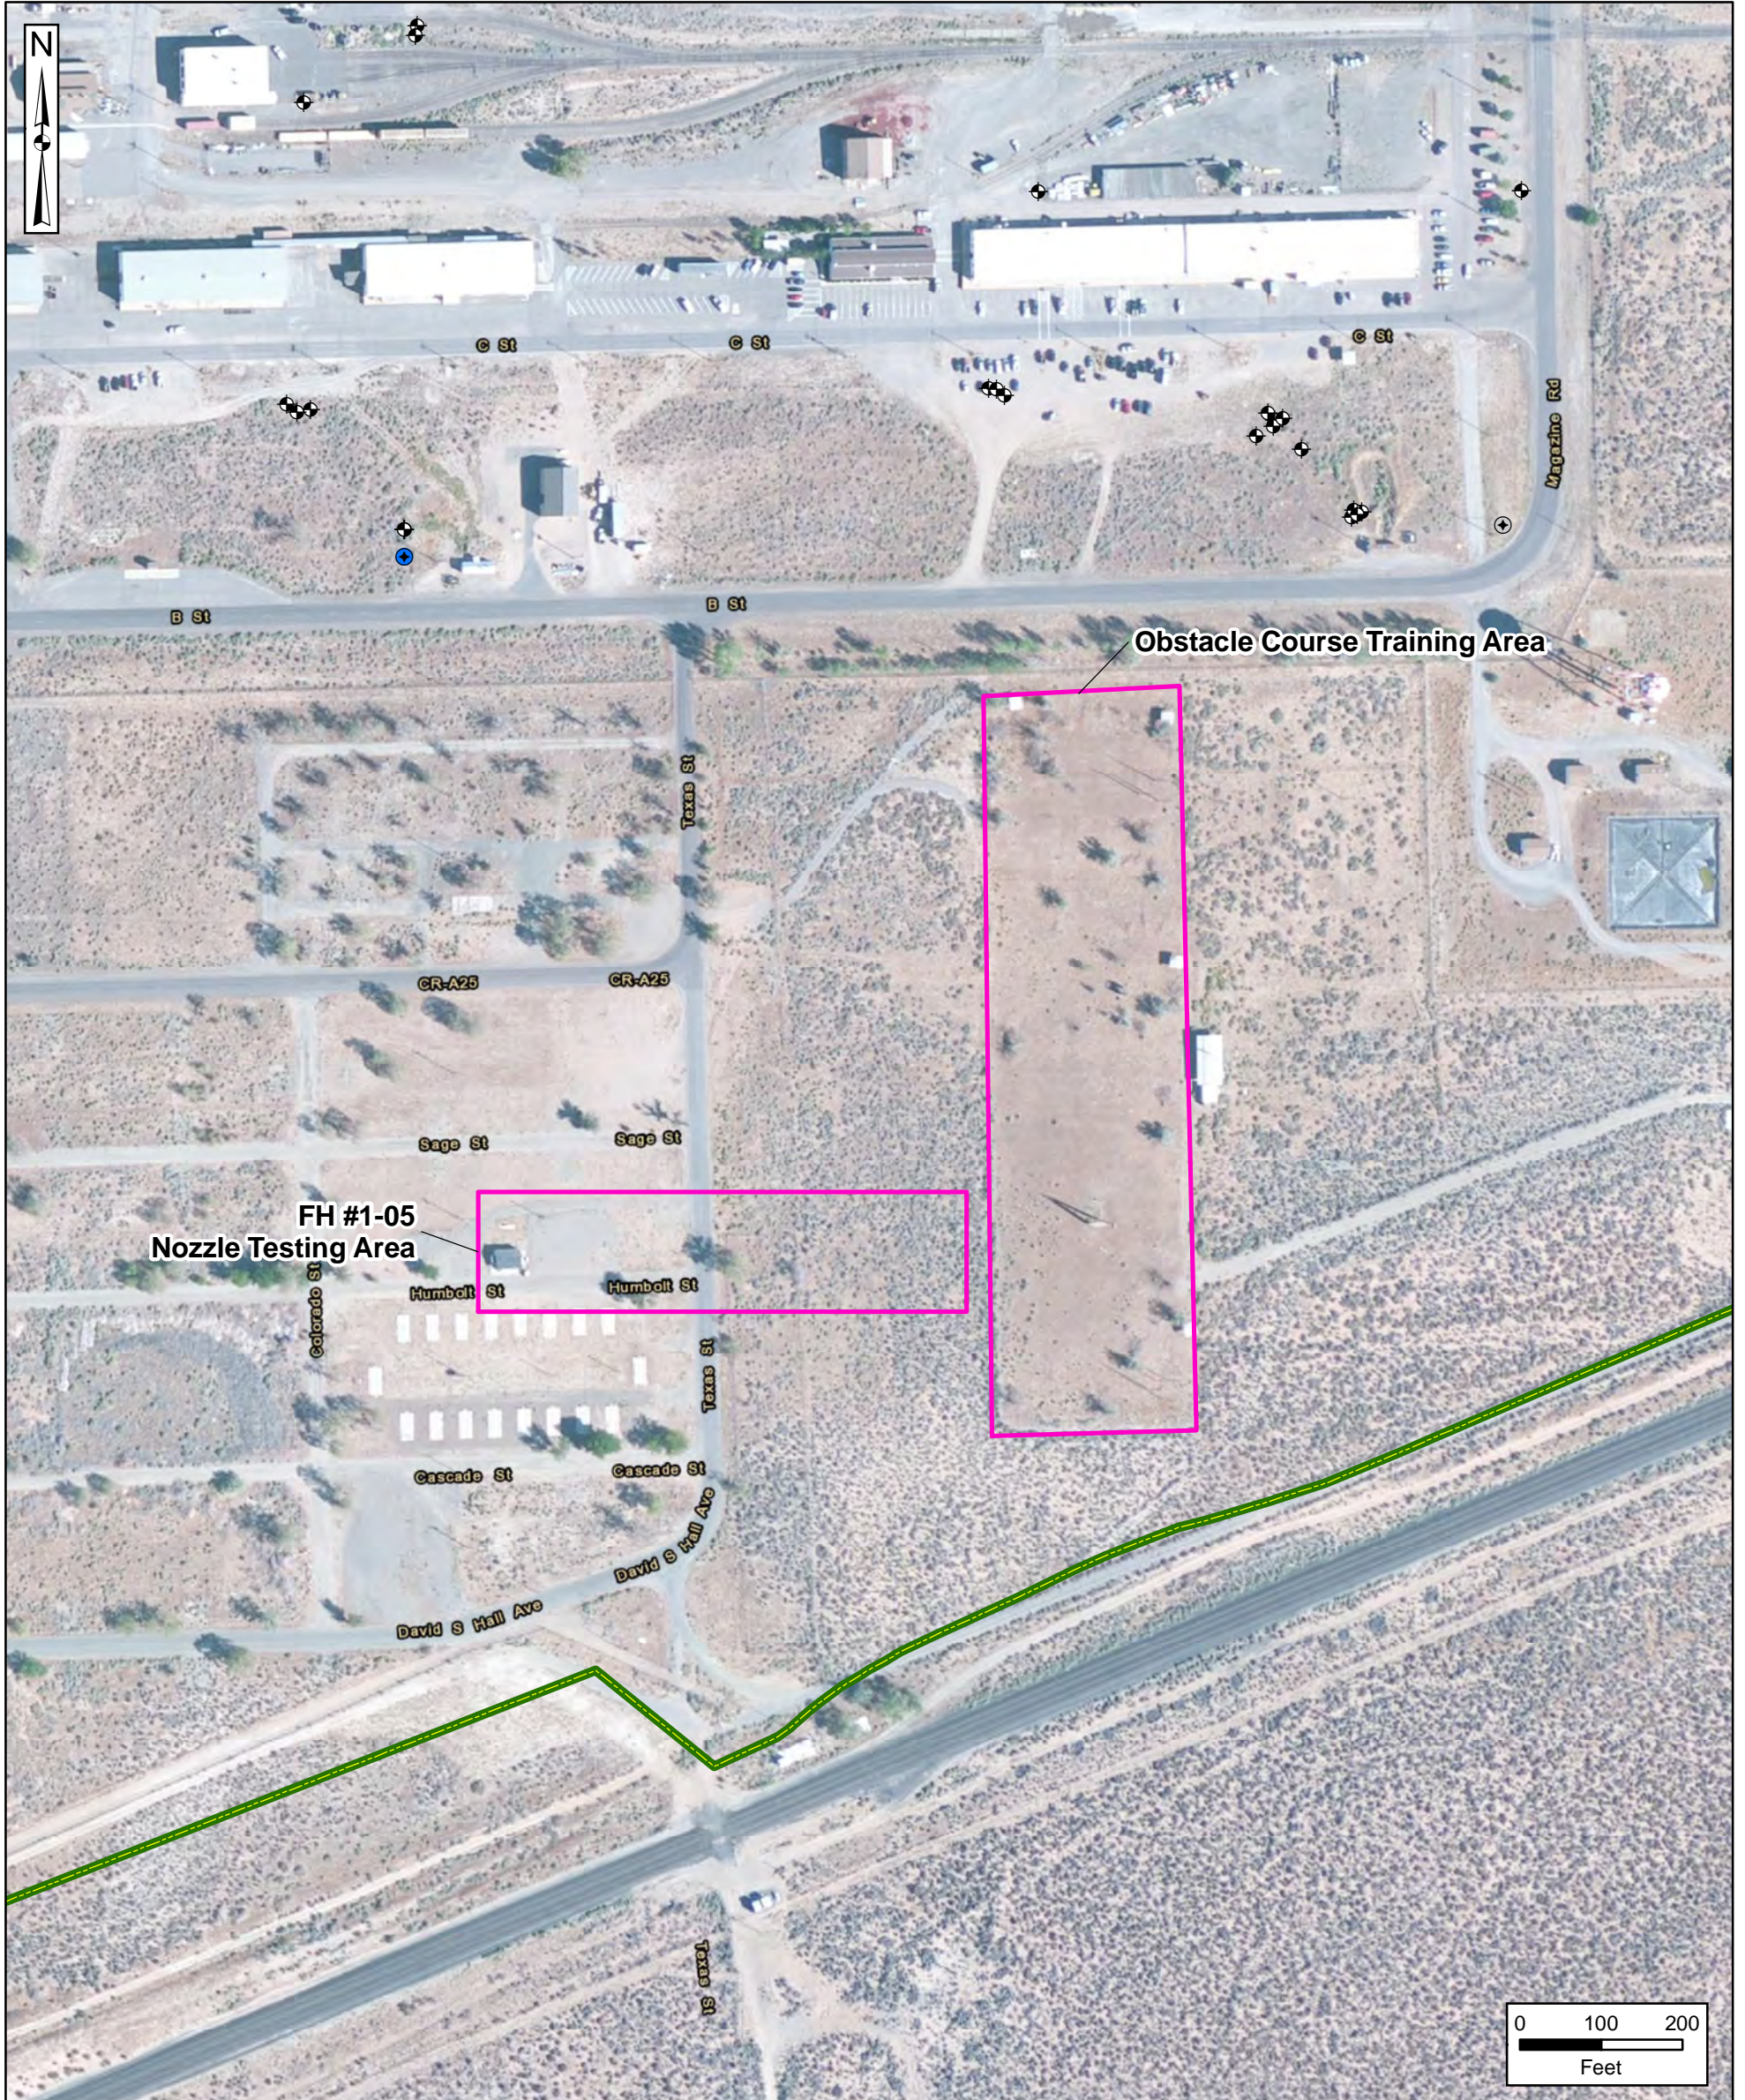
Figure 5-5
Aerial Photo of
Obstacle Course Training Area and
FH #1-05 Nozzle Testing Area

The Obstacle Course Training Area is identified as an AOPI following records research and personnel interviews due to training activities. Environmental personnel indicated that AFFF was used during training activities at the obstacle course (**Figure 5-5**).

The FH # 1-05 Nozzle Testing Area is identified as an AOPI following personnel interviews and site reconnaissance due to foam nozzle testing activities. FH #1-05 was used to support monthly nozzle testing with AFFF in the 1990s. Nozzle testing occurred on both sides of Texas Street in a former housing area, likely north of the Humboldt Street intersection (**Figure 5-5**).

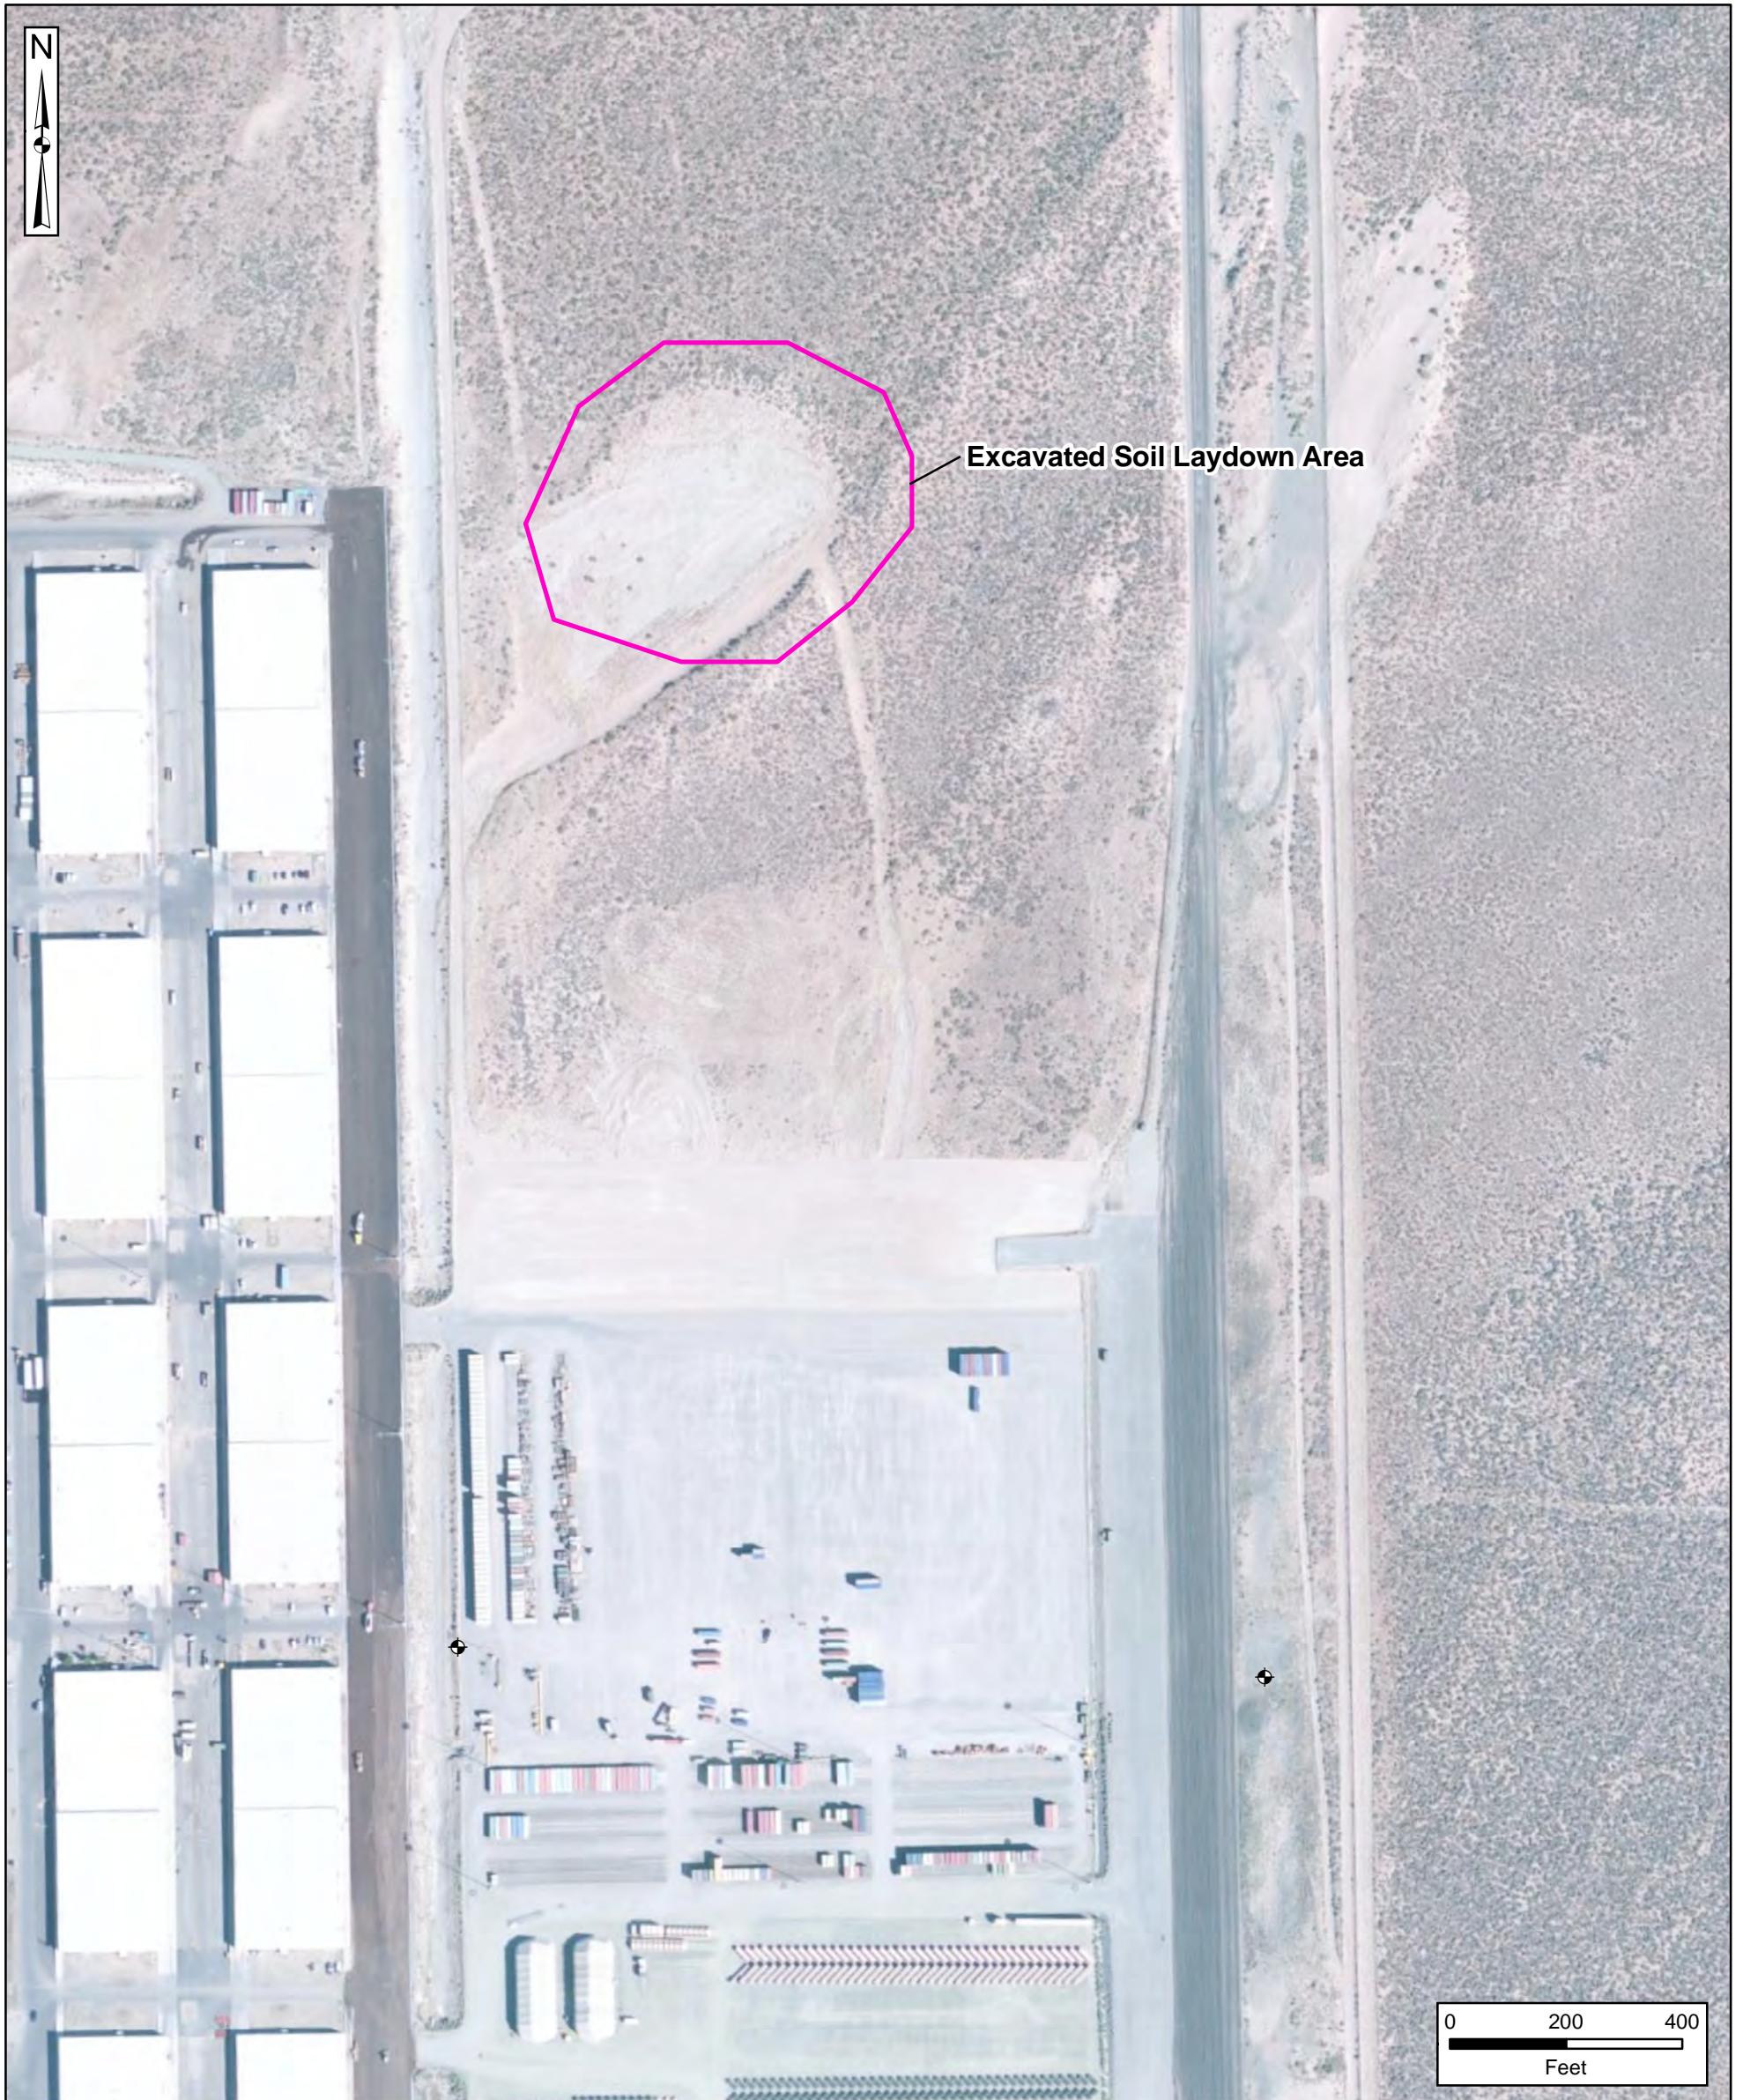
Figure 5-6
Aerial Photo of
Excavated Soil Laydown Area

The Excavated Soil Laydown Area is identified as an AOPI following personnel interviews and site reconnaissance due to temporary storage of potentially PFAS-containing soil. This AOPI was a temporary laydown area for approximately 3,700 cy of soil excavated from SIAD-007 Fire Training Area (Site 13). All the impacted soil was then reportedly moved and used at an unknown location as a base for a hardstand (**Figure 5-6**).

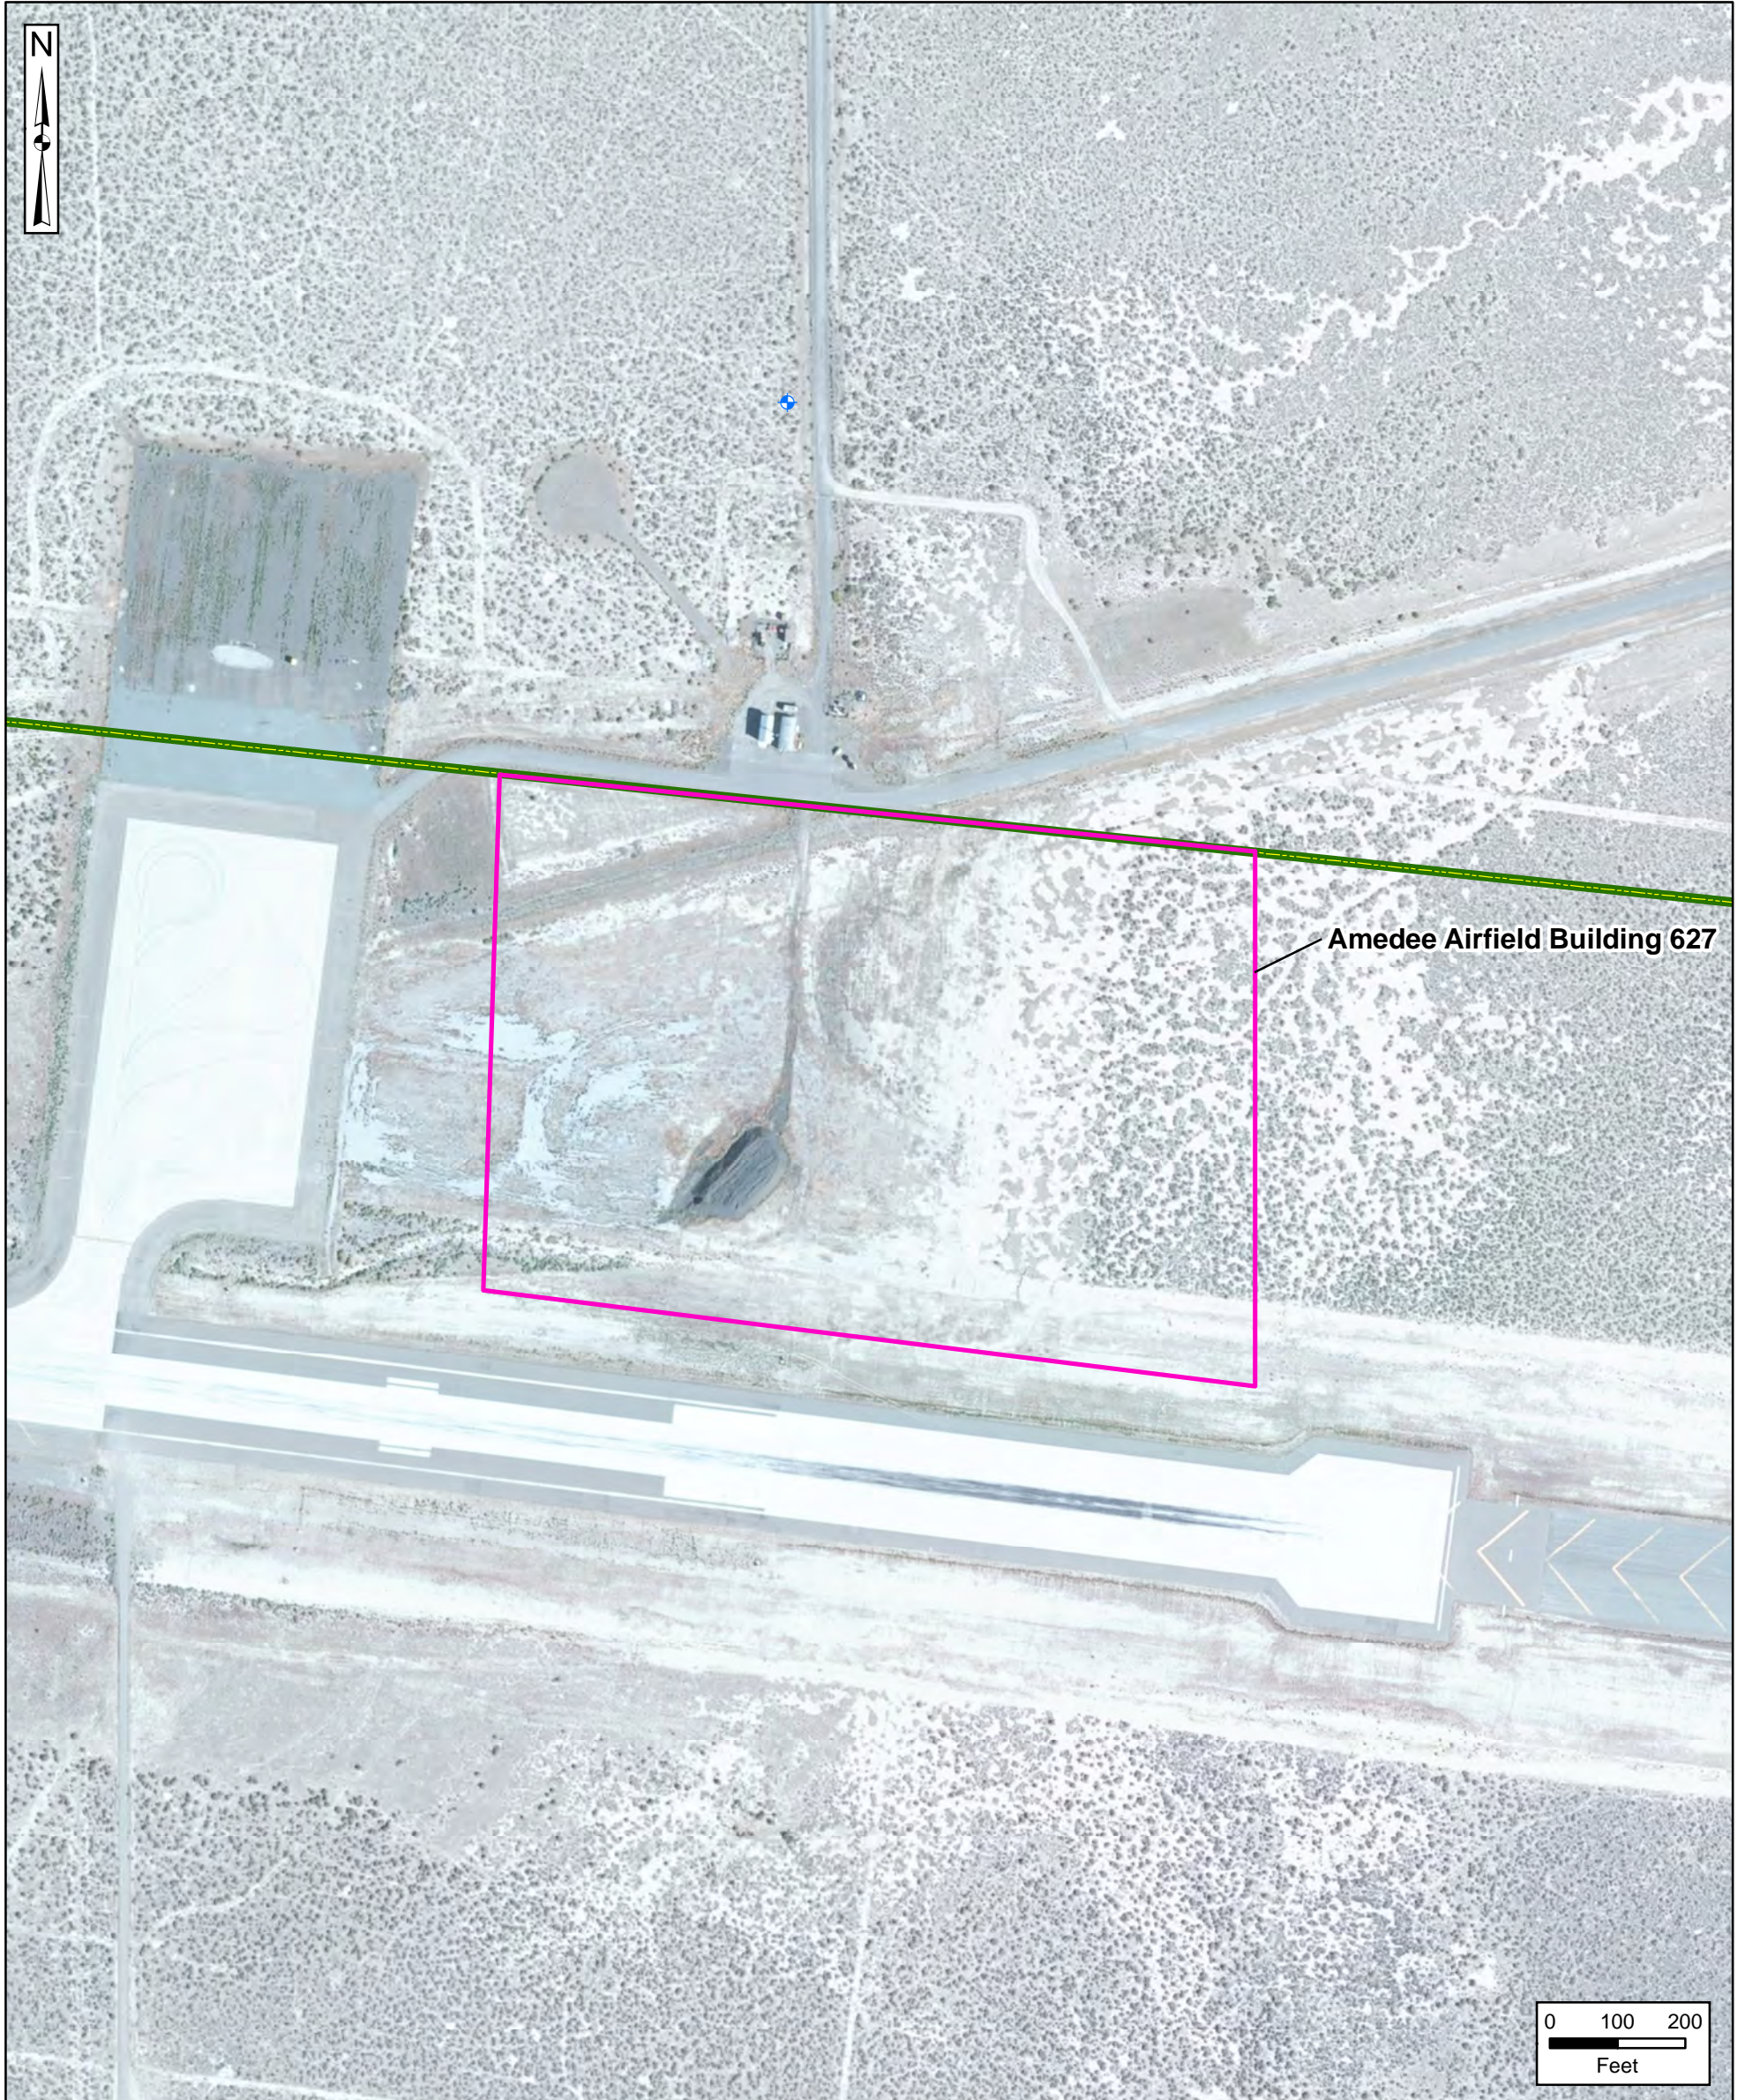
Figure 5-7
Aerial Photo of
Amedee Airfield Building 627

The Amedee Airfield Building 627 is identified as an AOPI following records research, personnel interviews, and site reconnaissance due to historic nozzle testing activities. AFFF was historically discharged adjacent to the airfield parking apron during nozzle testing in support of aviation activities and training. Soil samples collected in 2017 were non-detect for PFOS and PFOA, though other PFAS constituents were detected (**Figure 5-7, Table 2-2**).

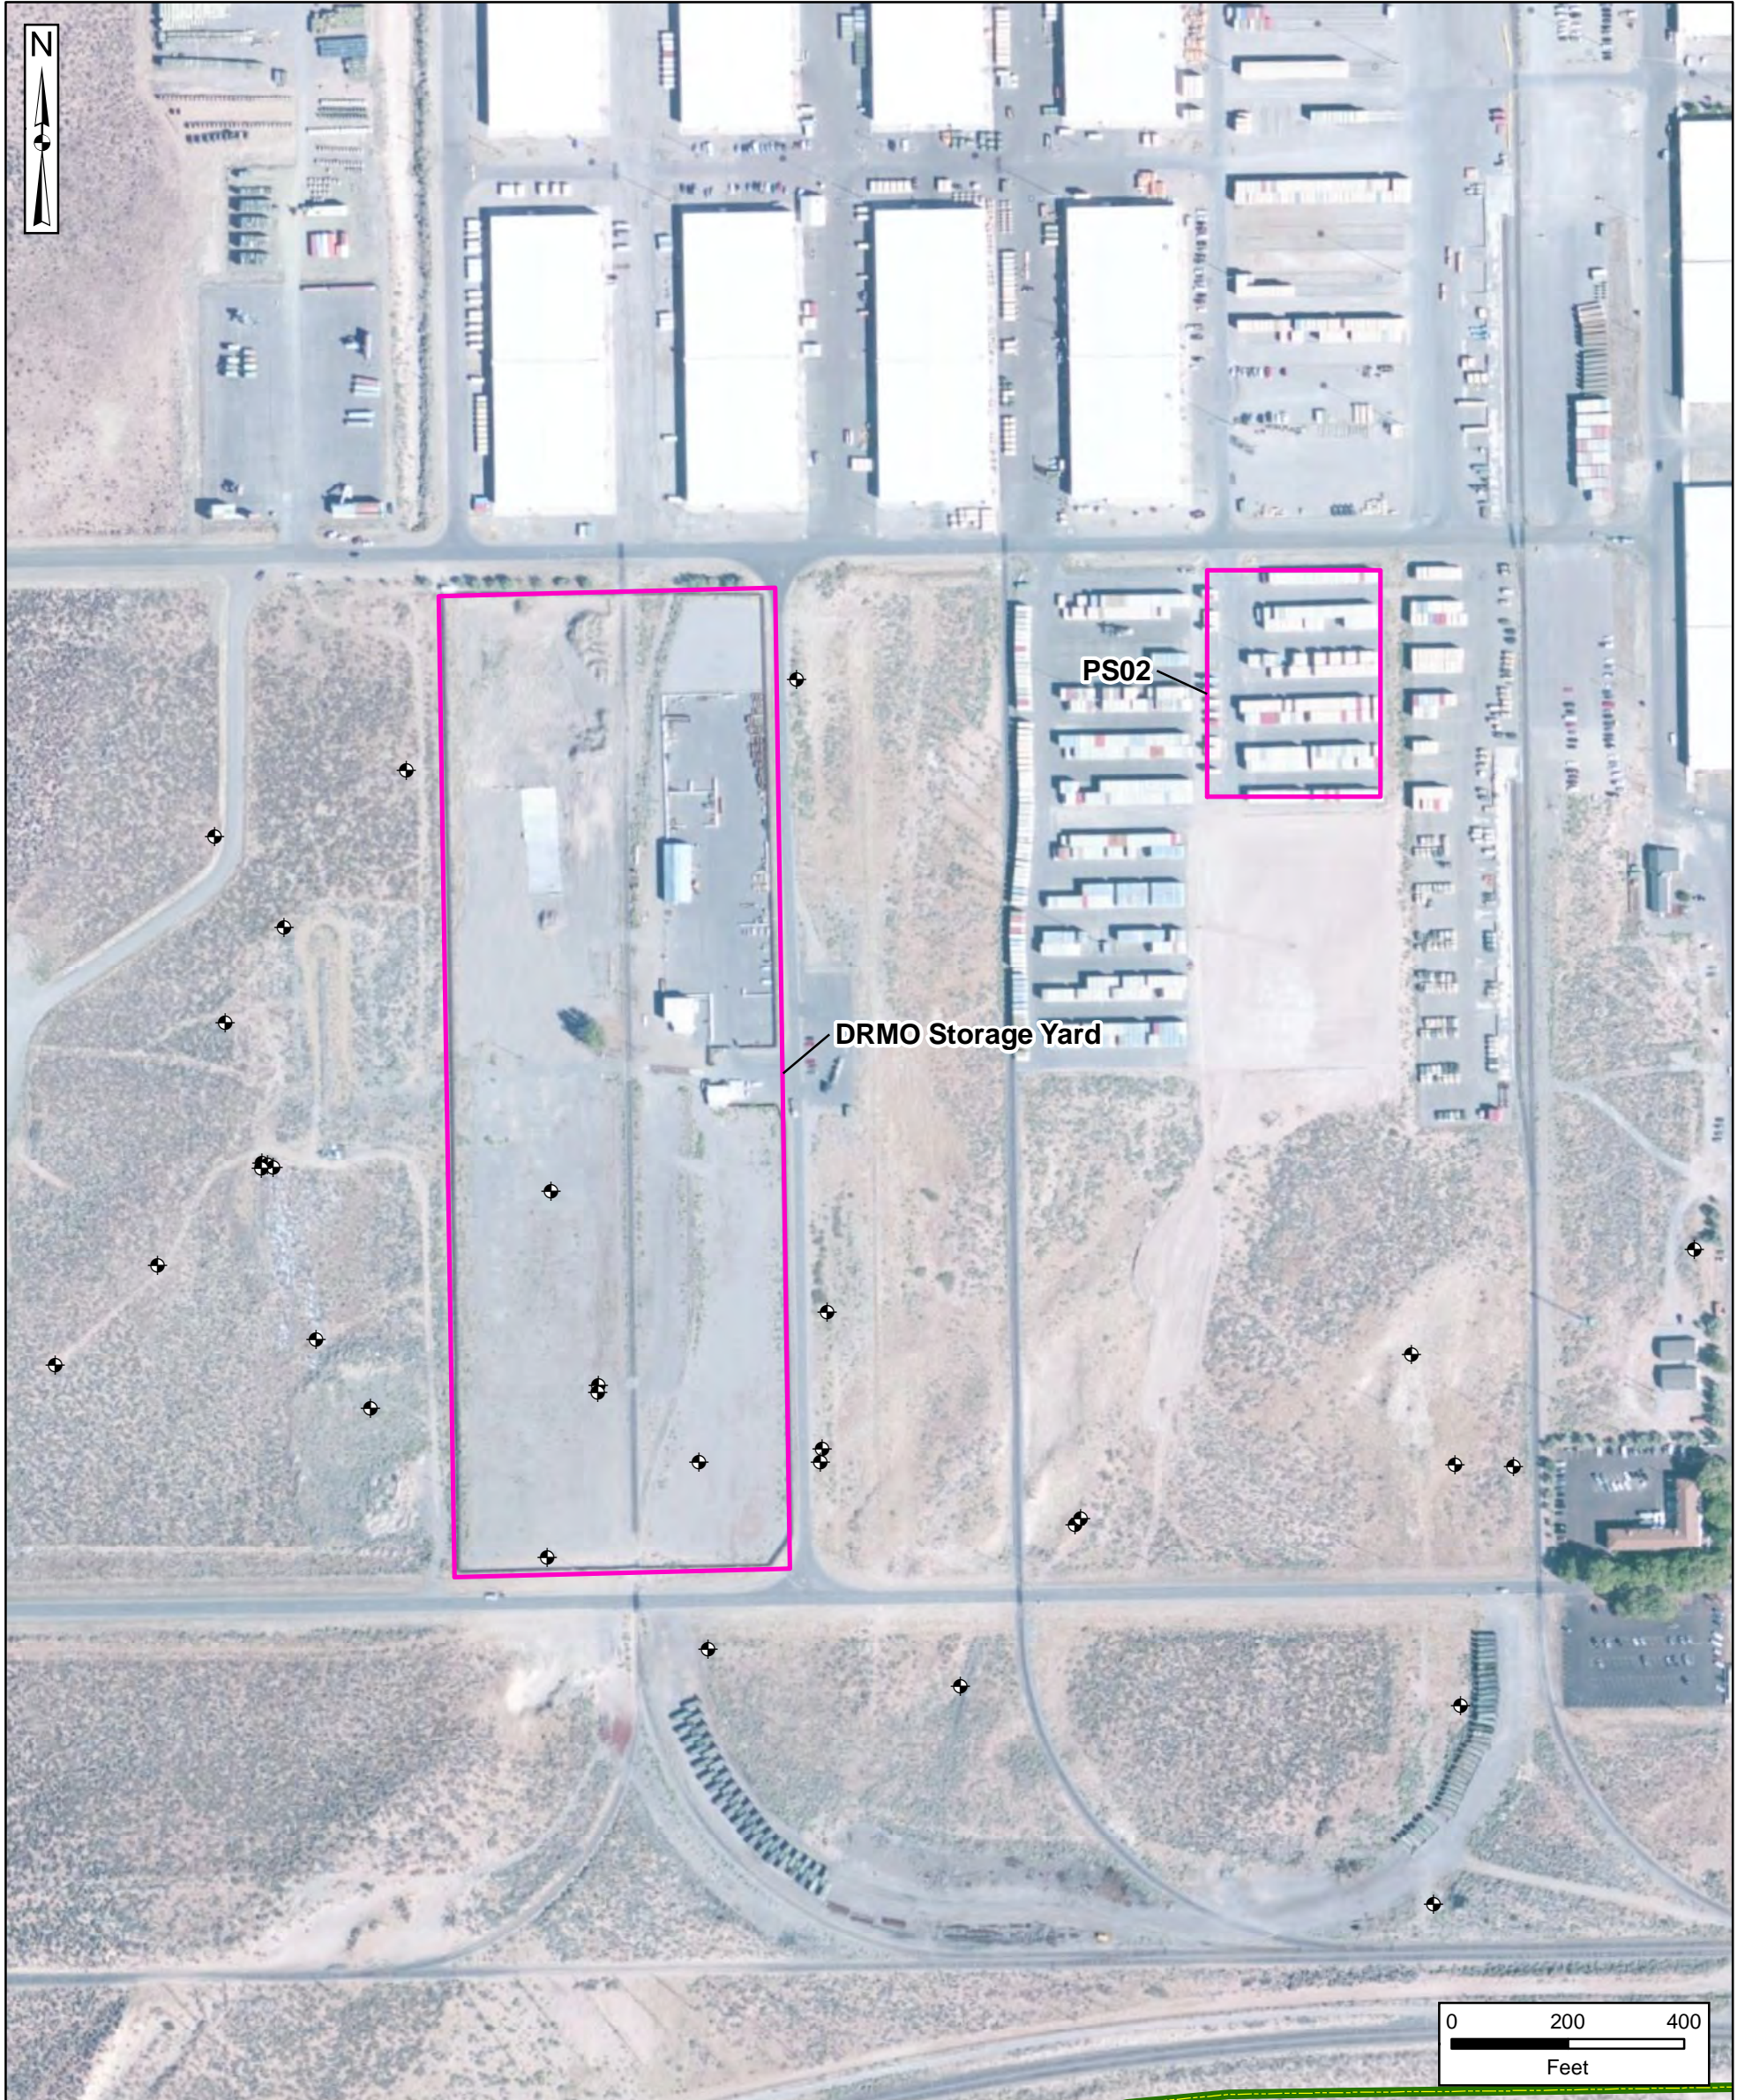
Figure 5-10
Aerial Photo of
DRMO Storage Yard and PS02

The DRMO Storage Yard is identified as an AOPI following records research, personnel interviews, and site reconnaissance due to historical AFFF storage. This location was used for storage of surplus and scrap materials that could be reutilized or sold by the Army. Storage of 690, 5-gallon containers of AFFF totaling 3,450-gallons were stored in the area (**Figure 5-10**).

The AFFF Storage Area PS02 is identified as an AOPI following the identification of 5-gallon buckets of AFFF currently stored at this location (**Figure 5-10**). Approximately 150 gallons of AFFF has been stored here for 10 to 15 years to support the Inland Petroleum Distribution System.
