FINAL PRELIMINARY ASSESSMENT AND SITE INSPECTION OF PER- AND POLYFLUOROALKYL SUBSTANCES

Sierra Army Depot, California

February 2022

Arcadis U.S., Inc.

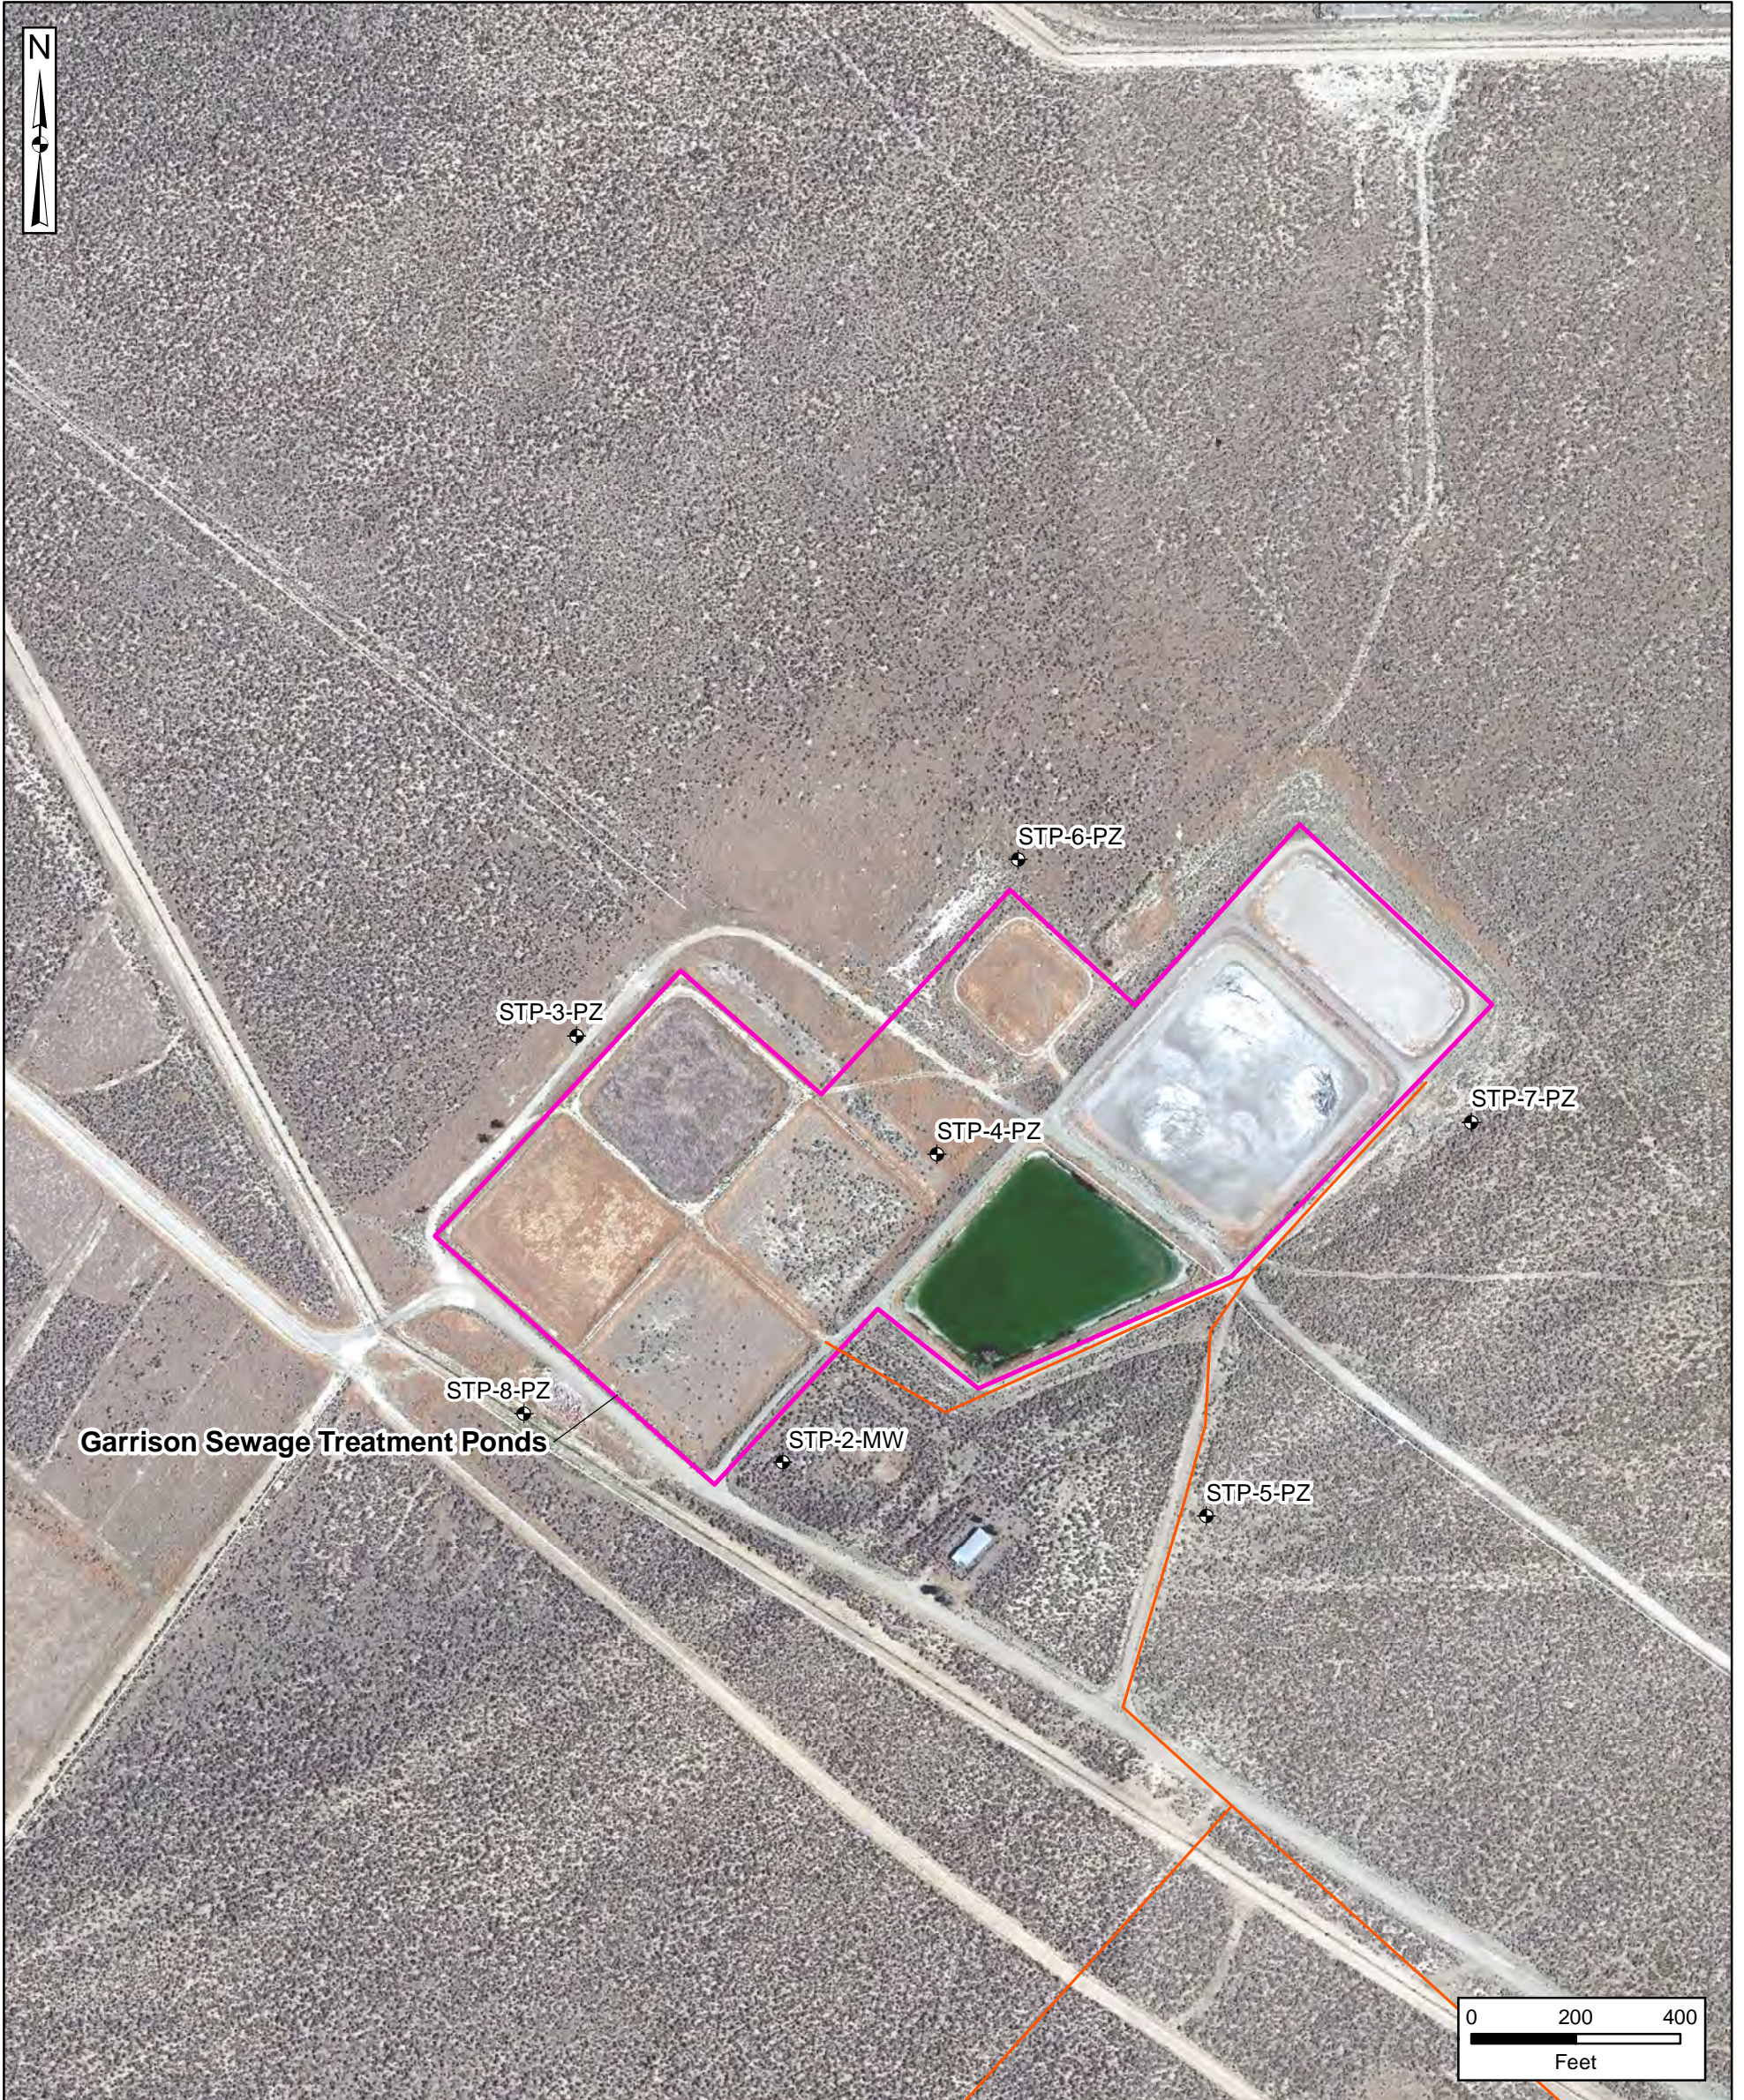
Figure 5-12
Aerial Photo of
Garrison Sewage Treatment Ponds

The Garrison Sewage Treatment Ponds were identified as an AOPI due to the potential influence of PFAS-containing wastes being disposed of at the ponds (**Figure 5-12**). A GAC unit was constructed in 2019 at PSW-08 to remove PFOA from drinking water. However, after flushing the system of approximately 250,000 gallons of water it was discovered that PFAS-containing materials were used during GAC unit construction, and the unit had to be rebuilt. The 250,000 gallons of water was sent to the Garrison Sewage Treatment Ponds and the Mission Sewage Treatment Ponds. The ponds are lined, however, there are known leaks in the liner.

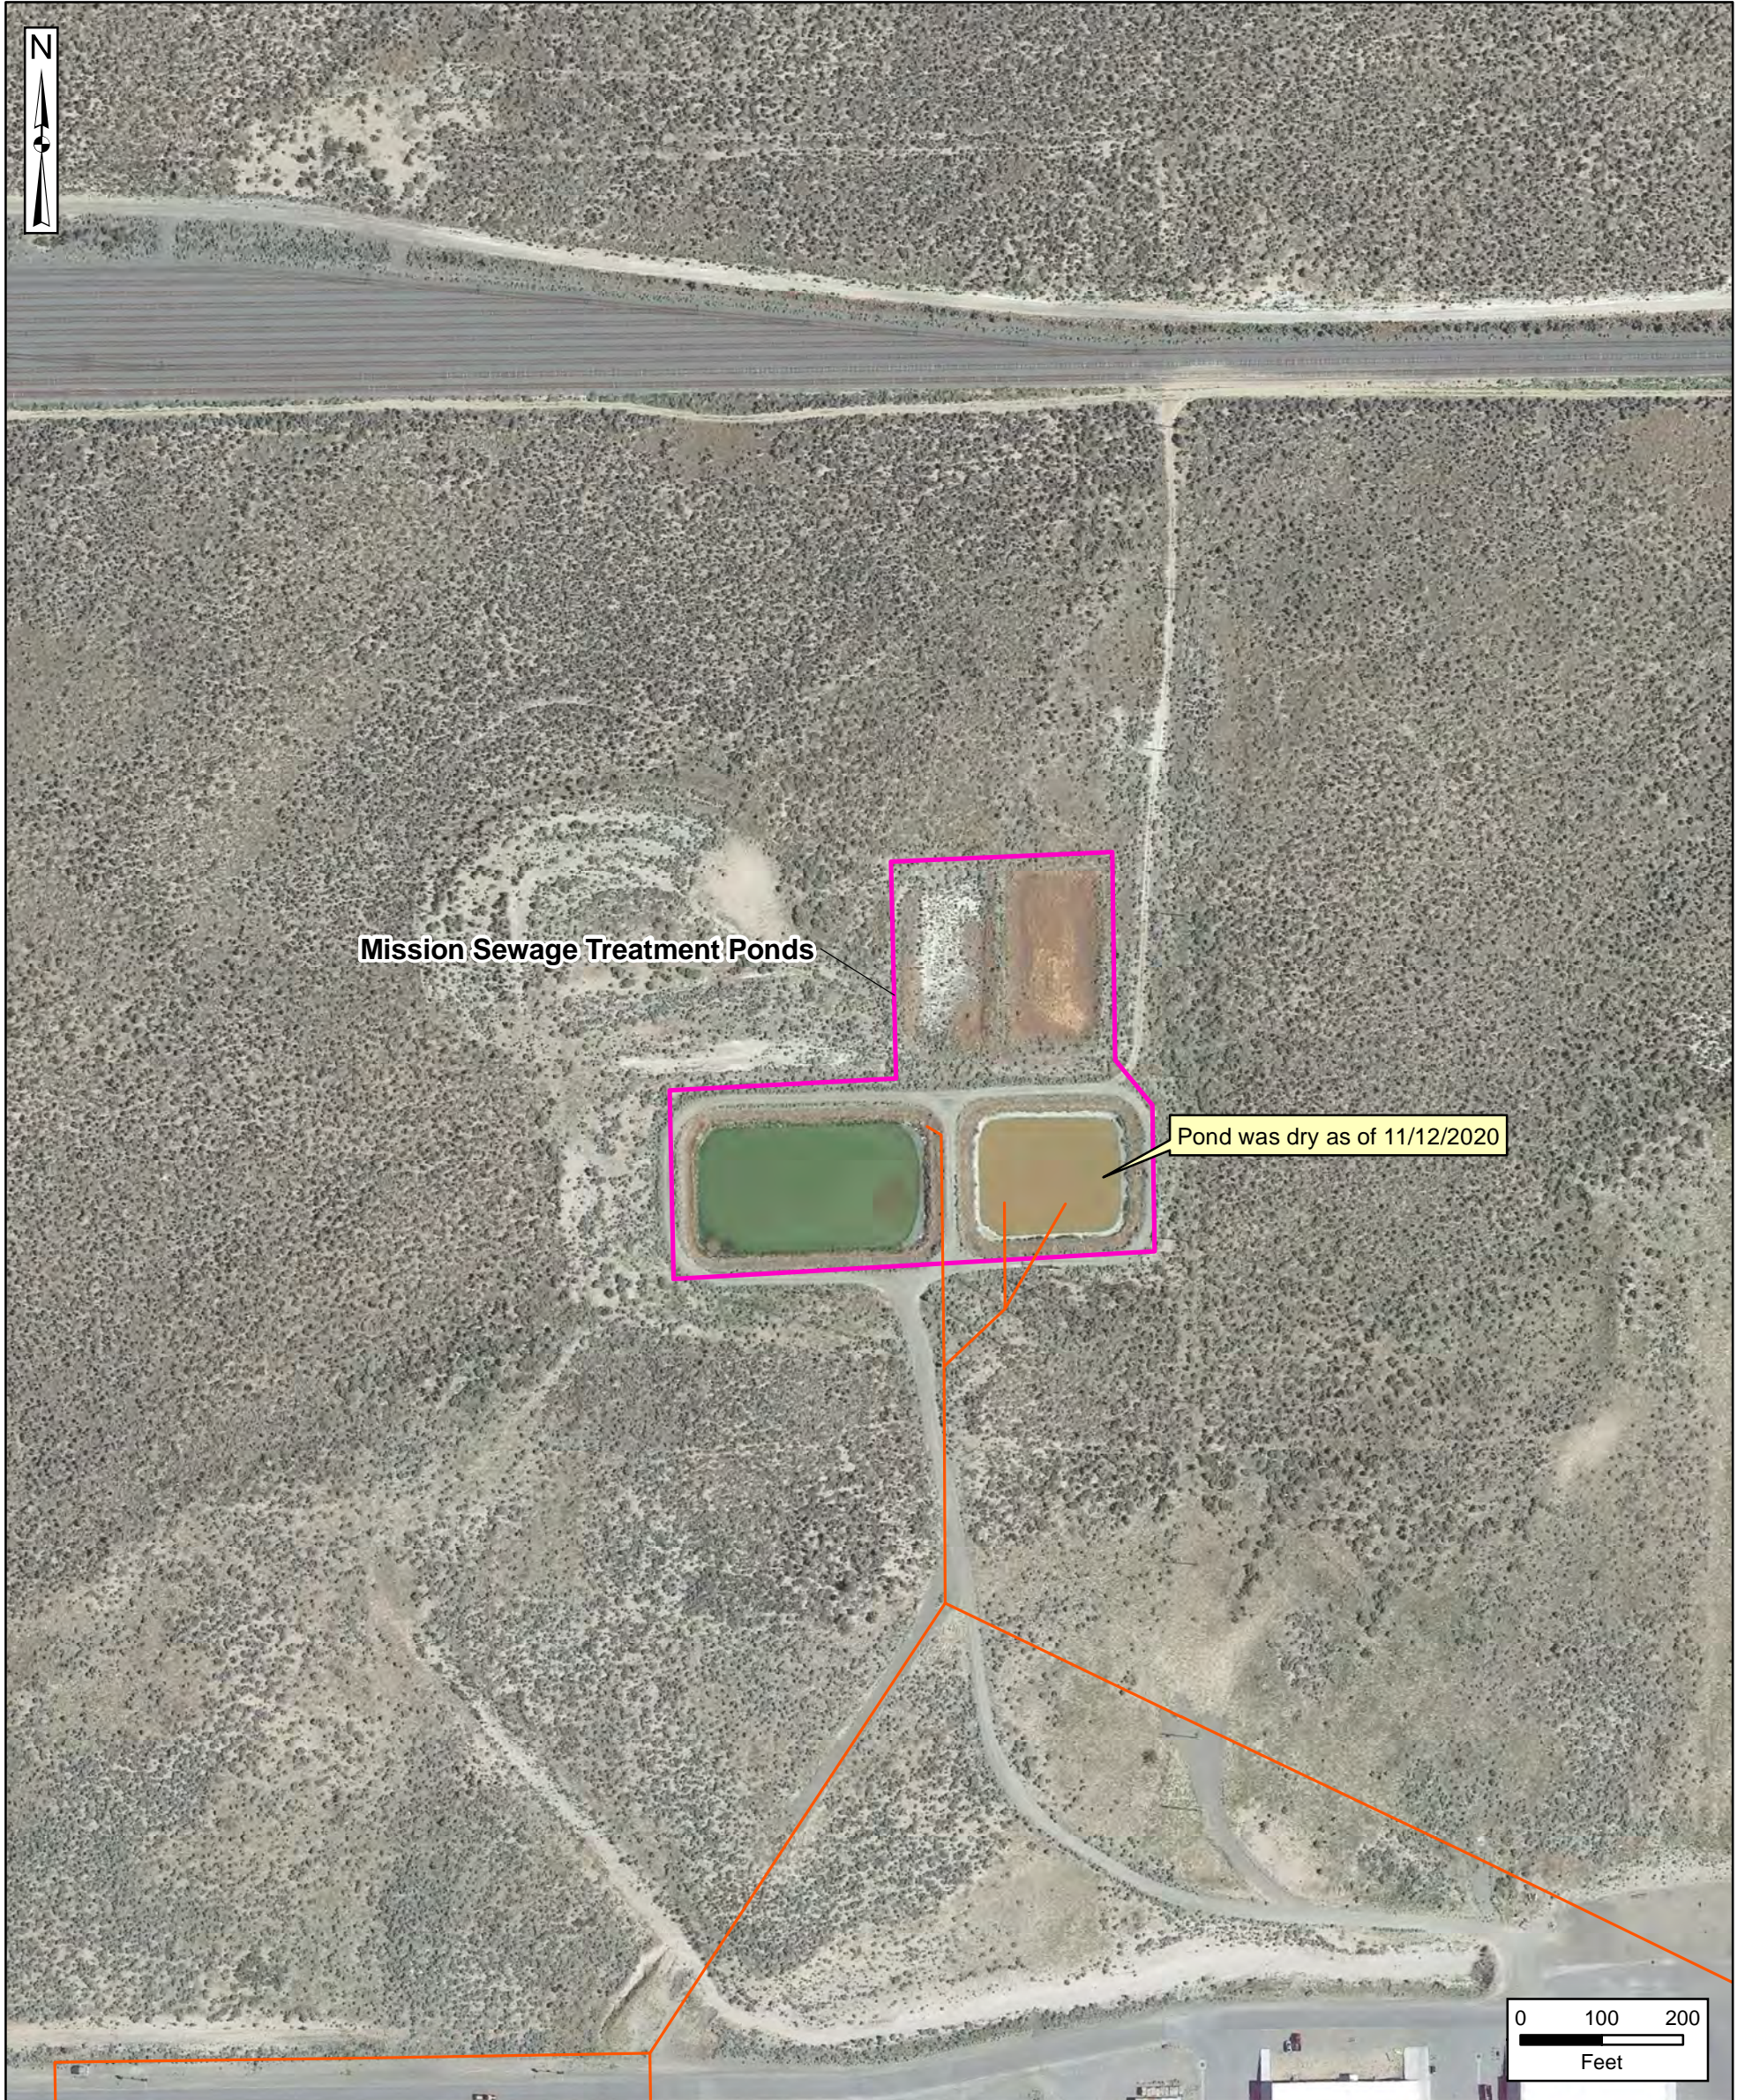
Figure 5-13
Aerial Photo of
Mission Sewage Treatment Ponds

The Mission Sewage Treatment Ponds were identified as an AOPI due to the potential influence of PFAS-containing wastes being disposed of at the ponds (**Figure 5-13**). Water from the PSW-08 GAC system
