FINAL PRELIMINARY ASSESSMENT OF PER- AND POLYFLUOROALKYL SUBSTANCES

St. Louis Army Ammunition Plant, Missouri

September 2022

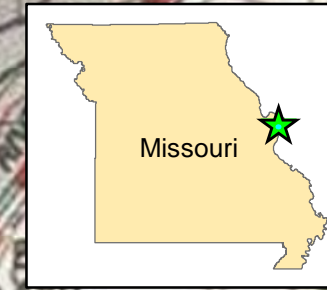
**Figure 2-4
Topographic Map**

SLAAP is located in the southern portion of the Dissected Till Plains Section of the Central Lowland Province. The topography of this area (**Figure 2-3**) consists of rolling uplands with slopes of 2 to 5 percent (%), and an elevation range of 500 to 550 feet above mean sea level sloping gently to the south within a 2-mile radius of the SLAAP property (URS Group, Inc. 2004).
