# FINAL PRELIMINARY ASSESSMENT AND SITE INSPECTION OF PER- AND POLYFLUOROALKYL SUBSTANCES

## Scranton Army Ammunition Plant, Pennsylvania

## Preliminary Assessment and Site Inspection of Per- and Polyfluoroalkyl Substances

Scranton Army Ammunition Plant,  
Pennsylvania

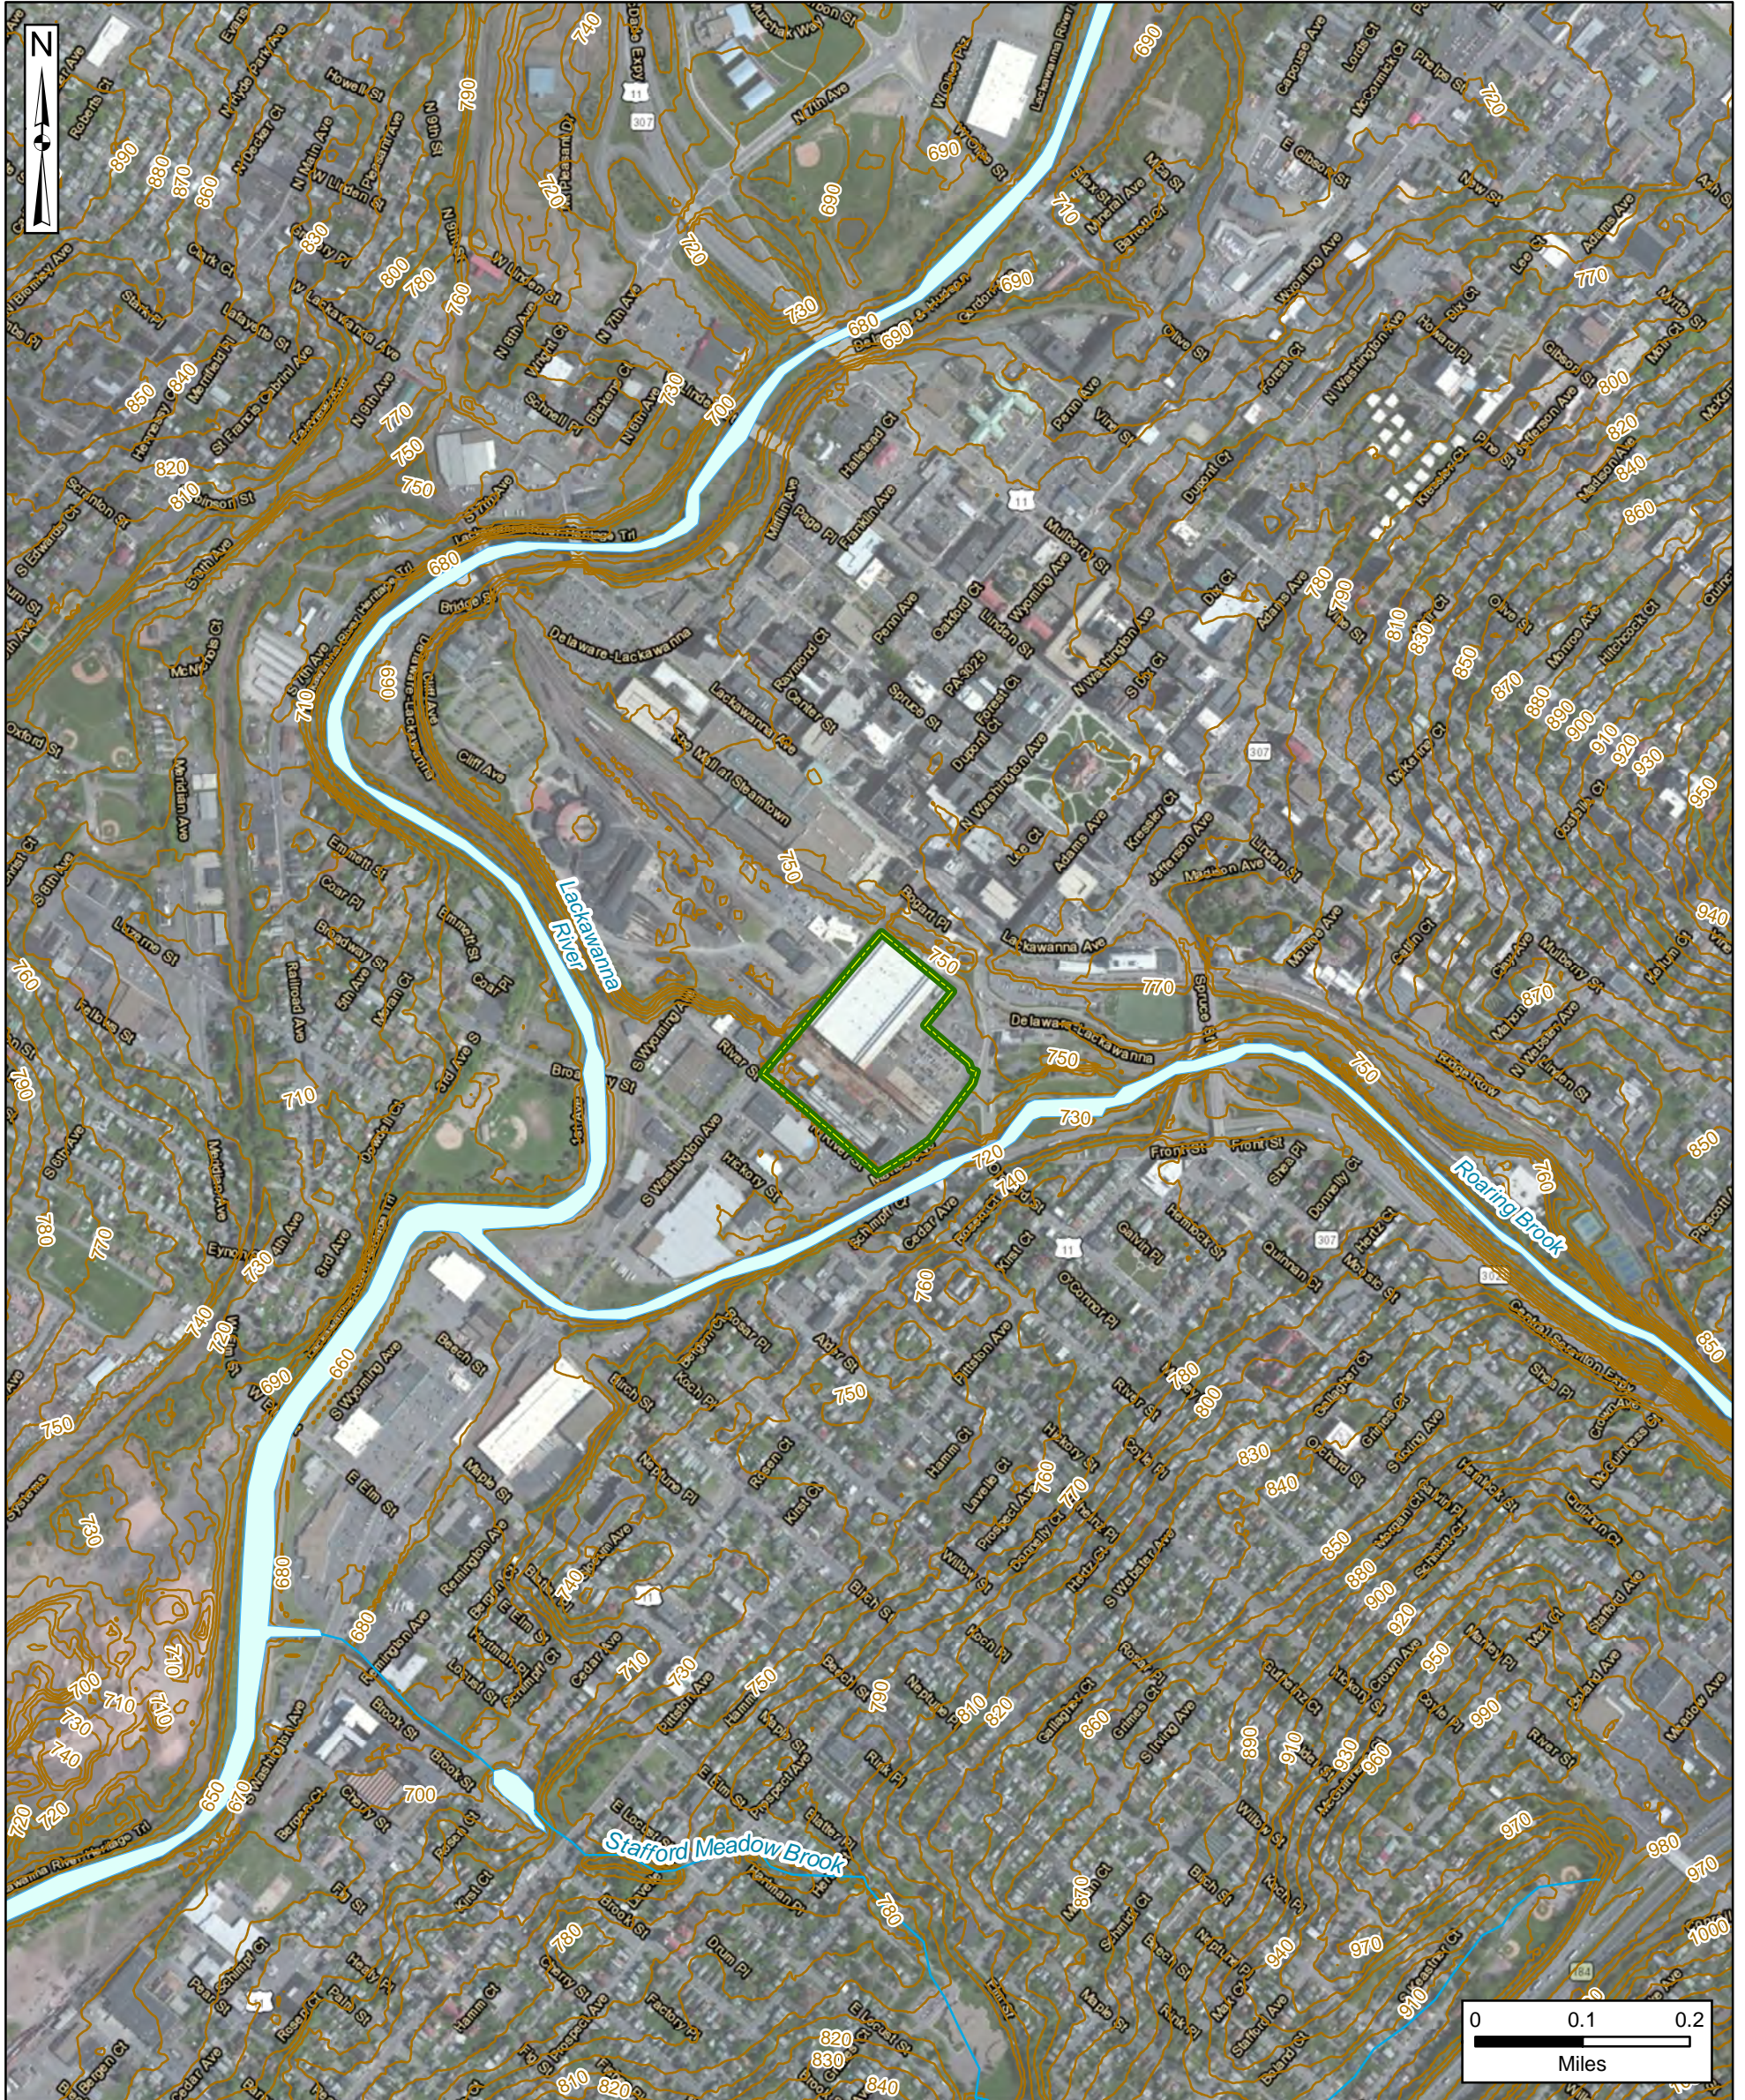
Figure 2-3  
Site Topography

SCAAP sits within a highly industrialized area in Scranton's historic downtown. The installation and the surrounding area are located in man-made and highly disturbed areas, often paved or covered with structures (NSA 2020) (**Figure 2-3**). The installation ground is covered primarily with asphalt or concrete and has a small grassy area proximal to South Washington Avenue. As railroad companies grew in the late 1800's and early 1900's, they re-landscaped the area, including the installation grounds, to support a large railroad yard, locomotive shop, and track. This effort raised the land to the current surface elevation as high as 40 feet above the existing natural grade. The elevation of the installation currently averages approximately 740 feet above mean sea level.

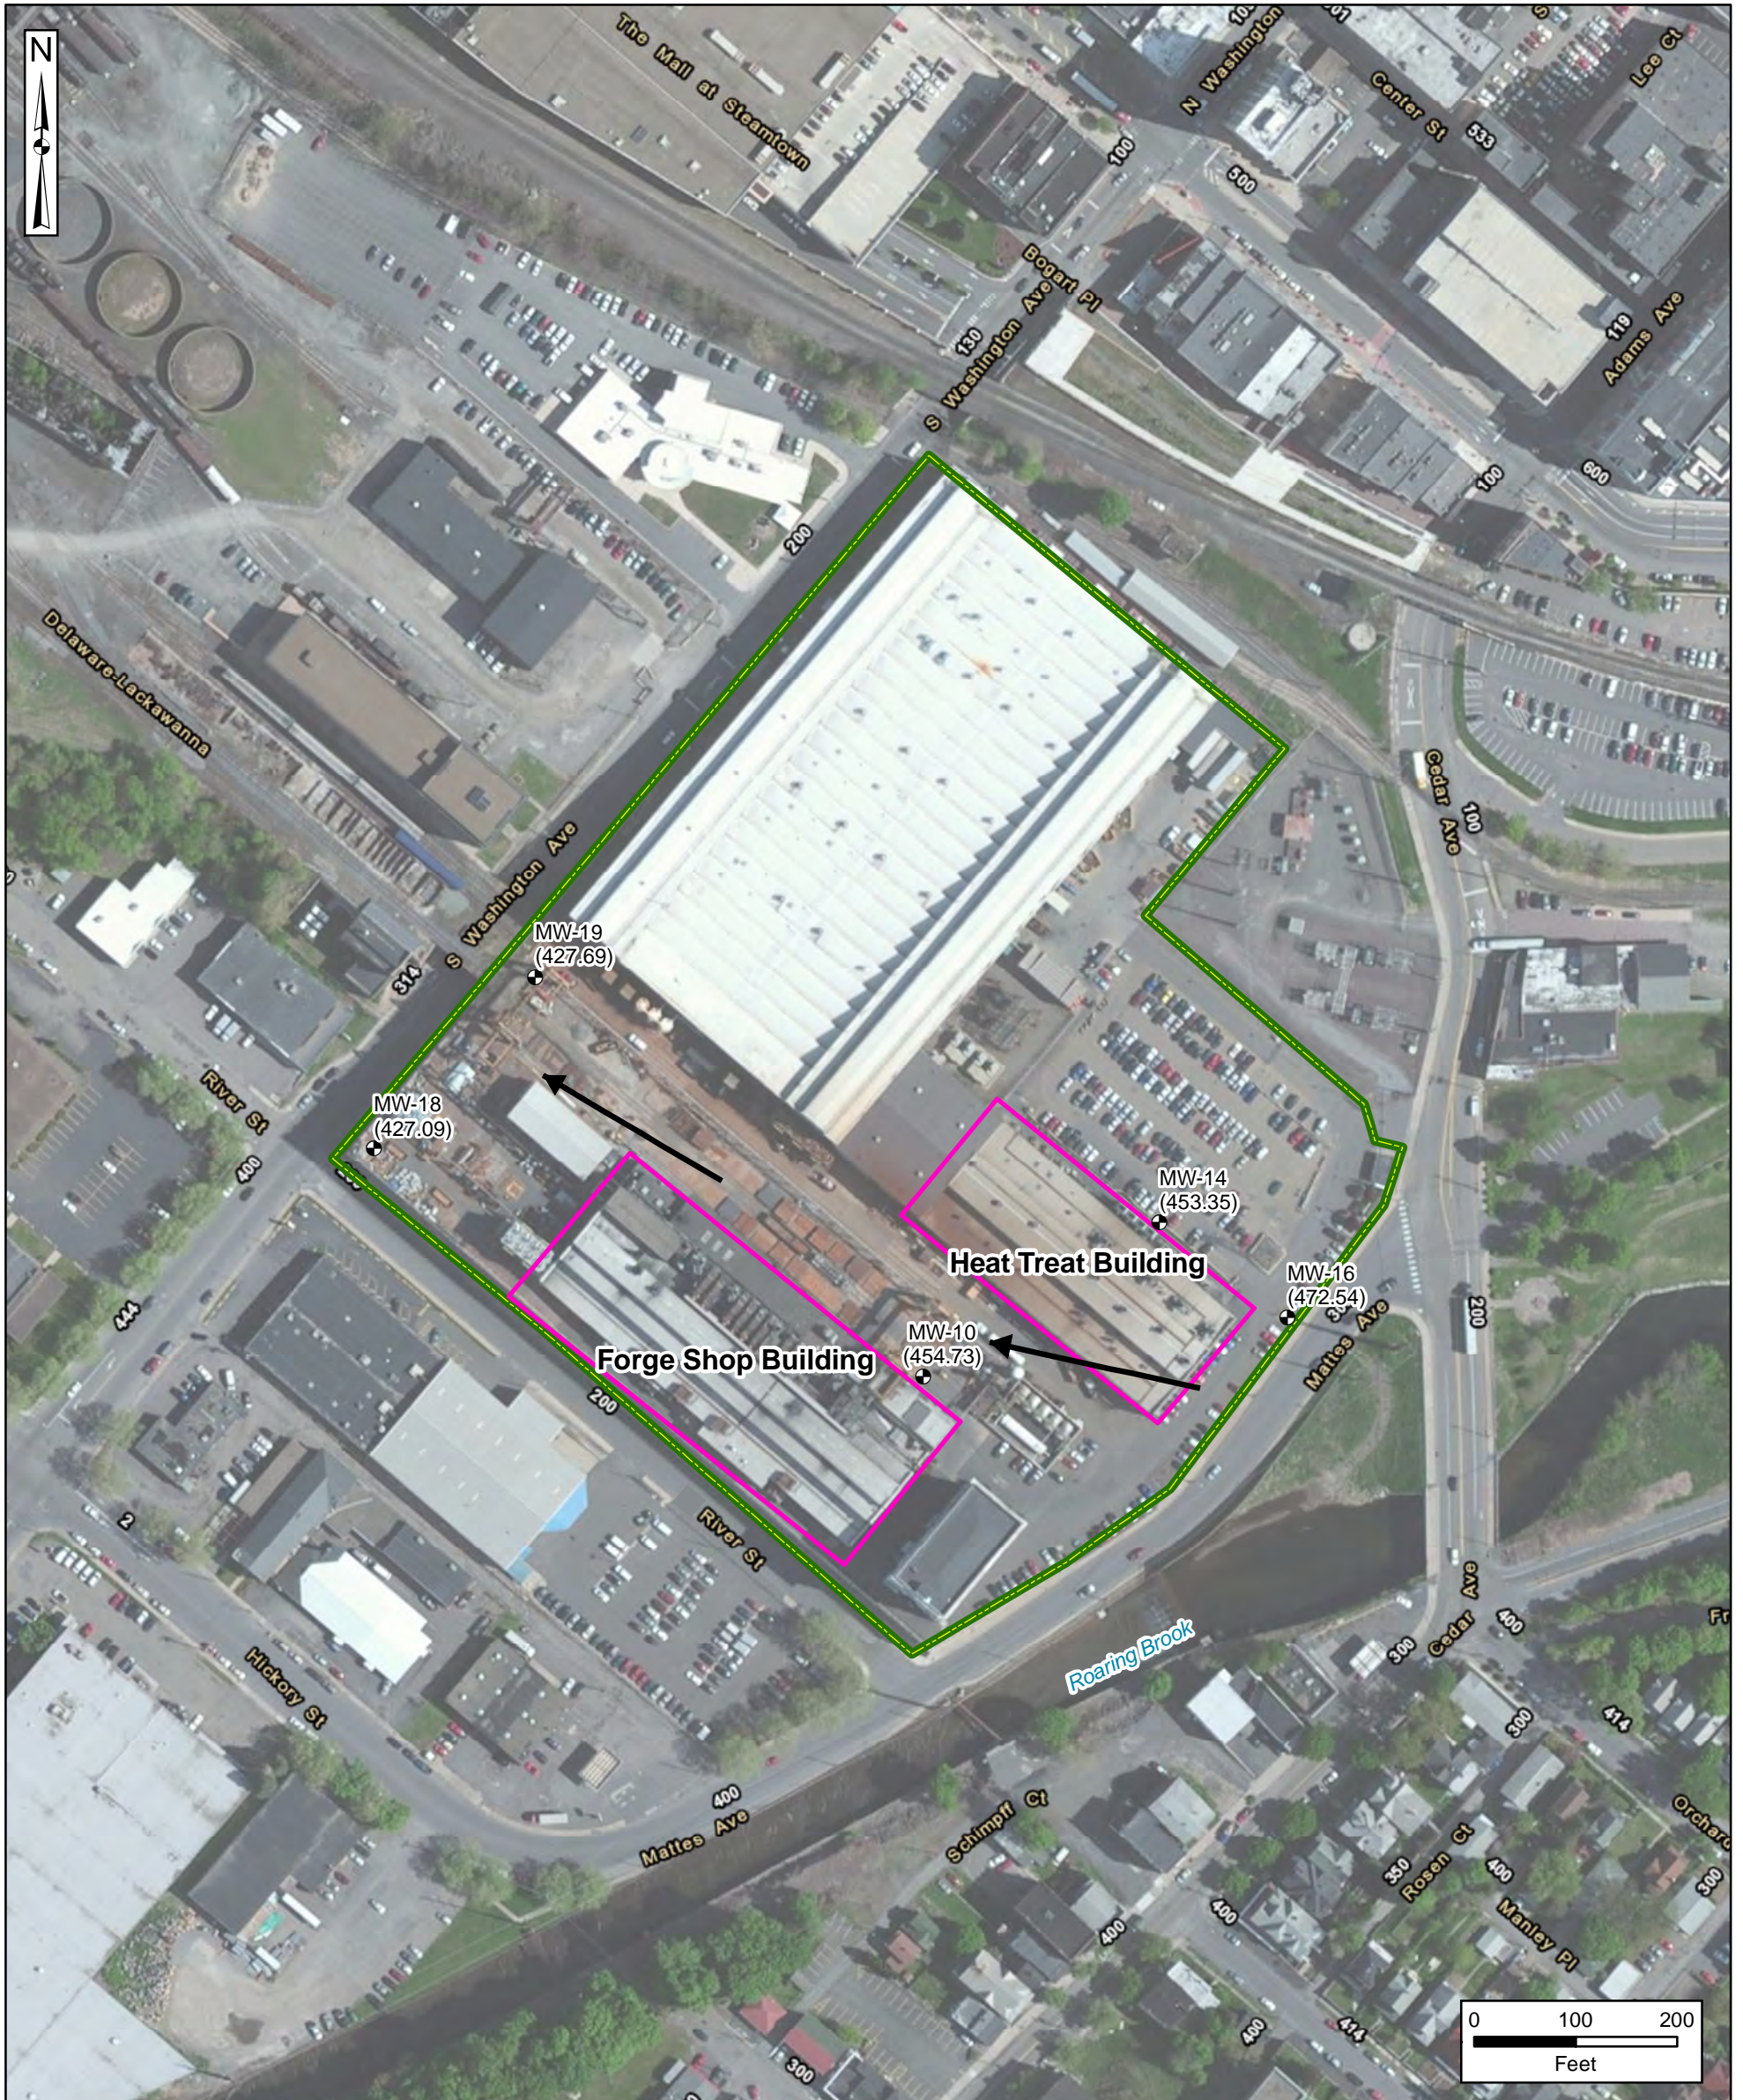
**Figure 7-1**  
**Forge Shop Building and Heat Treat Building AOPIs**  
**PFOS, PFOA, and PFBS Analytical Results**

Notes:  
 1. Groundwater results are reported in nanograms per liter (ng/L).  
 2. Duplicate sample results are shown in brackets.  
 3. Bolded values indicate detections.

Qualifiers:  
 J = The analyte was positively identified; however, the associated numerical value is an estimated concentration only.  
 U = The analyte was analyzed for but was not detected above the limit of quantitation (LOQ).

Although the CSM indicates potentially complete exposure pathways exist, the recommendation for future study in a remedial investigation or no action at this time is based on the comparison of the SI analytical results for PFOS, PFOA, and PFBS to the OSD risk screening levels (**Table 6-2**). **Table 8-1** below summarizes the AOPIs identified at SCAAP, PFOS, PFOA, and PFBS sampling, and recommendations for each AOPI; further investigation is not warranted at SCAAP.

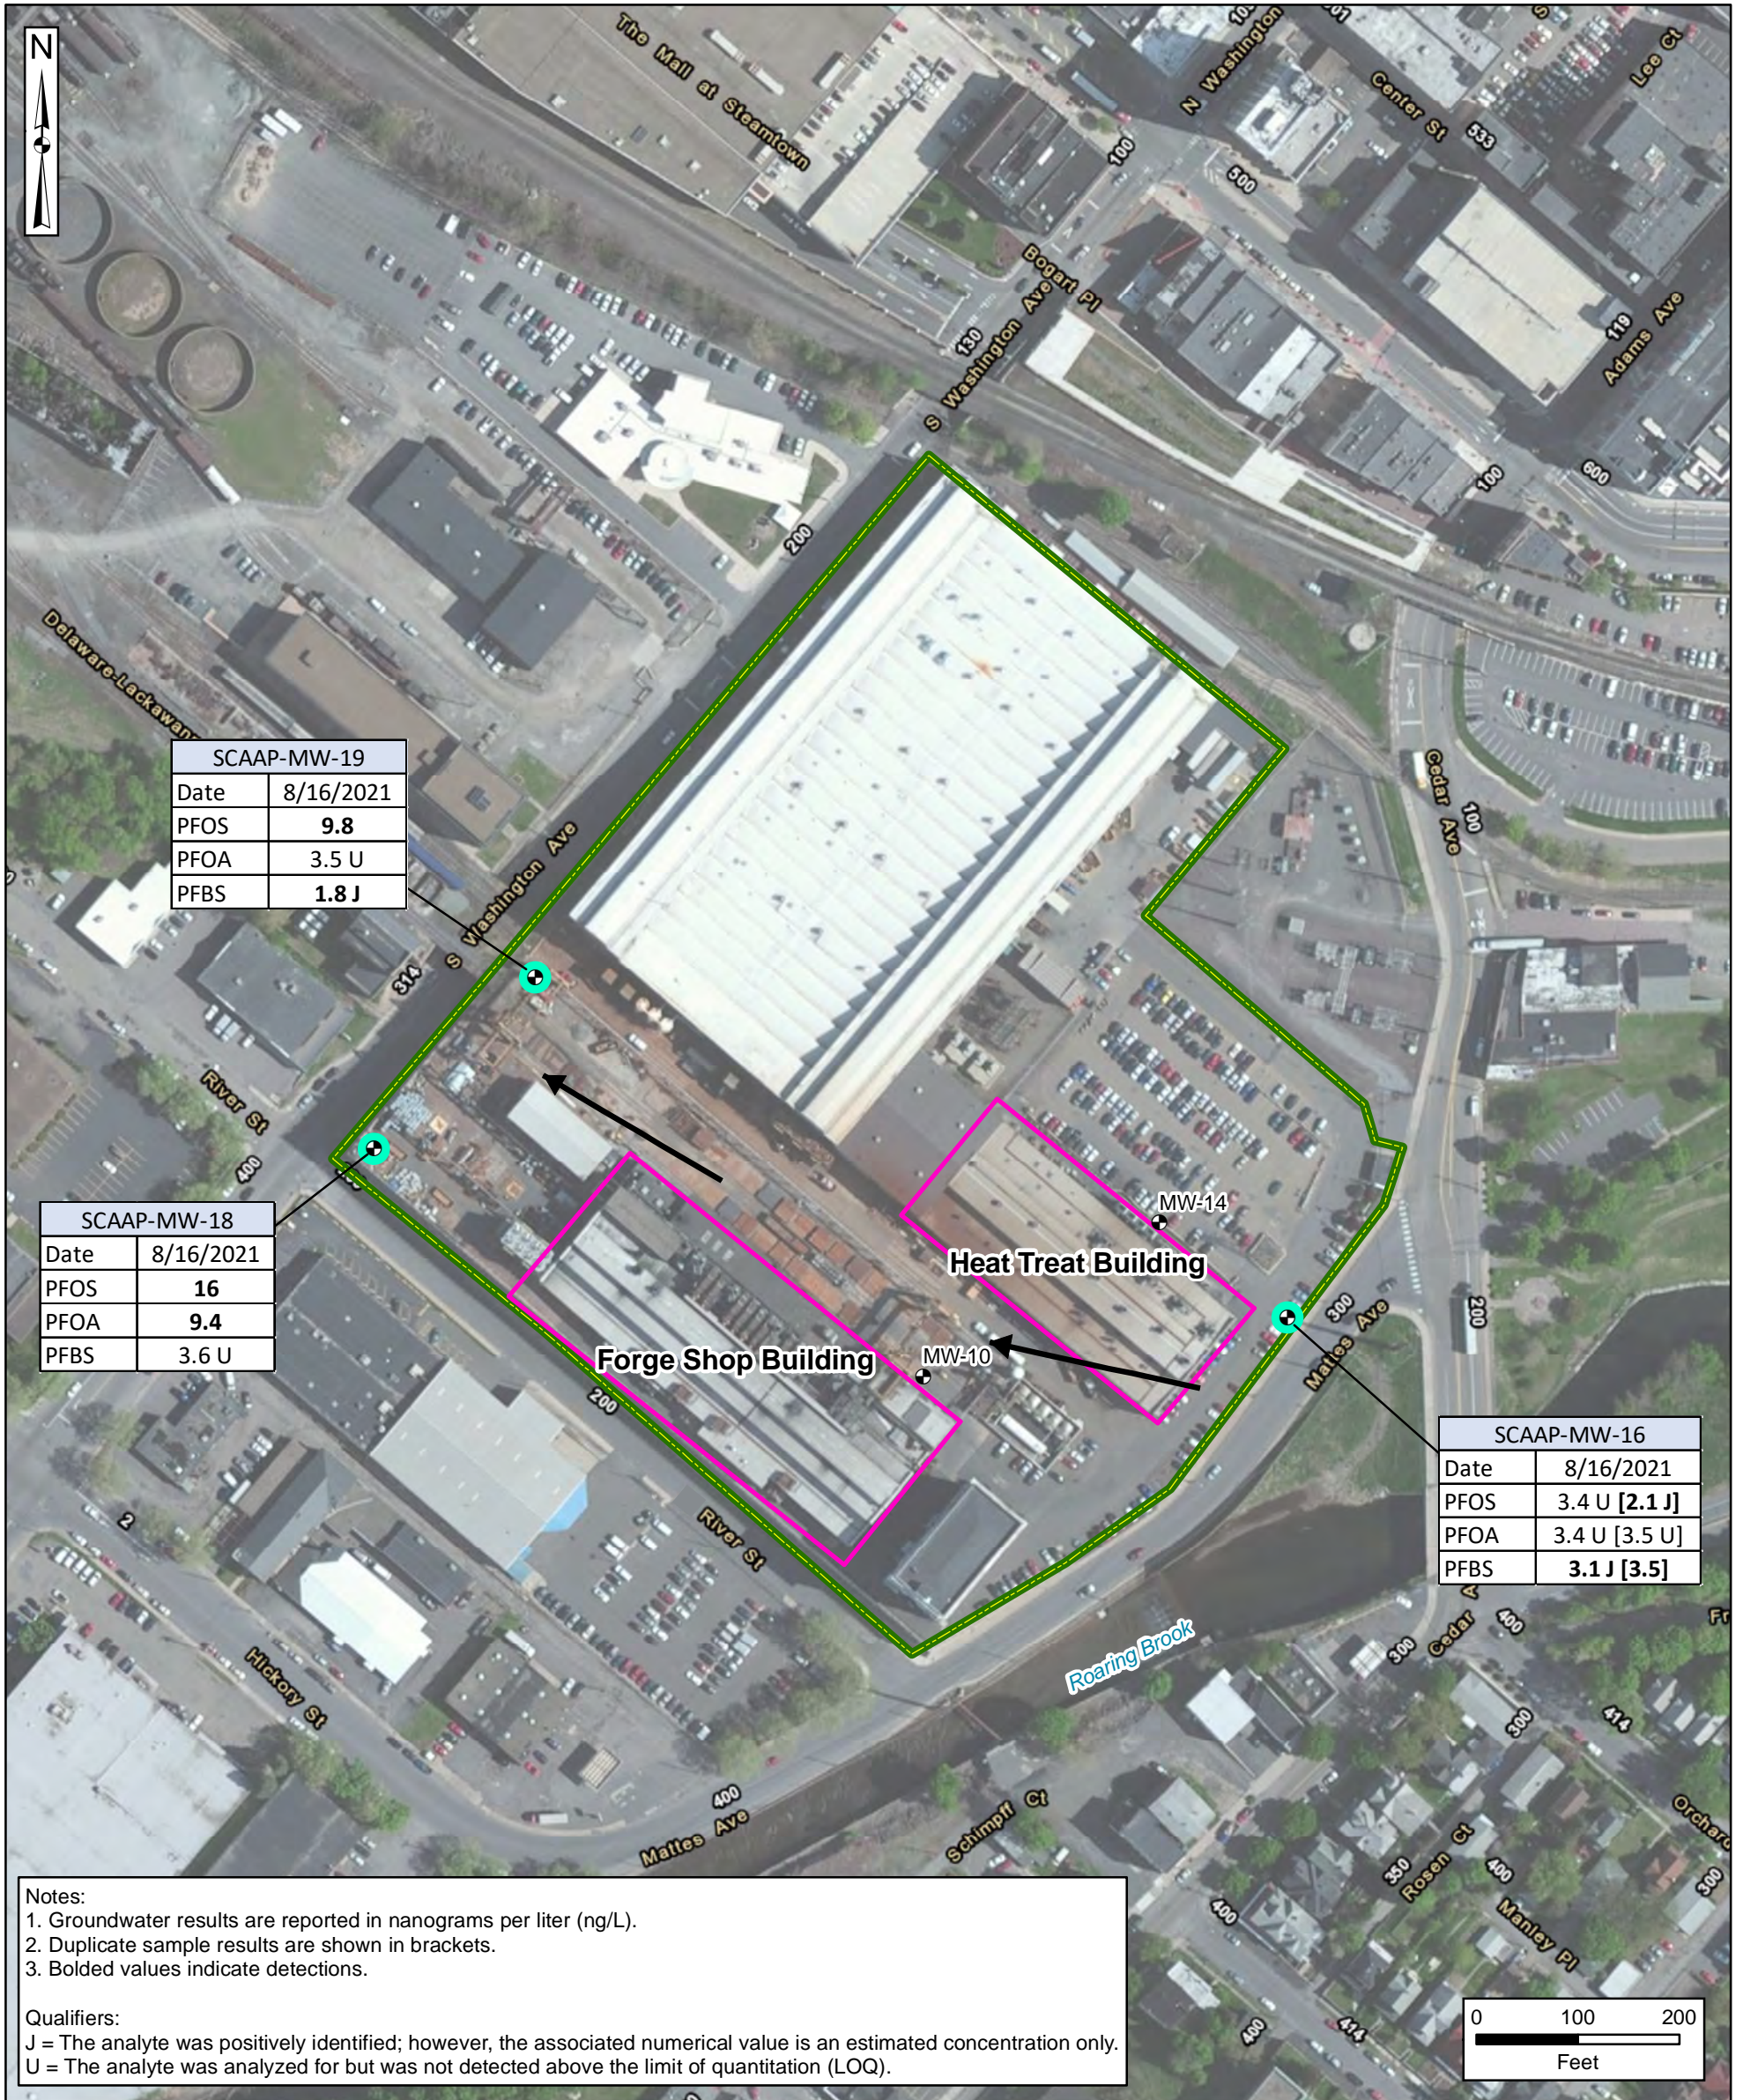
Groundwater samples were collected from three existing monitoring wells at the Forge Shop Building and Heat Treat Building AOPIs (SCAAP-MW-16 [upgradient of the AOPIs] and SCAAP-MW-18 and SCAAP-MW-19 [downgradient of the AOPIs]; **Figure 7-1**). The groundwater samples were collected from the middle of the screened interval. A summary of PFOS, PFOA, and PFBS groundwater analytical results is provided in **Table 7-1**. PFOS, PFOA, and/or PFBS were detected in the samples collected; however, there were no exceedances of OSD screening levels.

**Table 7-1** provides a summary of the groundwater analytical results for PFOS, PFOA, and PFBS. **Table 7-2** summarizes AOPIs and whether their SI results exceed the OSD risk screening levels. **Appendix M** includes the full suite of analytical results for these media, as well as for the QA/QC samples. **Figure 7-1** shows the PFOS, PFOA, and PFBS analytical results in groundwater for the AOPIs. Non-detected results are reported as less than the LOQ. There were no detections of PFOS, PFOA, or PFBS greater than the applicable OSD risk screening levels. Final qualifiers applied to the data by the laboratory and the project chemist (as defined in **Section 6.4.3**) are presented on the analytical tables. Groundwater data collected during the SI are reported in ng/L, or parts per trillion. Groundwater was generally first encountered at depths of approximately 28 feet below the top of well casing near the installation's eastern boundary (MW-16) and approximately 72 to 76 feet below top of well casing along the western boundary (MW-19 and MW-18, respectively).
