FINAL PRELIMINARY ASSESSMENT AND SITE INSPECTION OF PER- AND POLYFLUOROALKYL SUBSTANCES

**Fort Shafter and Fort DeRussy Military Reservation,
Hawaii**

August 2023

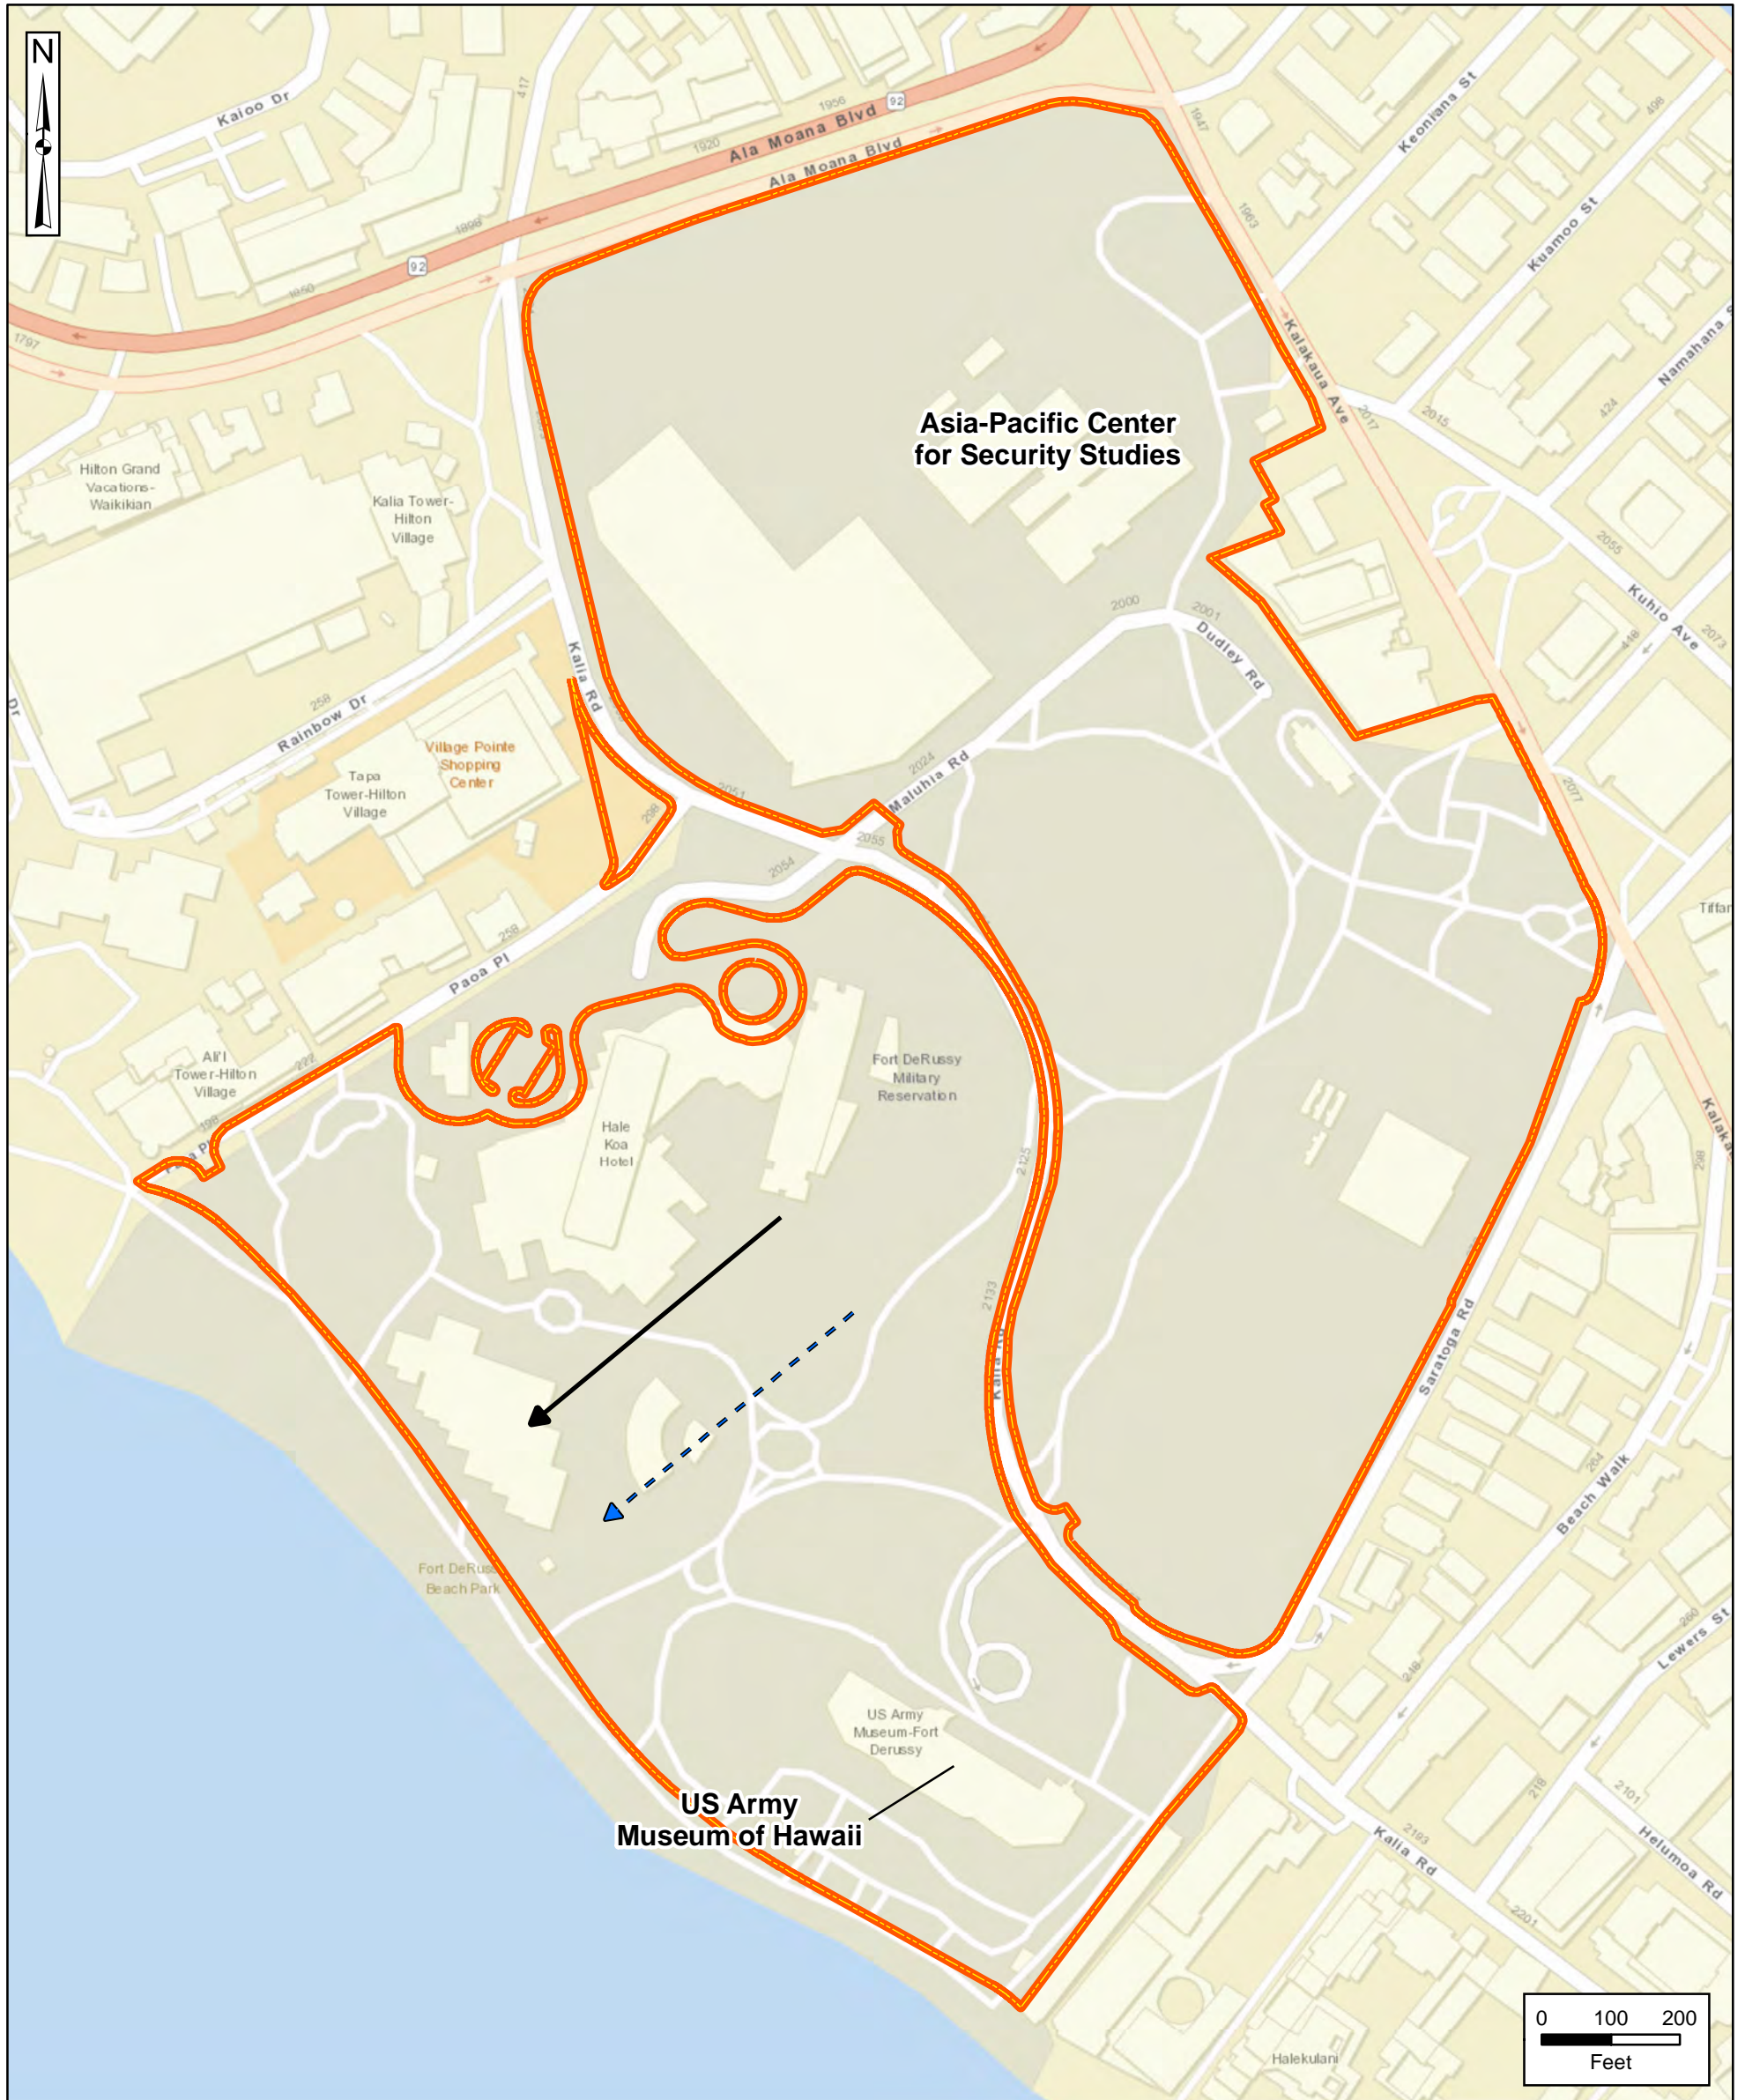
Figure 2-2b
Fort DeRussy Site Layout

No streams run through FTDR. The Ala Wai Canal is located to the north and east of FTDR (**Figure 2-2b**).

FTDR consists of the Daniel K. Inouye Asia-Pacific Center for Security Studies, Ainahau Triangle park, and a public parking lot to the north of Kalia Road, and the Hale Koa Hotel managed by the Armed Forces Recreation Center, the U.S. Army Museum, Hawaii (located in the historic Battery Randolph), and the U.S. Army Corps of Engineers Regional Visitor's Center (also in the historic Battery Randolph) to the south of Kalia Road. FTDR is an open post with park areas, tennis courts, a volleyball court, picnic area, and beachfront for both military and civilian use (**Figure 2-1**; **Figure 2-2b**; USAG-HI 2018). There are no foreseeable future land use changes for FTDR.

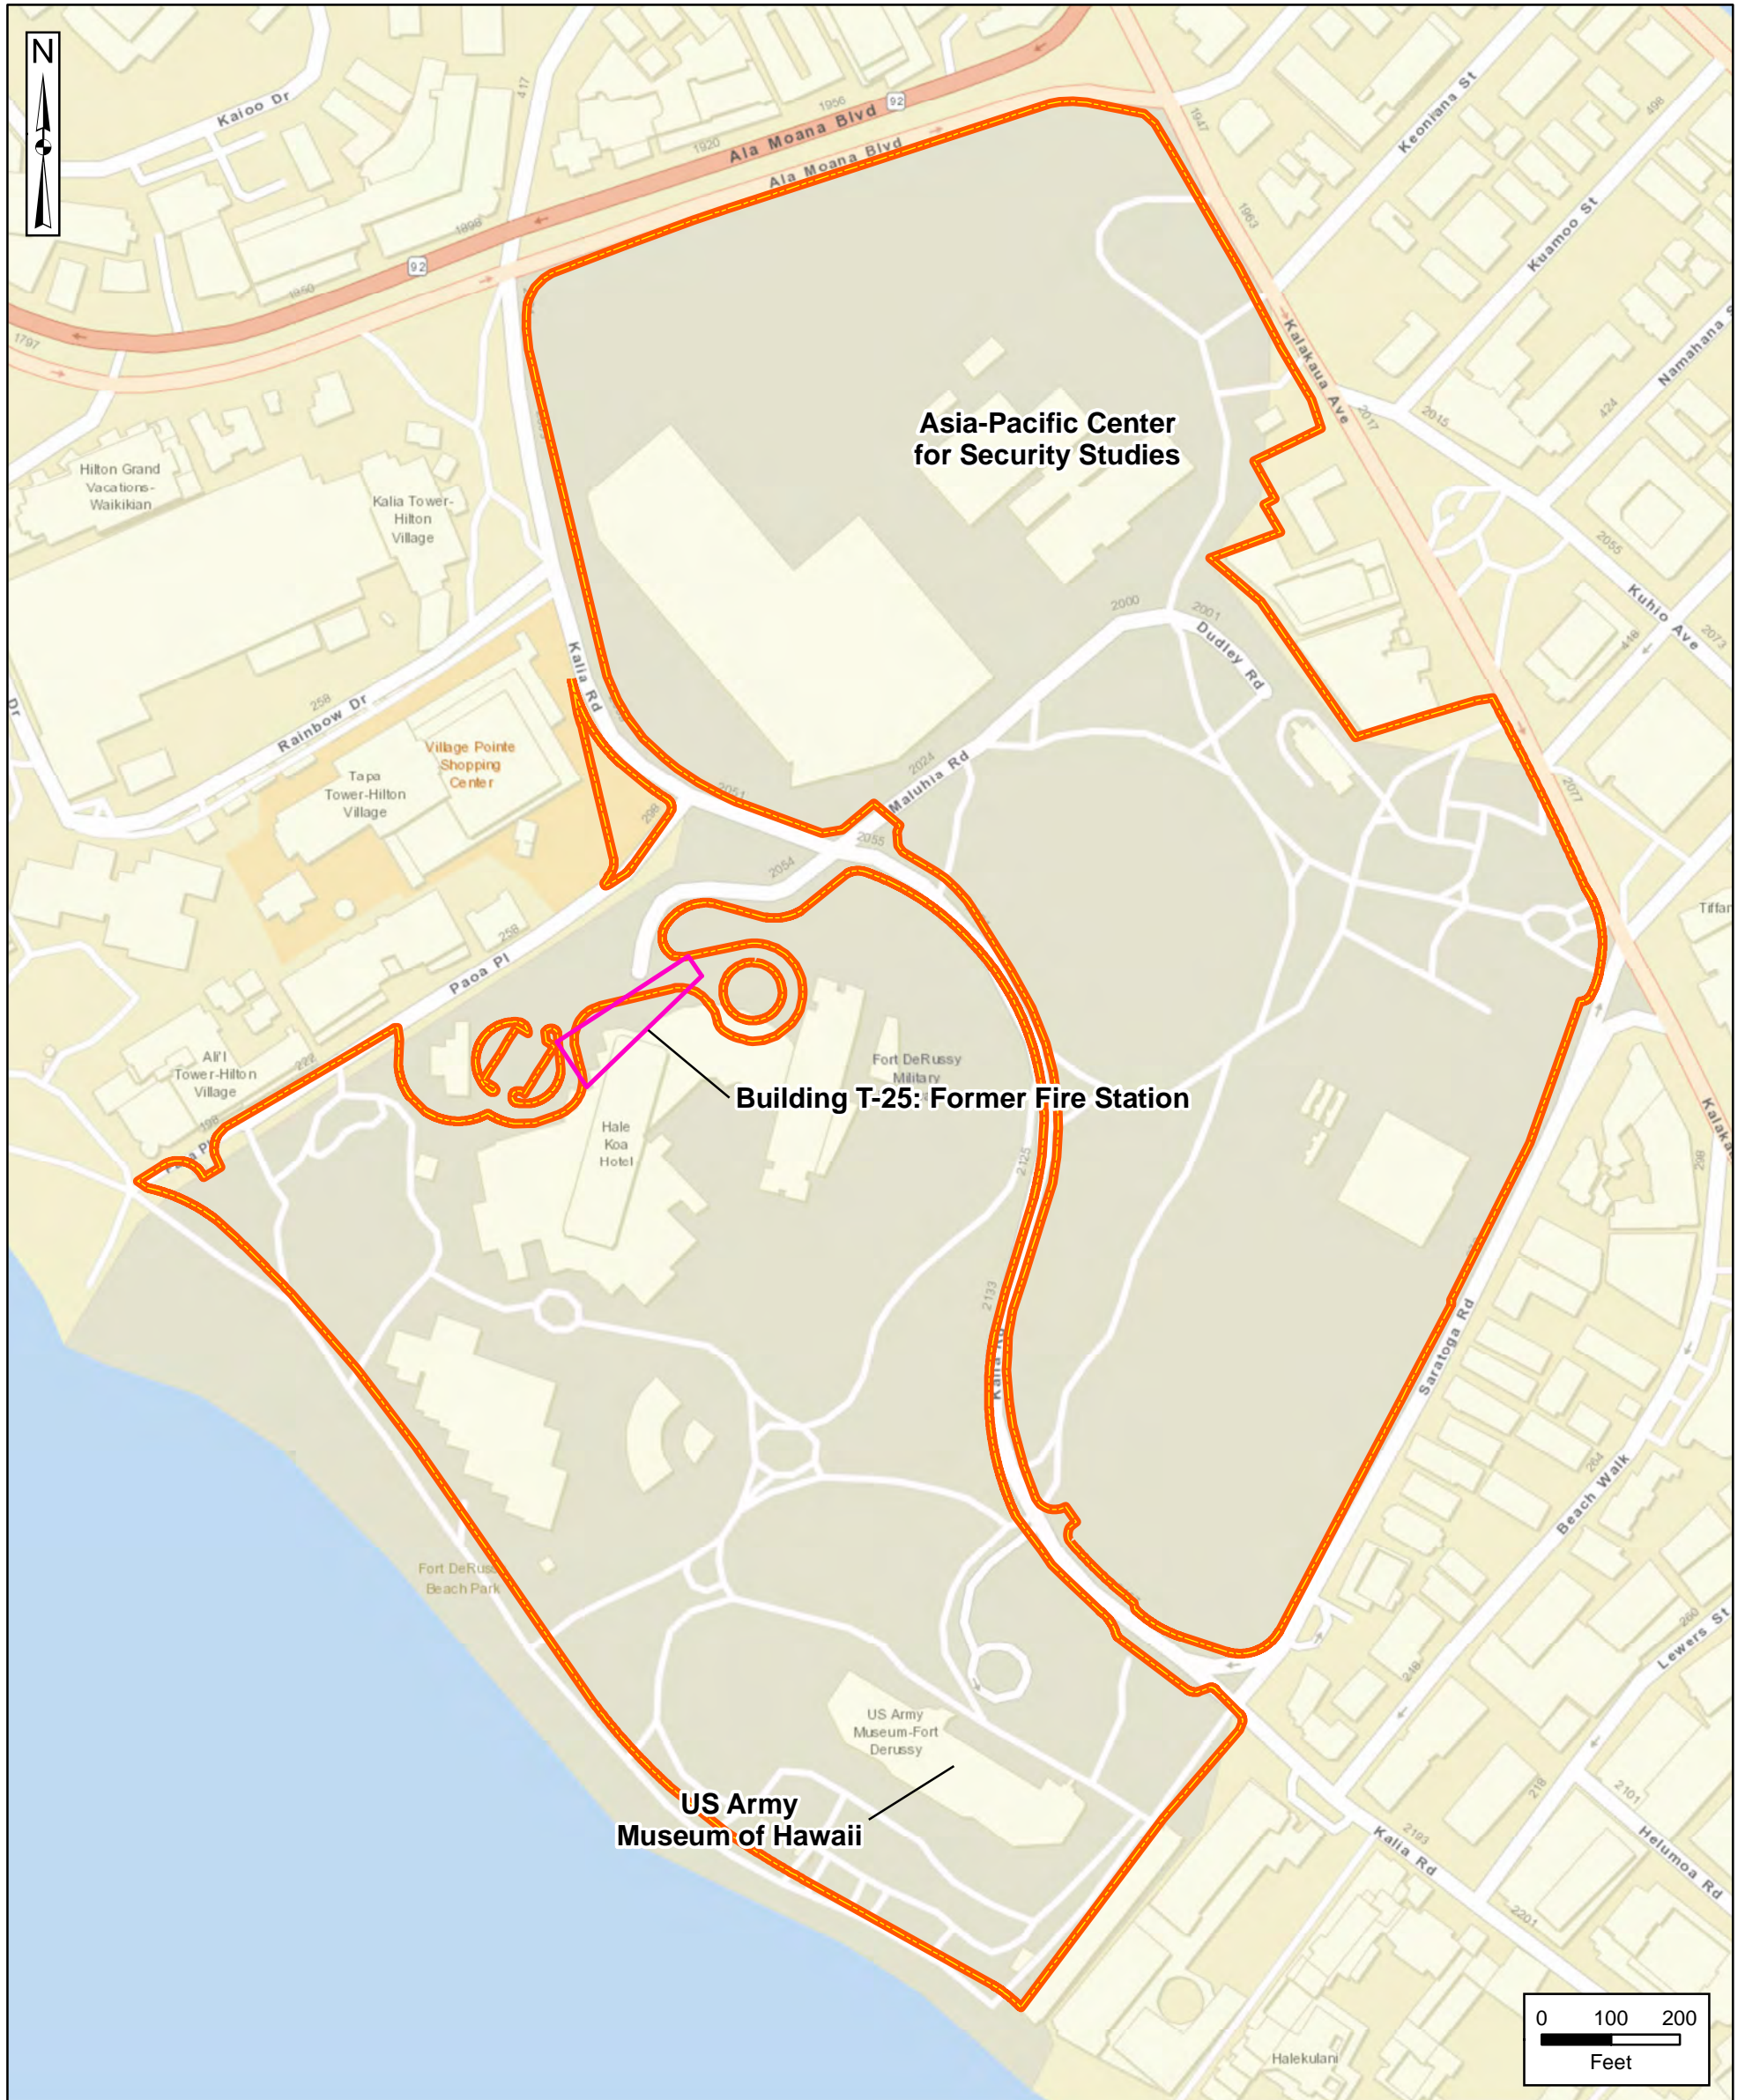
Figure 5-2b
Fort DeRussy AOPI Locations

Overviews of each AOPI identified during the PA process is presented in this section. The AOPI locations for FTSHF are shown on **Figure 5-2a** and FTDR are shown on **Figure 5-2b**. Detailed views of each AOPI showing the approximate extent of AFFF use (if applicable) are presented on **Figures 5-3** through **5-8** and include active monitoring wells (if present) in the vicinity of each AOPI.

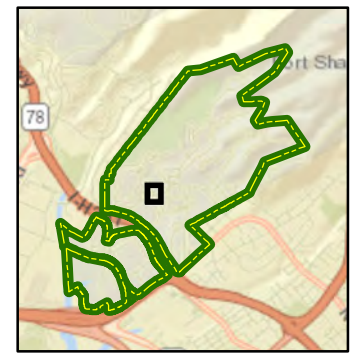
Figure 7-3
Canal Car Accident
PFOS, PFOA, PFBS, PFNA, and PFHxS Analytical Results

Two soil samples were collected via hand auger at the Canal Car Accident AOPI on 14 September 2022. Soil samples FTSHF-CCA-1-SO-091422 (0 to 1.7 feet bgs) and FTSHF-CCA-2-SO-091422 (0 to 2 feet bgs) were collected in the road adjacent to the canal shown in **Figure 7-3**.

The subsections below summarize the soil PFOS, PFOA, PFBS, PFNA, and PFHxS analytical results associated with Canal Car Accident shown on **Figure 7-3** and **Table 7-1**.

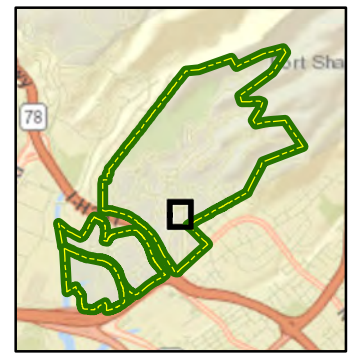
Figure 7-5
Building 322: Former Fire Station #3
PFOS, PFOA, PFBS, PFNA, and PFHxS Analytical Results

Chemical	Residential Scenario Risk Screening Level	Industrial/Commercial Scenario Risk Screening Level
	Soil (mg/kg)	Soil (mg/kg)
PFOS	0.013	0.16
PFOA	0.019	0.25
PFBS	1.9	25
PFNA	0.019	0.25
PFHxS	0.13	1.6

The subsections below summarize the soil PFOS, PFOA, PFBS, PFNA, and PFHxS analytical results associated with the Building 322: Former Fire Station #3 AOPI shown on **Figure 7-5** and **Table 7-1**.

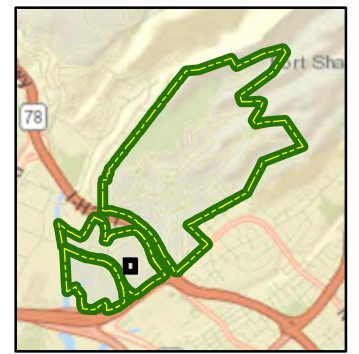
Figure 7-6
Building 1507: Former Metal Plating Facility
PFOS, PFOA, PFBS, PFNA, and PFHxS Analytical Results

Chemical	Residential Scenario Risk Screening Level		Industrial/Commercial Scenario Risk Screening Level
	Tap Water (ng/L)	Soil (mg/kg)	Soil (mg/kg)
PFOS	4	0.013	0.16
PFOA	6	0.019	0.25
PFBS	601	1.9	25
PFNA	6	0.019	0.25
PFHxS	39	0.13	1.6

FTSHF-BLDG1507-4-SO	
Date	4/25/2023
Depth	5-7 ft
PFOS	0.00061 U
PFOA	0.00061 U
PFBS	0.0020 U
PFNA	0.00061 U
PFHxS	0.00061 U

The subsections below summarize the soil and groundwater PFOS, PFOA, PFBS, PFNA, and PFHxS analytical results associated with the Building 1507 – Wing A: Former Metal Plating Shop shown on **Figure 7-6** and **Table 7-1** and **7-3**.

Five soil samples were collected using direct push drilling methods at the Building 1507 – Wing A: Former Metal Plating Shop AOPI on 25 April 2023. Soil samples FTSHF-BLDG1507-1-SO-042523 (5-7 feet bgs), FTSHF-BLDG1507-2-SO-042523 (5-7 feet bgs), FTSHF-BLDG1507-3-SO-042523 (5-7 feet bgs), FTSHF-BLDG1507-4-SO-042523 (5-7 feet bgs), and FTSHF-BLDG1507-5-SO-042523 (5-7 feet bgs) were located at a former sump excavation in an asphalt parking lot adjacent to Building 1507 shown in **Figure 7-6**. A field duplicate (FTSHF-FD-1-SO-042523) was collected and corresponds to parent sample FTSHF-BLDG1507-2-SO-042523. The field duplicate sample results are shown in brackets below following the parent sample results. PFOS, PFOA, PFBS, PFNA, and PFHxS were not detected in any of the five soil samples and therefore do not exceed the respective OSD residential risk screening levels.
