FINAL PRELIMINARY ASSESSMENT AND SITE INSPECTION OF PER- AND POLYFLUOROALKYL SUBSTANCES

Former Tarheel Army Missile Plant, North Carolina

June 2023

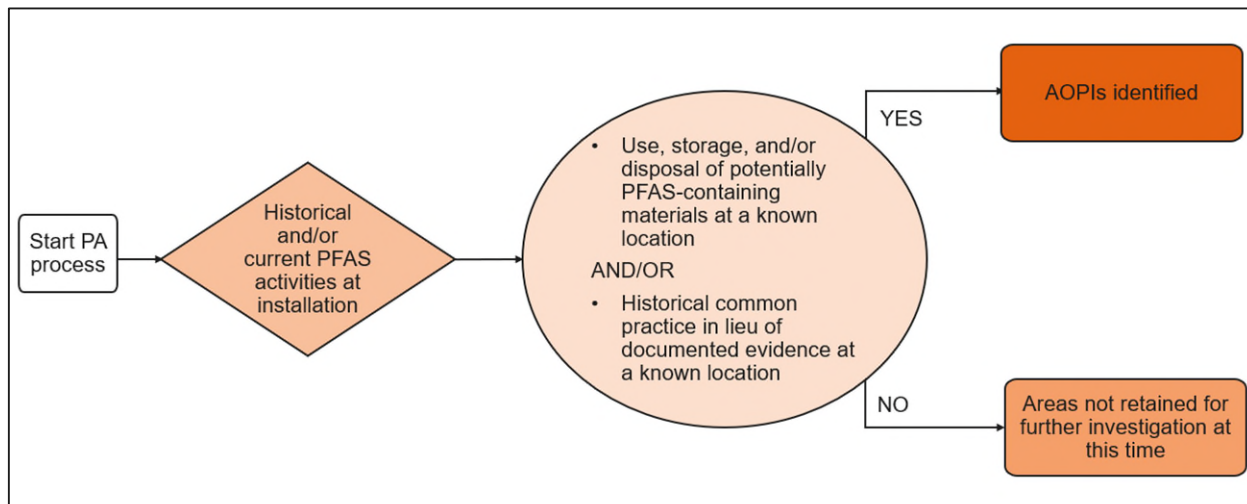
Figure 5-1: AOPI Decision Flowchart

The preliminary locations evaluated for potential use, storage, and/or disposal of PFAS-containing materials at TAMP, were further refined during the PA process and identified either as an area not retained for further investigation or as an AOPI. In accordance with the established process for the PA/SI, two areas have been identified as AOPIs. The process used for refining these areas is presented on **Figure 5-1**, below.

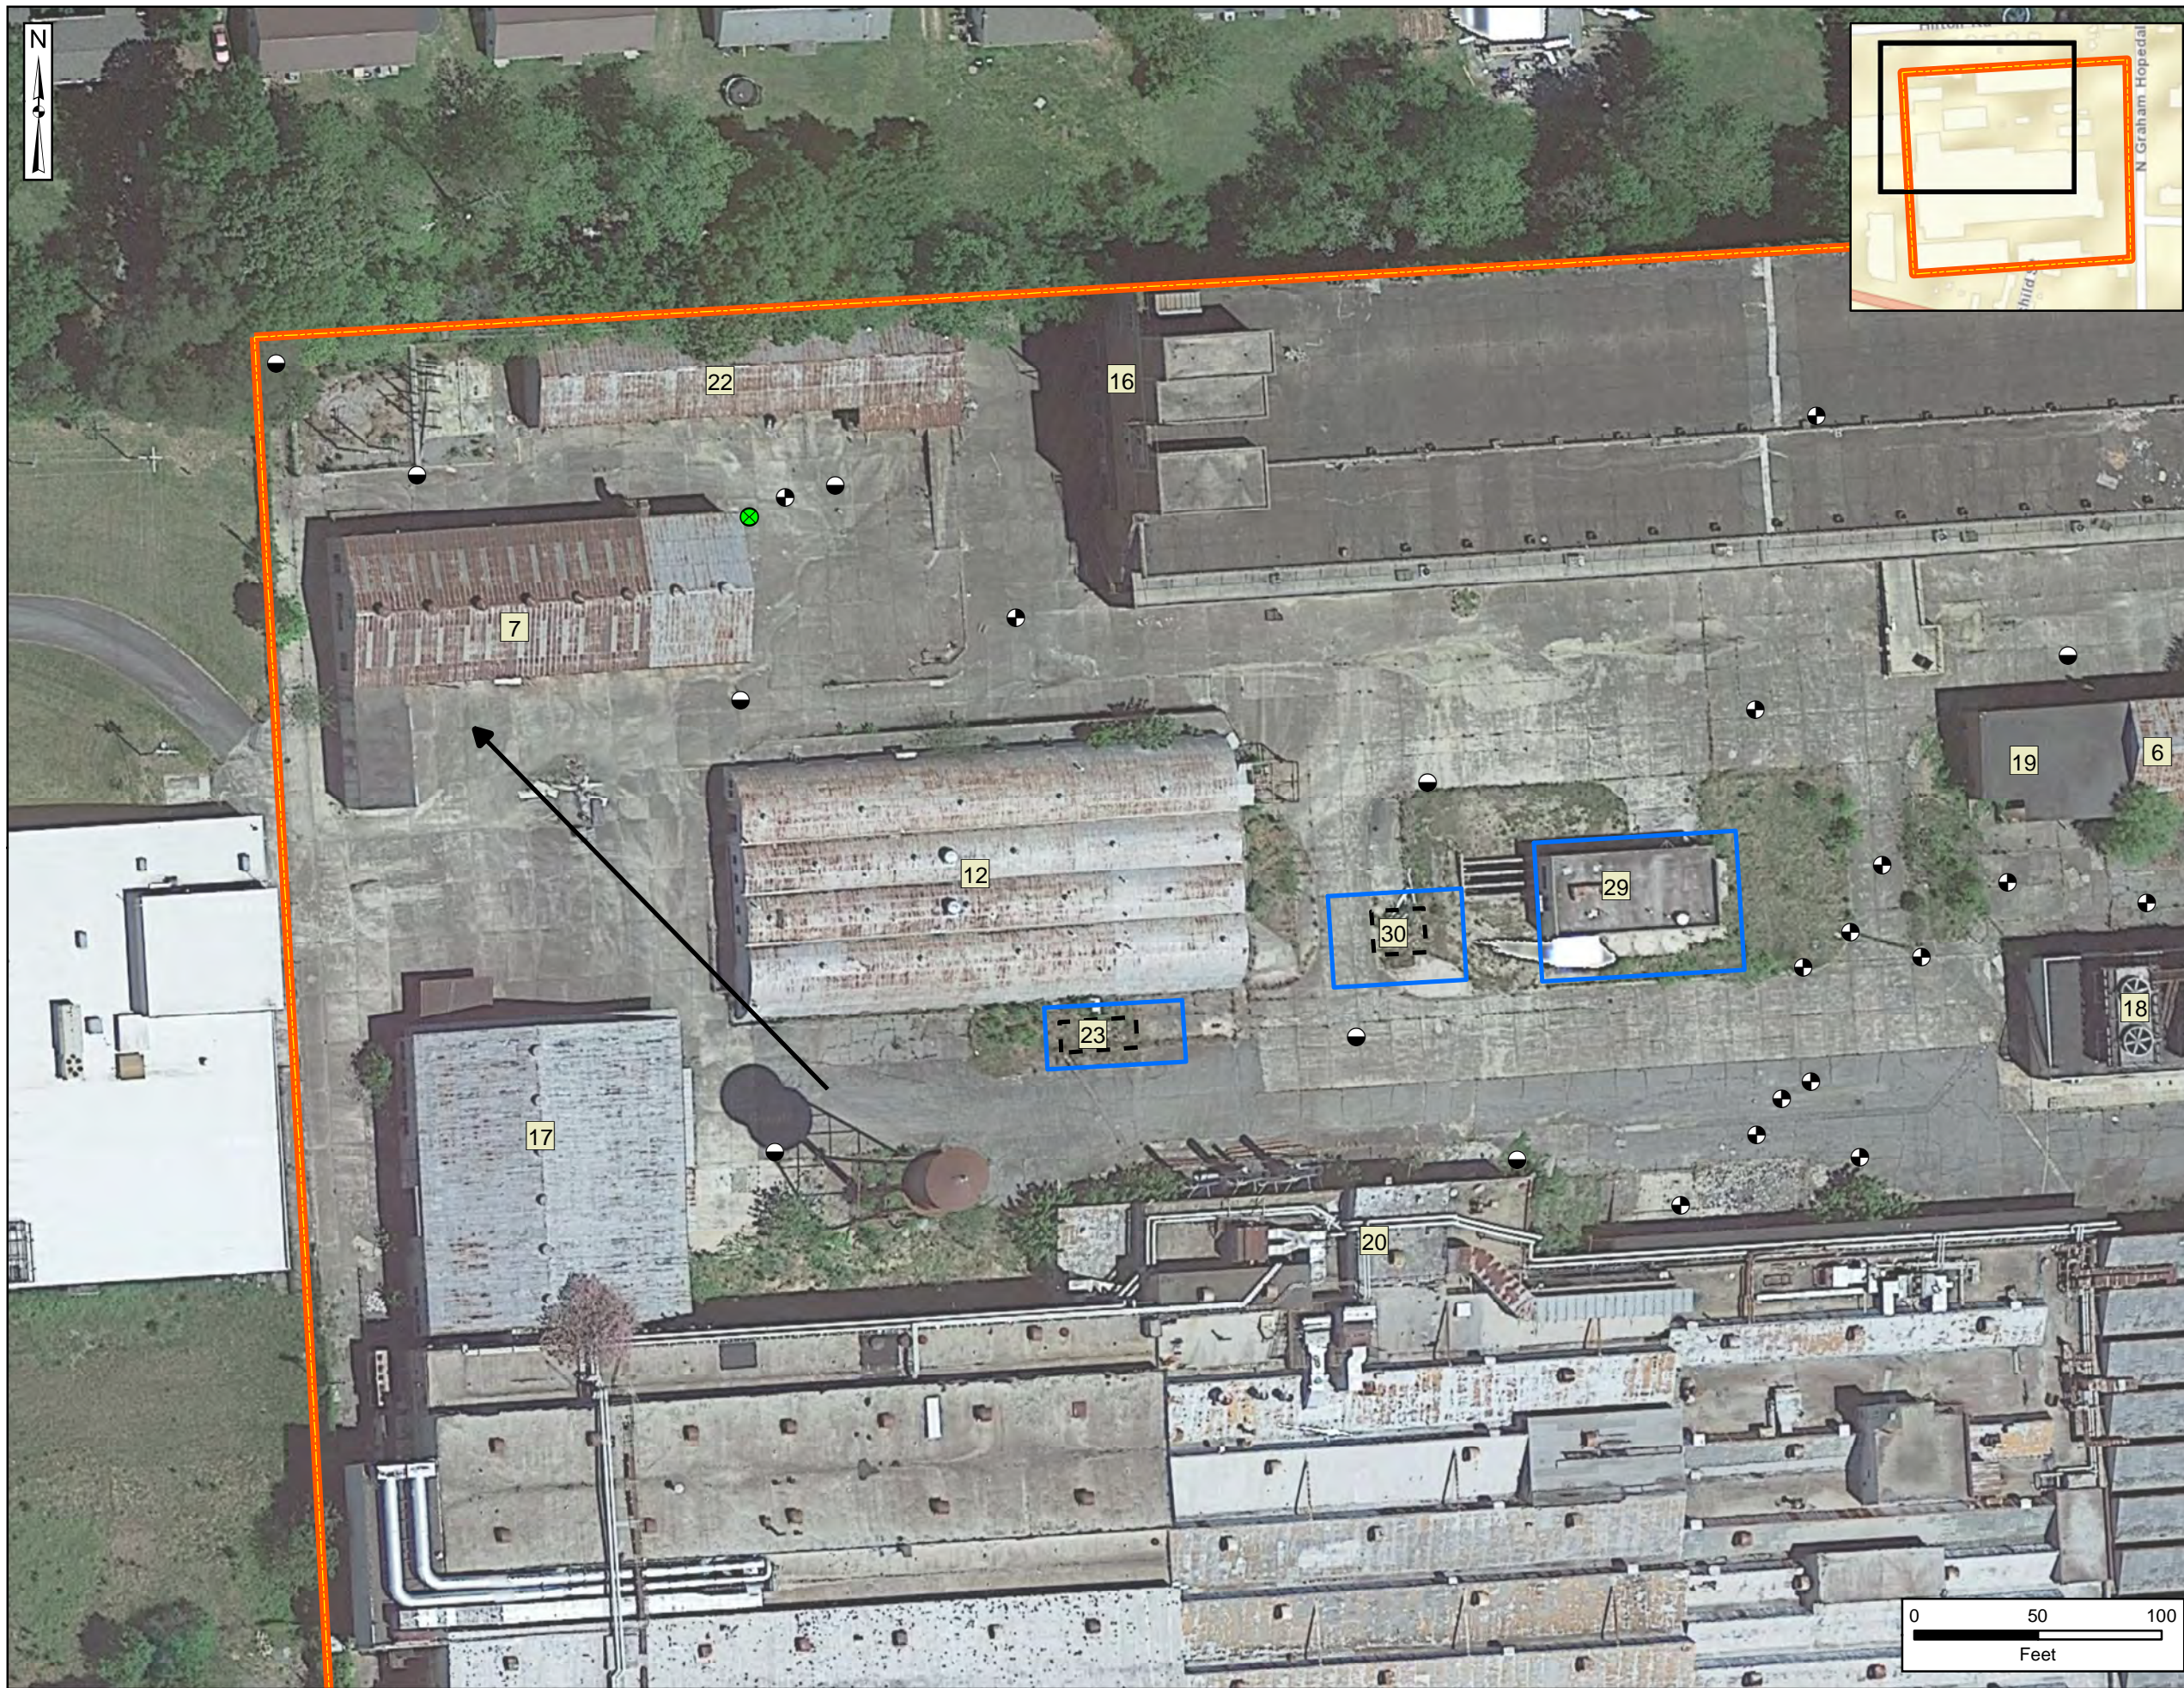
Figure 5-4
Aerial Photo of
IWTP Area
(Buildings 23, 29, and 30)

The IWTP Area (Buildings 23, 29, and 30) is identified as an AOPI based on research of historical files. It was noted the chromium plating area discharged to the IWTP. Permeable grass and/or soil covered areas around the IWTP were identified for potential seepage (B&V Waste Science and Technology 1992). Drainage likely flows to stormwater channels located within TAMP footprint or seeps to the subsurface to the northwest.
