# FINAL PRELIMINARY ASSESSMENT AND SITE INSPECTION OF PER- AND POLYFLUOROALKYL SUBSTANCES

## **Twin Cities Army Ammunition Plant, Minnesota**

September 2023

PRELIMINARY ASSESSMENT/SITE INSPECTION OF PFAS AT TWIN CITIES ARMY AMMUNITION  
PLANT, MINNESOTA

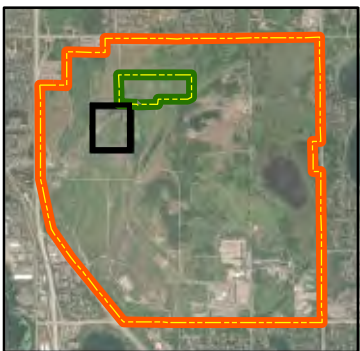
Figure 5-7  
Aerial Photo of  
Open Burn Area/Salvage Area (Site C)

The Open Burn Area/Salvage Area (Site C) (IRP ID: TCAAP-05) is identified as an AOPI due to documentation of machinery decontamination related to Building 103 (**Figure 5-7**). In May 1962, a 3-foot-deep pit was excavated for waste disposal as well as decontamination of 64 machines from Building 103, where metal plating activities occurred. The machines were contaminated with explosives and burned using wood and fuel oil. Site C was primarily used for burning and disposal activities from 1947 to 1982. Between 2000 and 2007, a total of 21,450 cubic yards of contaminated soil was excavated and transported offsite for disposal. In 2007 and 2008, a 4-foot soil cover was placed over the site (Shaw Environmental, Inc. 2009). At the time of this report, this area is located on property owned by Ramsey County (Arcadis 2023). Ramsey County completed additional soil remedial actions in 2011, including extending the 4-foot thick soil cover to the south and southeast, and excavation of 12,180 cubic yards of contaminated soil until to at least 4 feet below ground surface (bgs) (Army 2020).

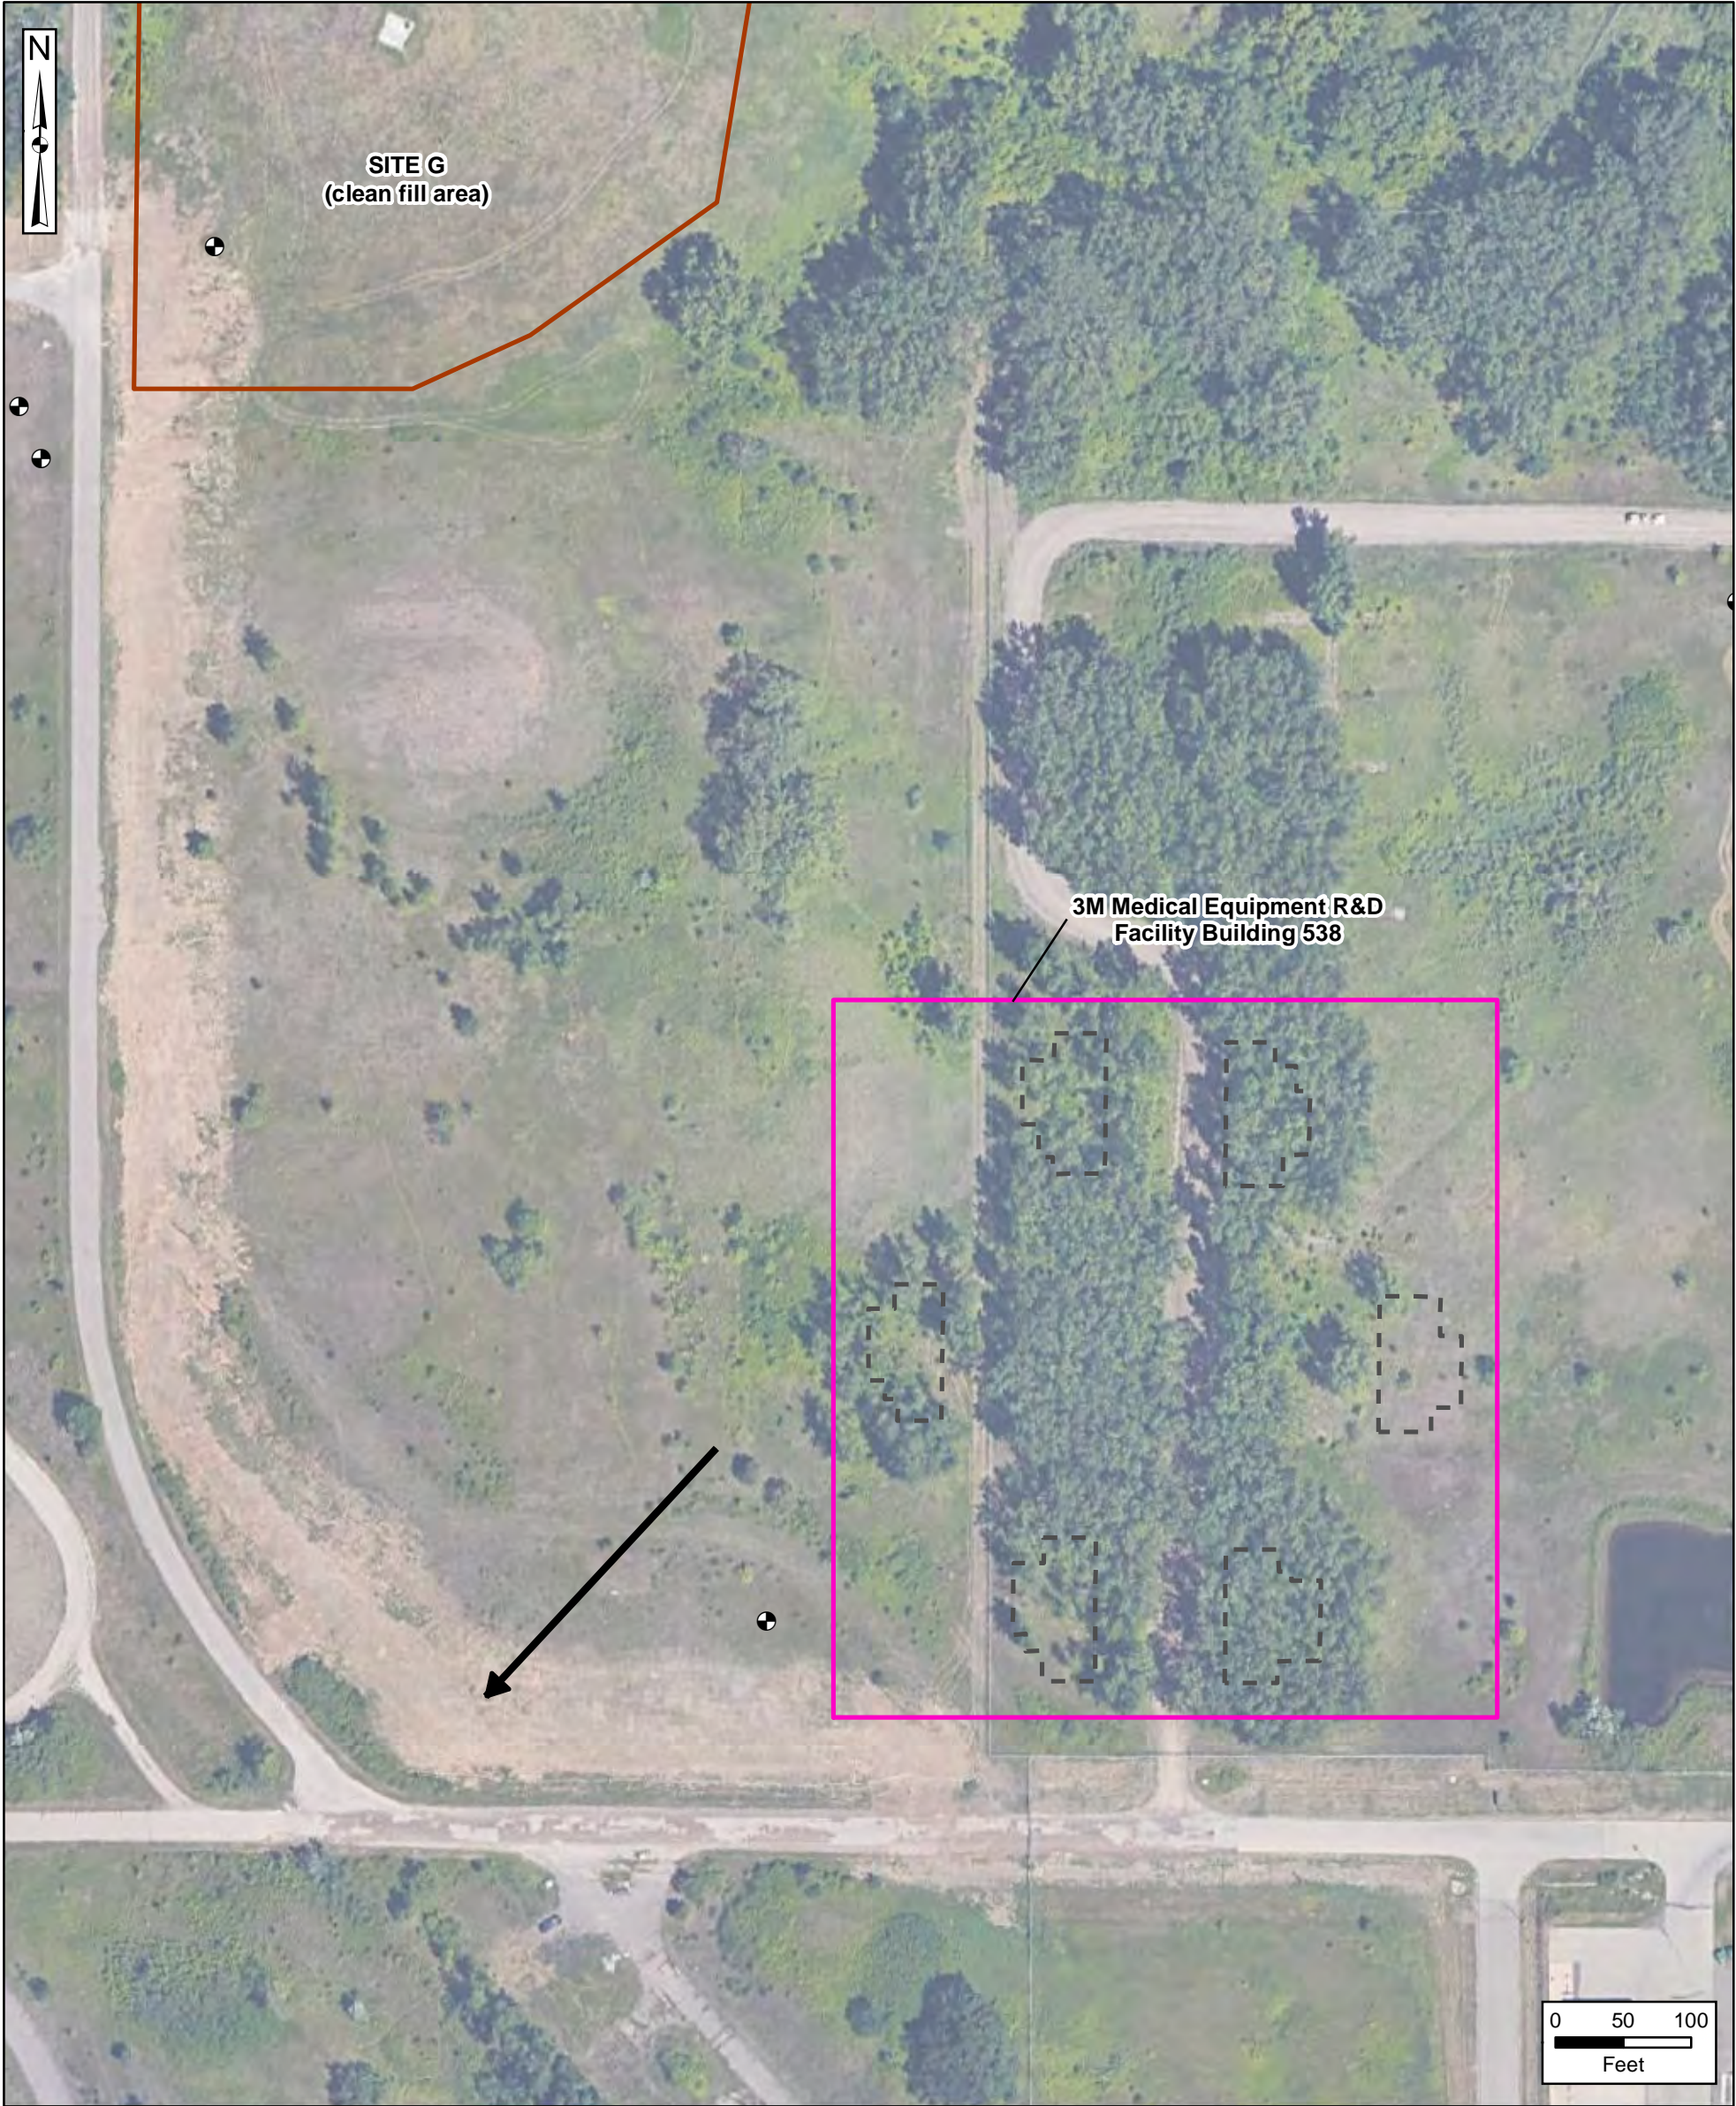
Figure 5-8  
Aerial Photo of  
3M Medical Equipment R&D Facility Building 538

The 3M Medical Equipment R&D Facility Building 538 is identified as an AOPI due to documentation that the building was leased by 3M and used for researching fluorine-containing solid propellants (**Figure 5-8**). 3M also used Building 538 for the research, development, and production of uranium dioxide and thorium dioxide micro-spheres as nuclear fuel. By 1991, the facility was used for medical diagnosis and therapy equipment research and development (R&D and work with radiological materials was also conducted in Buildings 113, 573, 575, and 590). Disposal of drums in the “Clean Fill Area,” also known as Site G, was reported in 1964. (United States Army Toxic and Hazardous Materials Agency 1978). Control of this area has since been reassigned to the National Guard Bureau who licenses the use of the property to the Minnesota Army National Guard (Arcadis 2023).

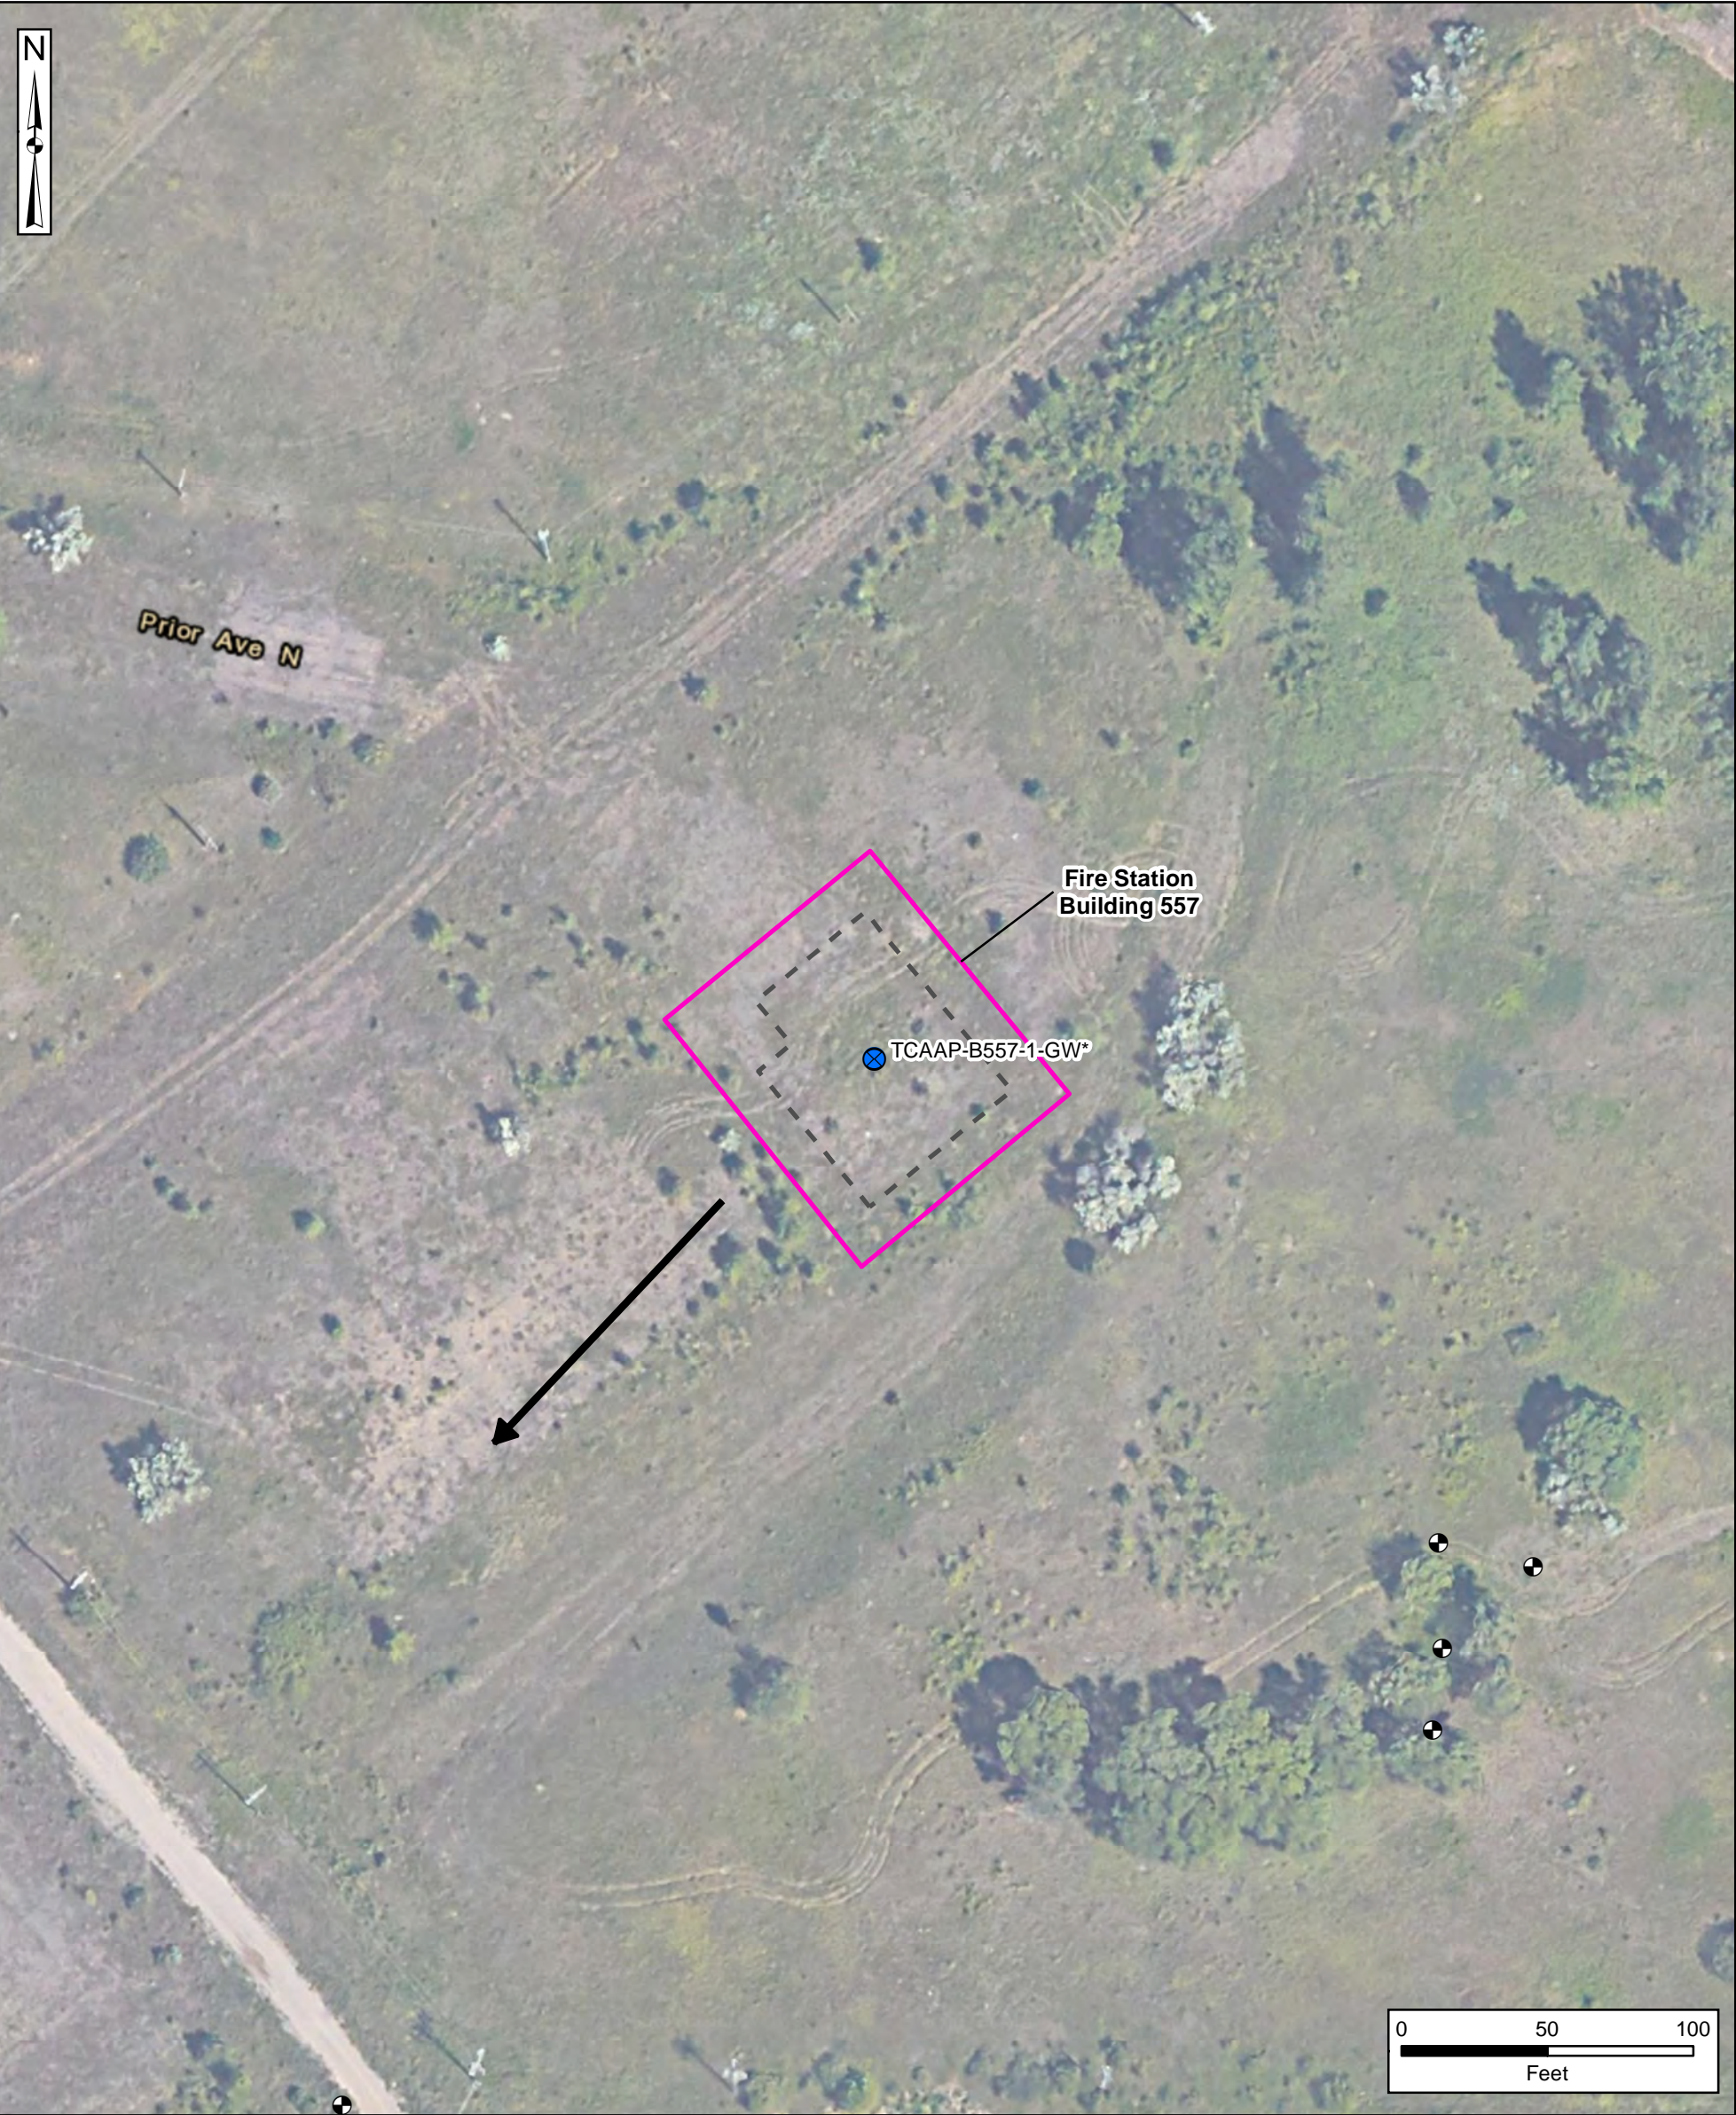
**Figure 7-3**  
**Fire Station Building 557**  
**PFOS, PFOA, PFBS, PFNA, and PFHxS Analytical Results**

The subsections below summarize the groundwater PFOS, PFOA, PFBS, PFNA, and PFHxS analytical results associated with Fire Station Building 557 AOPI shown on **Figure 7-3** and **Table 7-1**. Soil samples were not collected at the Fire Station Building 557 AOPI due to the soil investigations and remediation conducted by Ramsey County, as described in **Section 6.2**.

One proposed groundwater sample was unable to be collected due to the drill rig hitting refusal prior to reaching groundwater (TCAAP-B557-1-GW). One groundwater sample was collected from one existing monitoring well at the Industrial Operations Building 502 (Site I) AOPI (TCAAP-03U028) as described in **Section 7.4.1** and shown on **Figure 7-4**. While this sample is not located within the Fire Station Building 557 AOPI boundary, it is located downgradient of the Fire Station Building 557 AOPI.

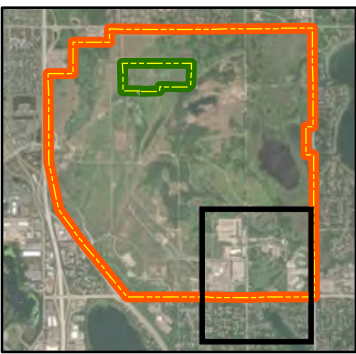
Figure 7-8  
Sewer Cleanout Drum Storage Building 576  
PFOS, PFOA, PFBS, PFNA, and PFHxS Analytical Results

The subsection below summarizes the groundwater PFOS, PFOA, PFBS, PFNA, and PFHxS analytical results associated with the Sewer Cleanout Drum Storage Building 576 AOPI shown on **Figure 7-8** and **Table 7-1**. Soil samples were not collected at the Sewer Cleanout Drum Storage Building 576 AOPI due to the field conditions at the time of sampling, as described in **Section 6.2**.
