FINAL PRELIMINARY ASSESSMENT AND SITE INSPECTION OF PER- AND POLYFLUOROALKYL SUBSTANCES

Tooele Army Depot - North, Utah

April 2022

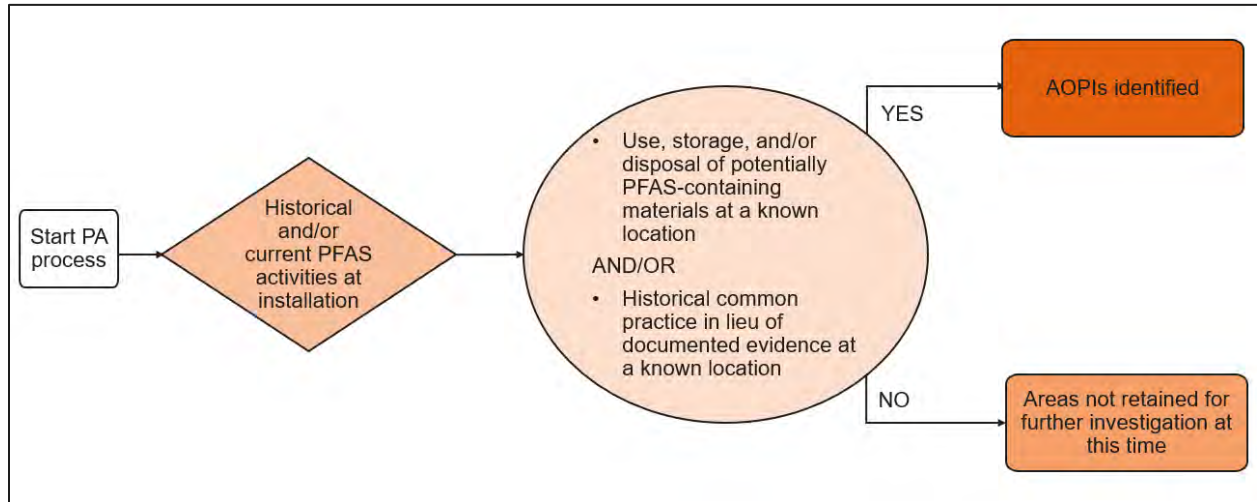
Figure 5-1: AOPI Decision Flowchart

The preliminary locations evaluated for potential use, storage, and/or disposal of PFAS-containing materials at TEAD-N were further refined during the PA process and identified either as an area not retained for further investigation or as an AOPI. In accordance with the established process for the PA/SI, 20 areas have been identified as AOPIs. The process used for refining these areas is presented on **Figure 5-1**, below.

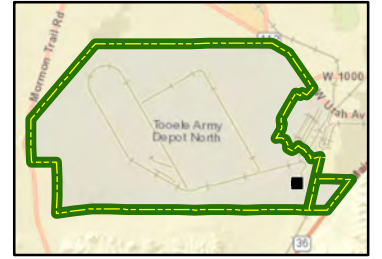
Figure 5-5
Aerial Photo of Car Wash (Building 16),
Maple Street Hydrants Tank Flushes, and
Fire Truck Maintenance (Building 507) AOPIs

The Car Wash (Building 16) AOPI does not overlap with IRP sites and consists of Building 16 and paved surfaces (**Figure 5-5**).

The Maple Street Hydrants Tank Flushes AOPI does not overlap with IRP sites and consists of paved surfaces. The surface generally slopes towards the west to the stormwater drain (**Figure 5-5**).

The Fire Truck Maintenance (Building 507) AOPI does not overlap with IRP sites and consists of Building 507 and paved areas (**Figure 5-5**).

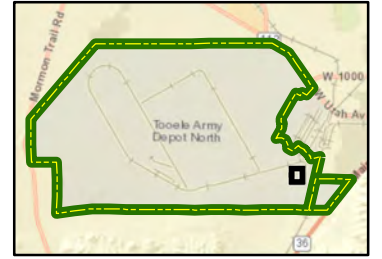
Figure 5-6
Aerial Photo of Drafting Pit and RAP
Greasewood and Sagebrush Roads AOPIs

The Drafting Pit AOPI does not overlap with IRP sites and consists of grassy and graveled areas (**Figure 5-6**).

The RAP Greasewood and Sagebrush Roads AOPI does not overlap with IRP sites and consists of paved and grassy areas. Potable well WW1 is located within the boundary of the RAP Greasewood and Sagebrush Roads AOPI (**Figure 5-6**).

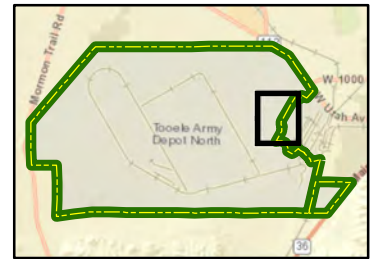
Figure 5-9
Aerial Photo of Former IWL and Ditches
(SWMU 30 and SWMU 2) AOPi

The Former IWL and Ditches (SWMU 30 and SWMU 2) overlaps with IRP sites SWMU 30 and SWMU 2, identified by HQAES 49575.1023 and 49575.1024, and 49575.1013, respectively. SWMU 30 received a no further action declaration in 2001 (USAEC 2016). The corrective measures at the Former IWL and Ditches (SWMU 30 and SWMU 2) AOPI includes soil vapor extraction and air sparging at several groundwater contaminant sources (USAEC 2016). The area is largely vegetated with several paved roads traversing the area (**Figure 5-9**).

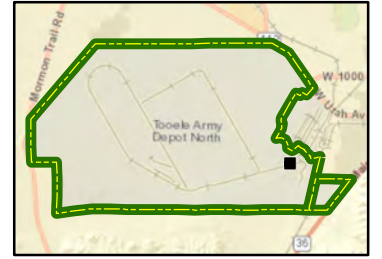
Figure 5-12
**Aerial Photo of Stormwater Evaporation/
 Percolation Basin (SWMU 45) AOPI**

The Stormwater Evaporation/Percolation Basin (SWMU 45) overlaps with IRP site SWMU 45, identified by HQAES 49575.1049. Long term monitoring is conducted at the AOPI, including semiannual land use control inspections to ensure that the corrective measures remain protective (USAEC 2016). The area is predominantly vegetated (**Figure 5-12**).

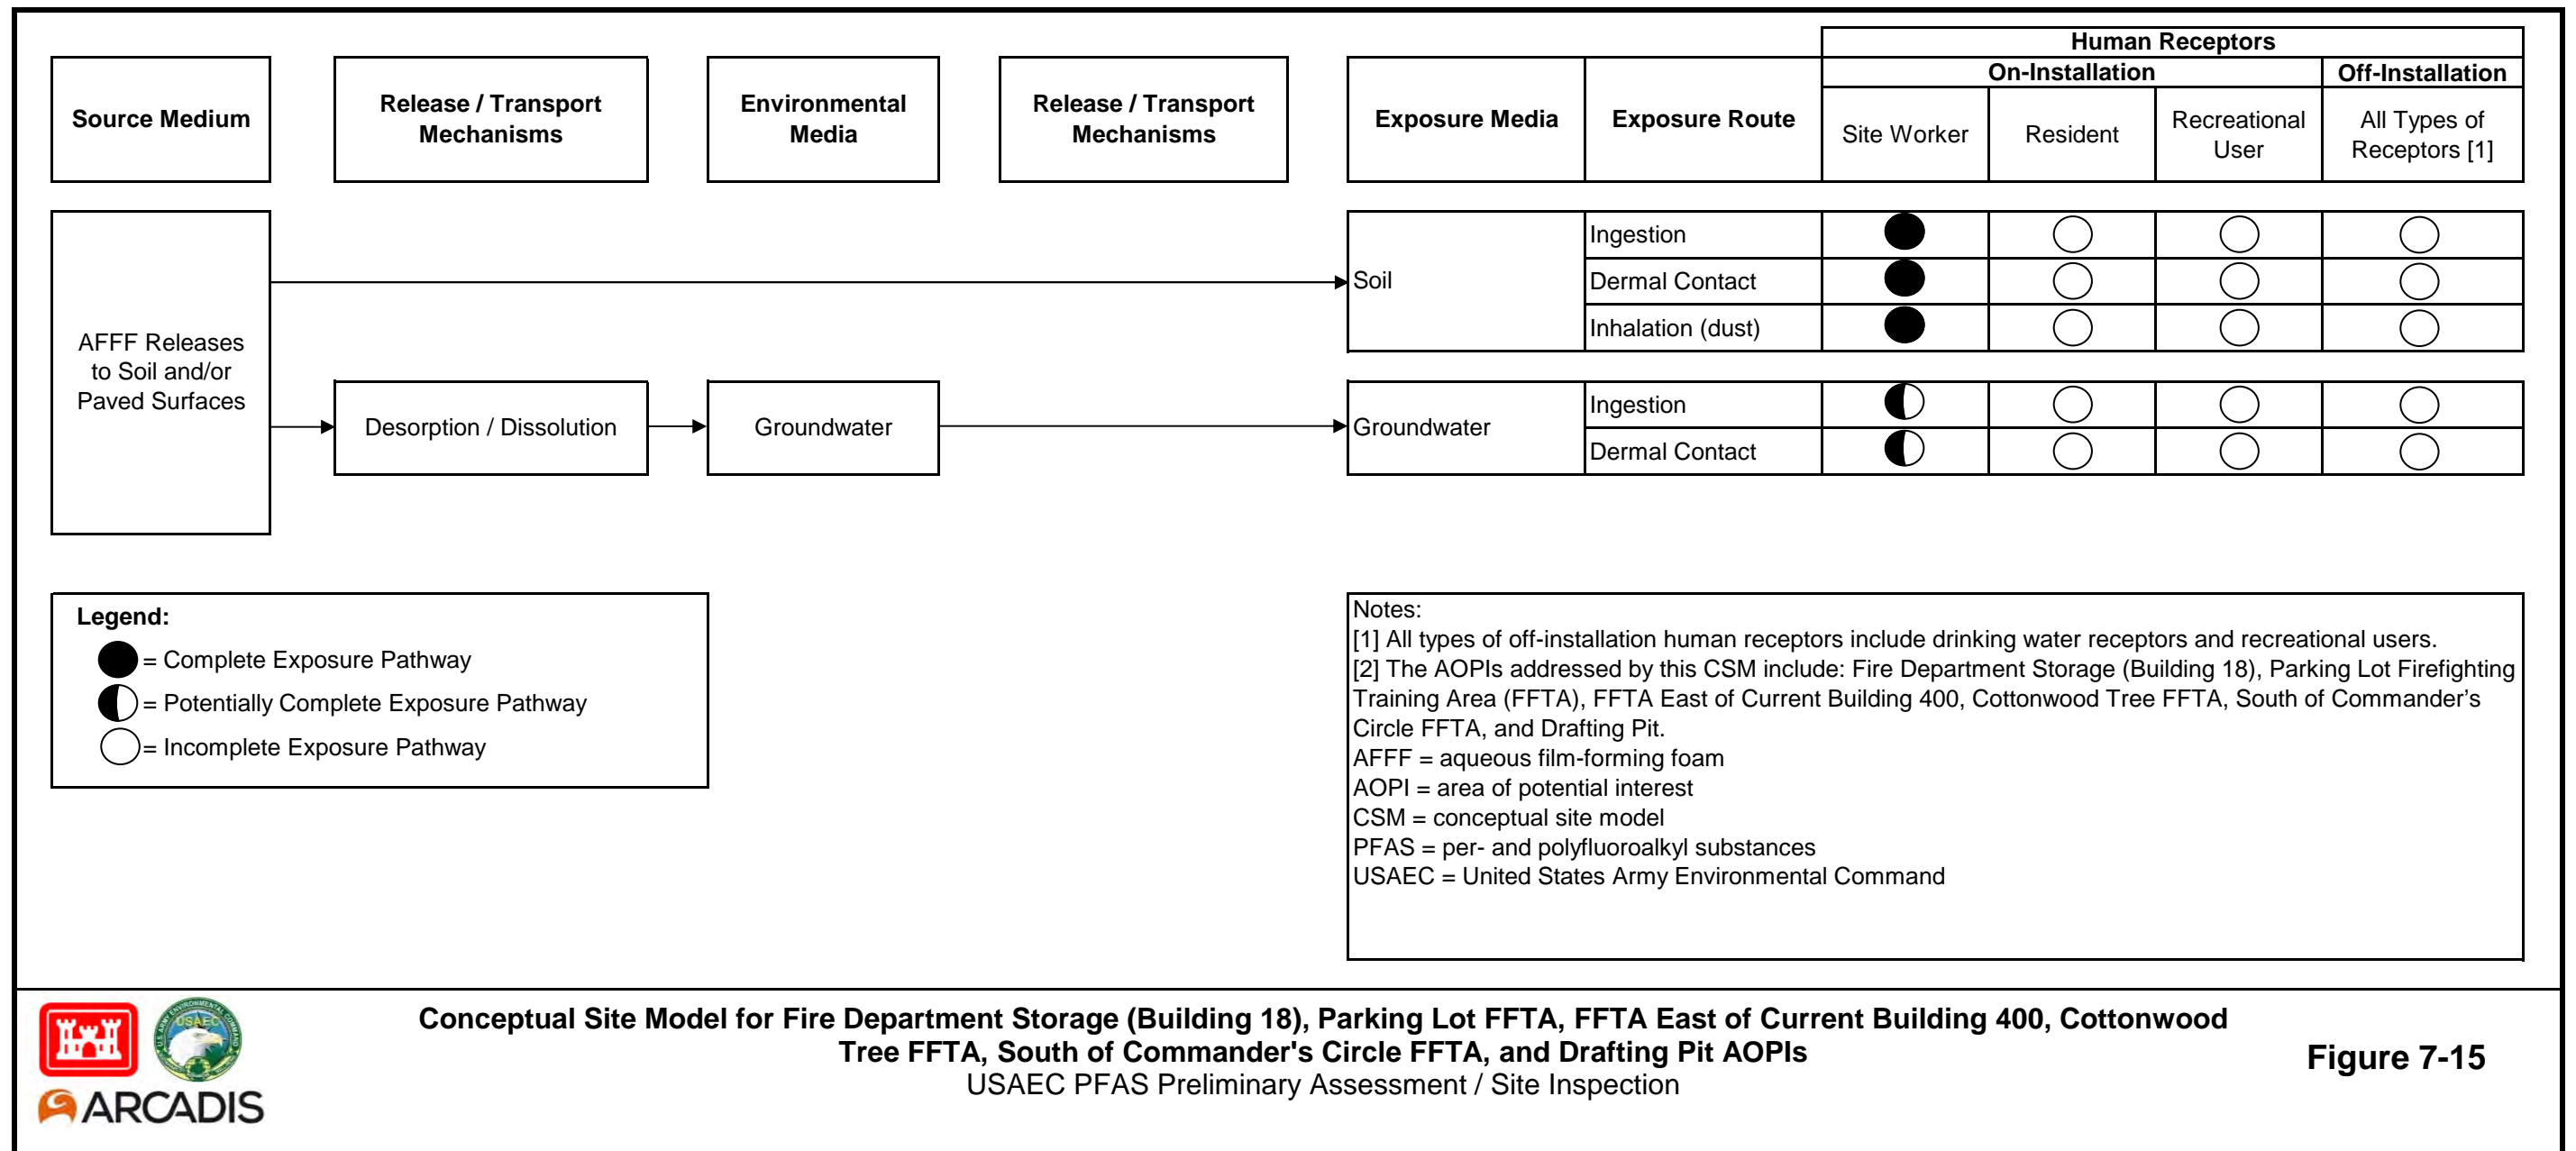
Figure 7-15

Conceptual Site Model for Fire Department Storage (Building 18), Parking Lot FFTA, FFTA East of Current Building 400, Cottonwood Tree FFTA, South of Commander's Circle FFTA, and Drafting Pit AOPIs
 USAEC PFAS Preliminary Assessment / Site Inspection

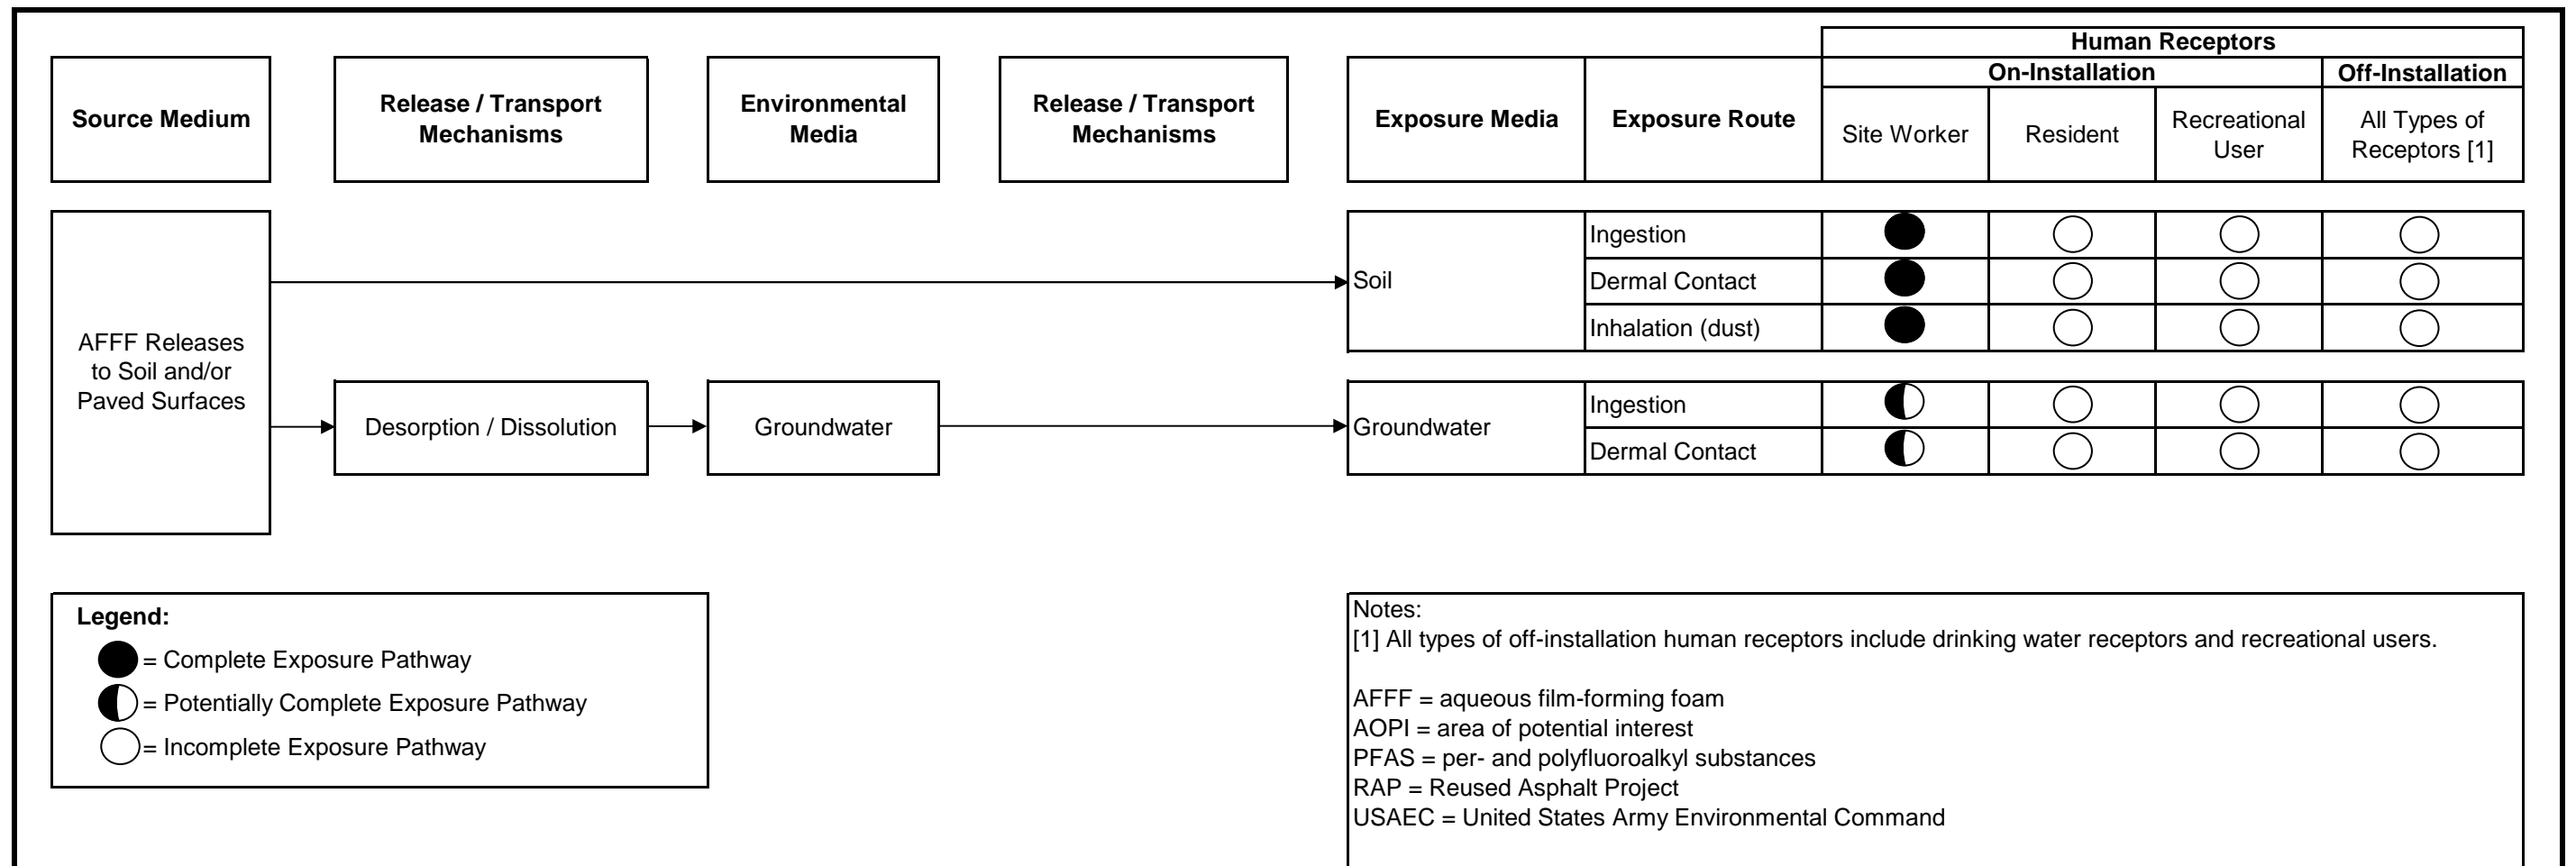
Figure 7-19

Conceptual Site Model for RAP TV Site Road Loop (Building 1376 Area) AOPI
 USAEC PFAS Preliminary Assessment / Site Inspection
 Tooele Army Depot - North, Utah

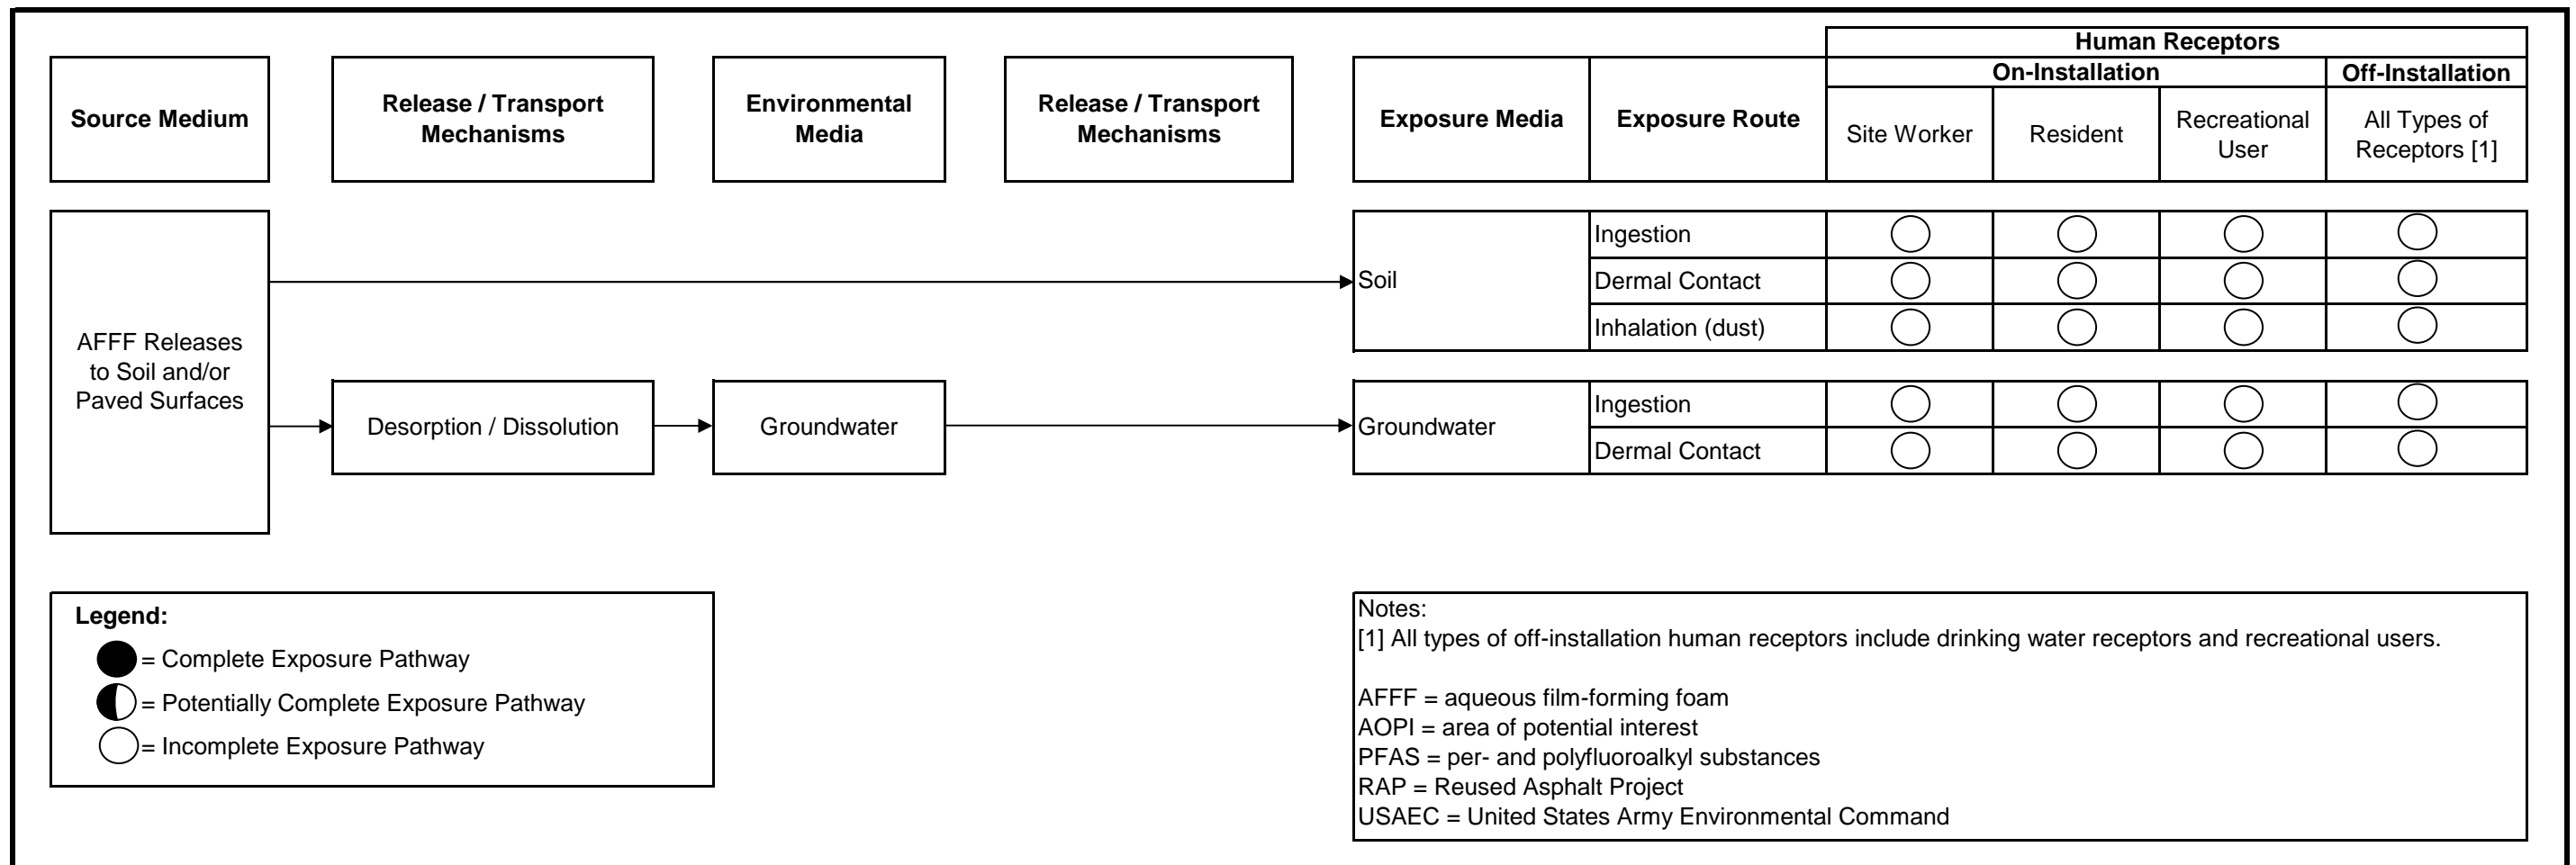
Figure 7-20

**Conceptual Site Model for Building 1400 Area Tank Flush, RAP Ammo Gate / Railroad Classification Yard,
 and Demo Pit Range Dumpster Fire AOPIs**
 USAEC PFAS Preliminary Assessment / Site Inspection

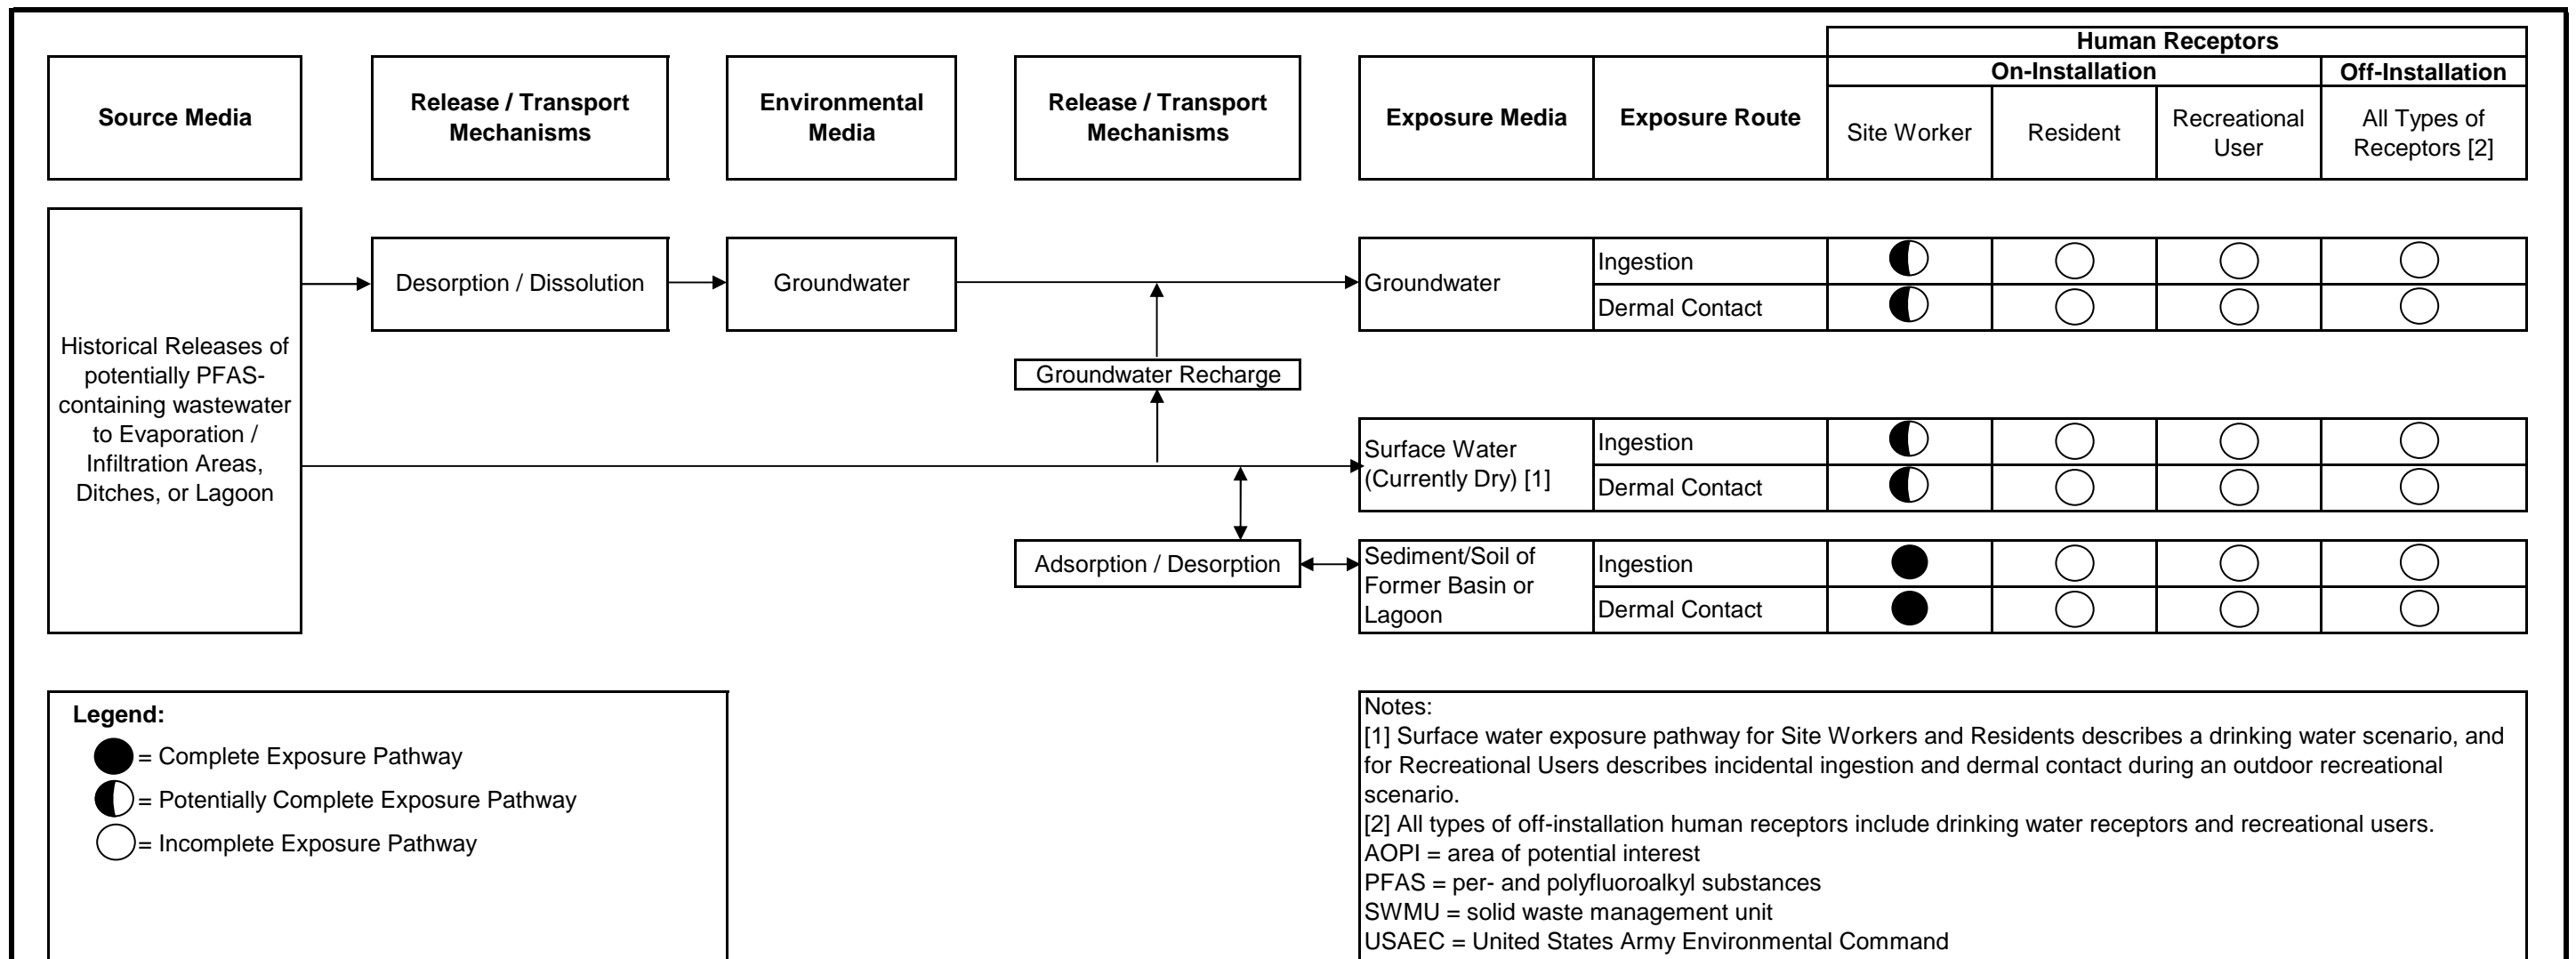
Figure 7-22

Conceptual Site Model for the Stormwater Evaporation/Percolation Basin (SWMU 45) and Former Industrial Waste Lagoon and Ditches (SWMU 30 and SWMU 2) AOPIs
 USAEC PFAS Preliminary Assessment / Site Inspection
