# FINAL PRELIMINARY ASSESSMENT AND SITE INSPECTION OF PER- AND POLYFLUOROALKYL SUBSTANCES

## Tooele Army Depot - South, Utah

Prepared For:  
U.S. Army Corps of Engineers, Baltimore District  
2 Hopkins Plaza  
Baltimore, Maryland 21201

April 2022

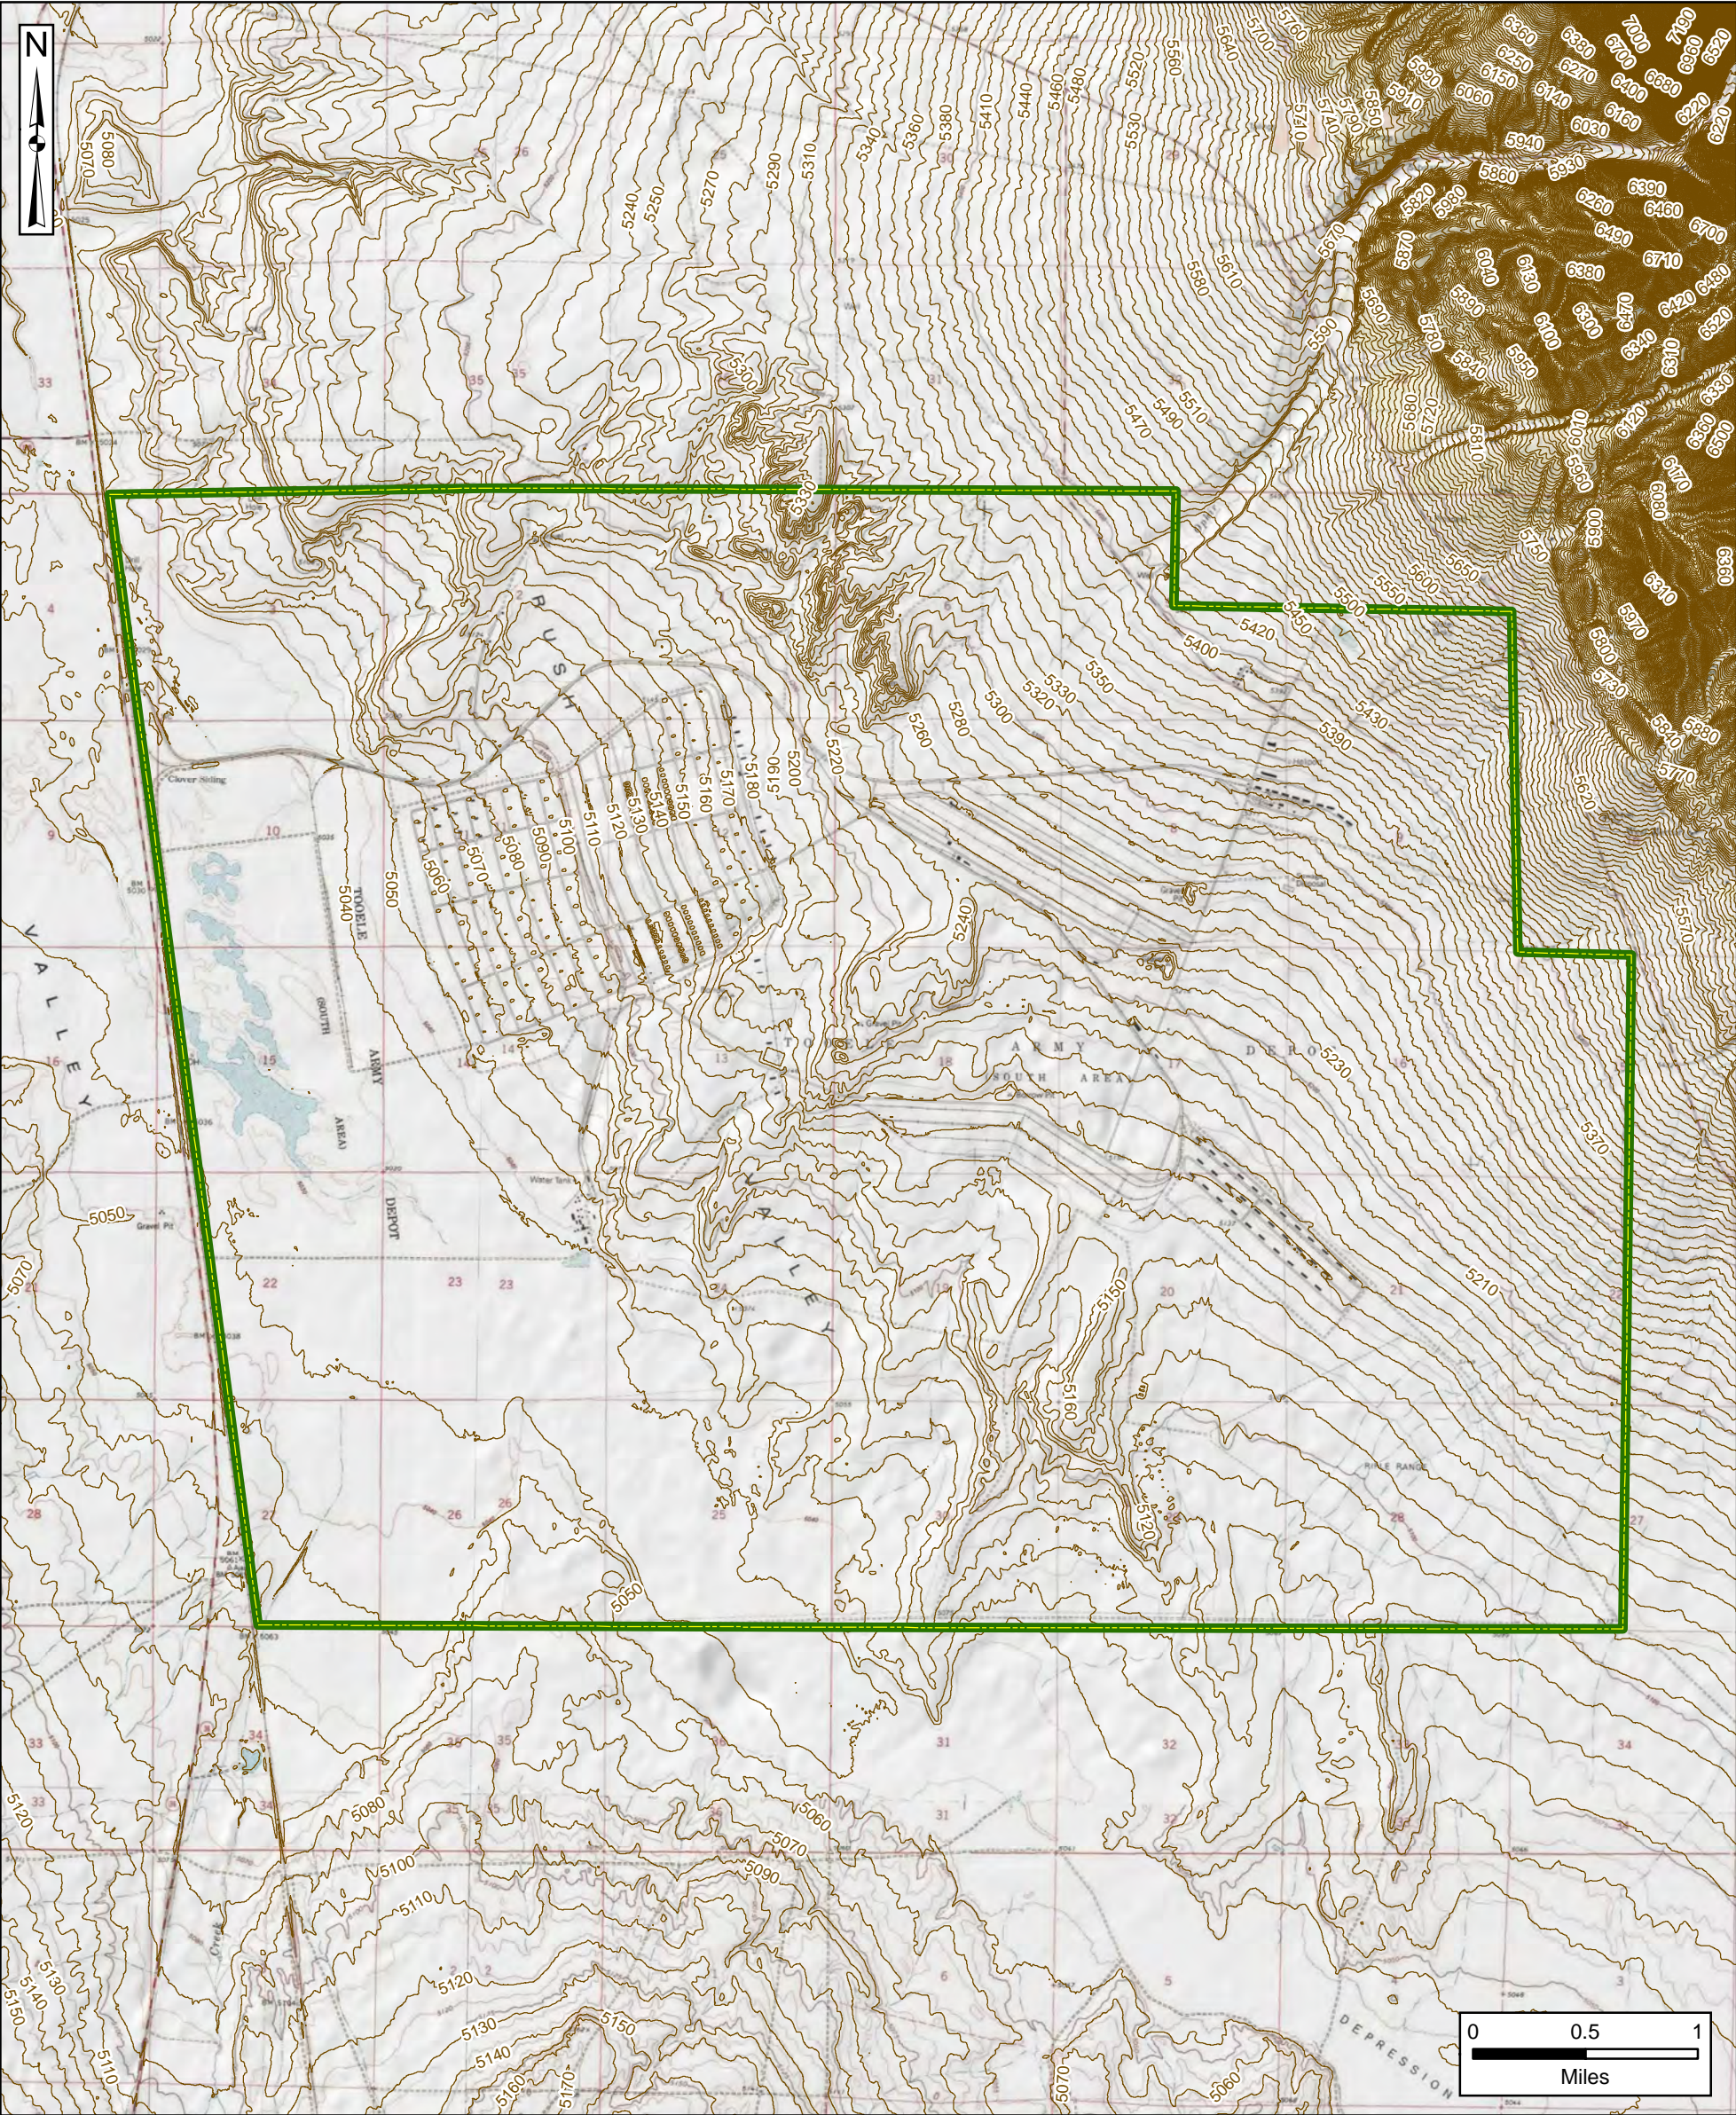
Figure 2-3  
Topographic Map

Information in this section is excerpted from the TEAD-S Final Groundwater Management Plan (Parsons 2017). TEAD-S is located on the eastern side of Rush Valley. The valley is a large, north-south trending, internally drained basin, defined by a series of narrow, normal fault-bounded bedrock mountain ranges and adjoining low hills that surround a broad, gently sloping valley floor. The surface topography of TEAD-S is generally flat with a gradual and gentle slope toward the west-southwest (Parsons 2017). Ground surface elevations across TEAD-S range from approximately 5,030 feet above mean sea level along the southern boundary to 5,600 feet above mean sea level along the northeastern boundary. **Figure 2-3** shows the topography of the installation and surrounding area.

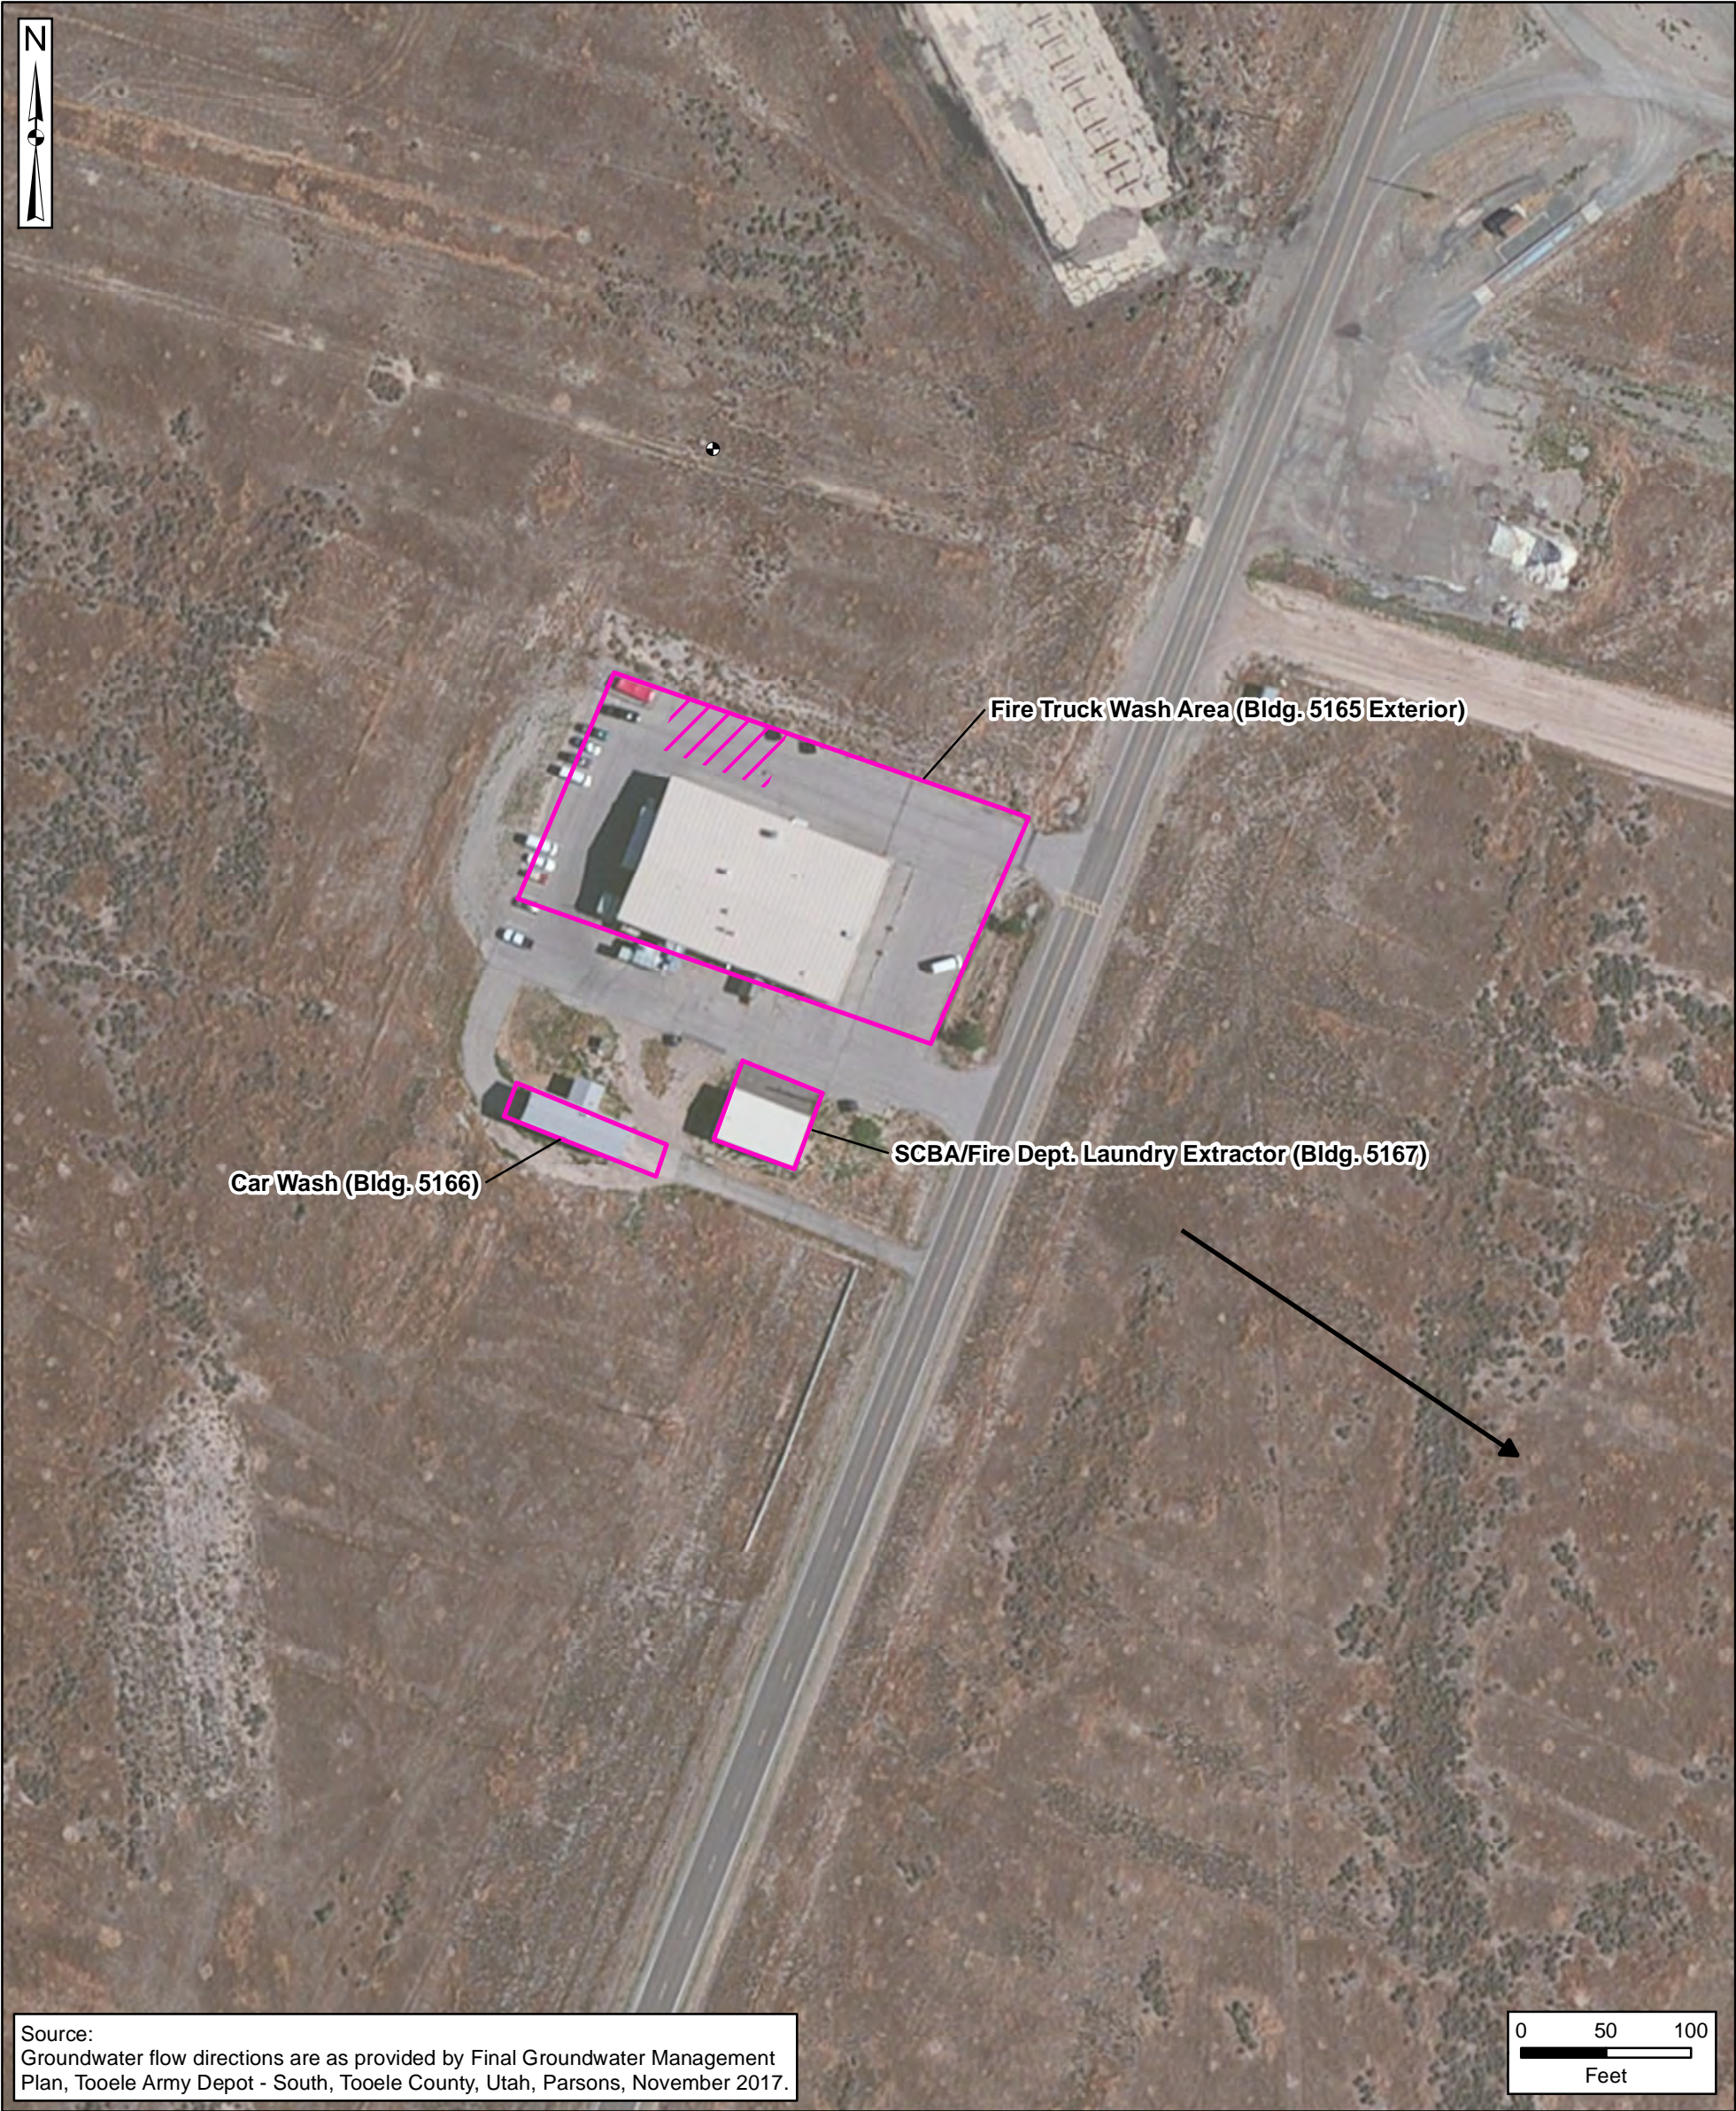
**Figure 5-3**  
**Aerial Photo of Fire Truck Wash Area (Building 5165 Exterior), Car Wash (Building 5166), and SCBA/Fire Department Laundry Extractor (Building 5167) AOPIs**

The SCBA/Fire Department Laundry Extractor System (Building 5167) is identified as an AOPI following records research, personnel interviews, and site reconnaissance due to laundry extractor system leaks. The TEAD fire department uses the extractor system in Building 5167 to launder its turnout gear (PPE). The extractor system experiences frequent leaks that flood the floor of the building, and bubbles are observed on the floor during these leaks. According to firefighter interviews, these leaks occur almost every time the extractor system is used. The floor drain is connected to the TOCDF Lagoons. Fire department personnel have also pushed the floodwater out the building door on numerous occasions, and floodwaters may have also leaked out the back of the building.

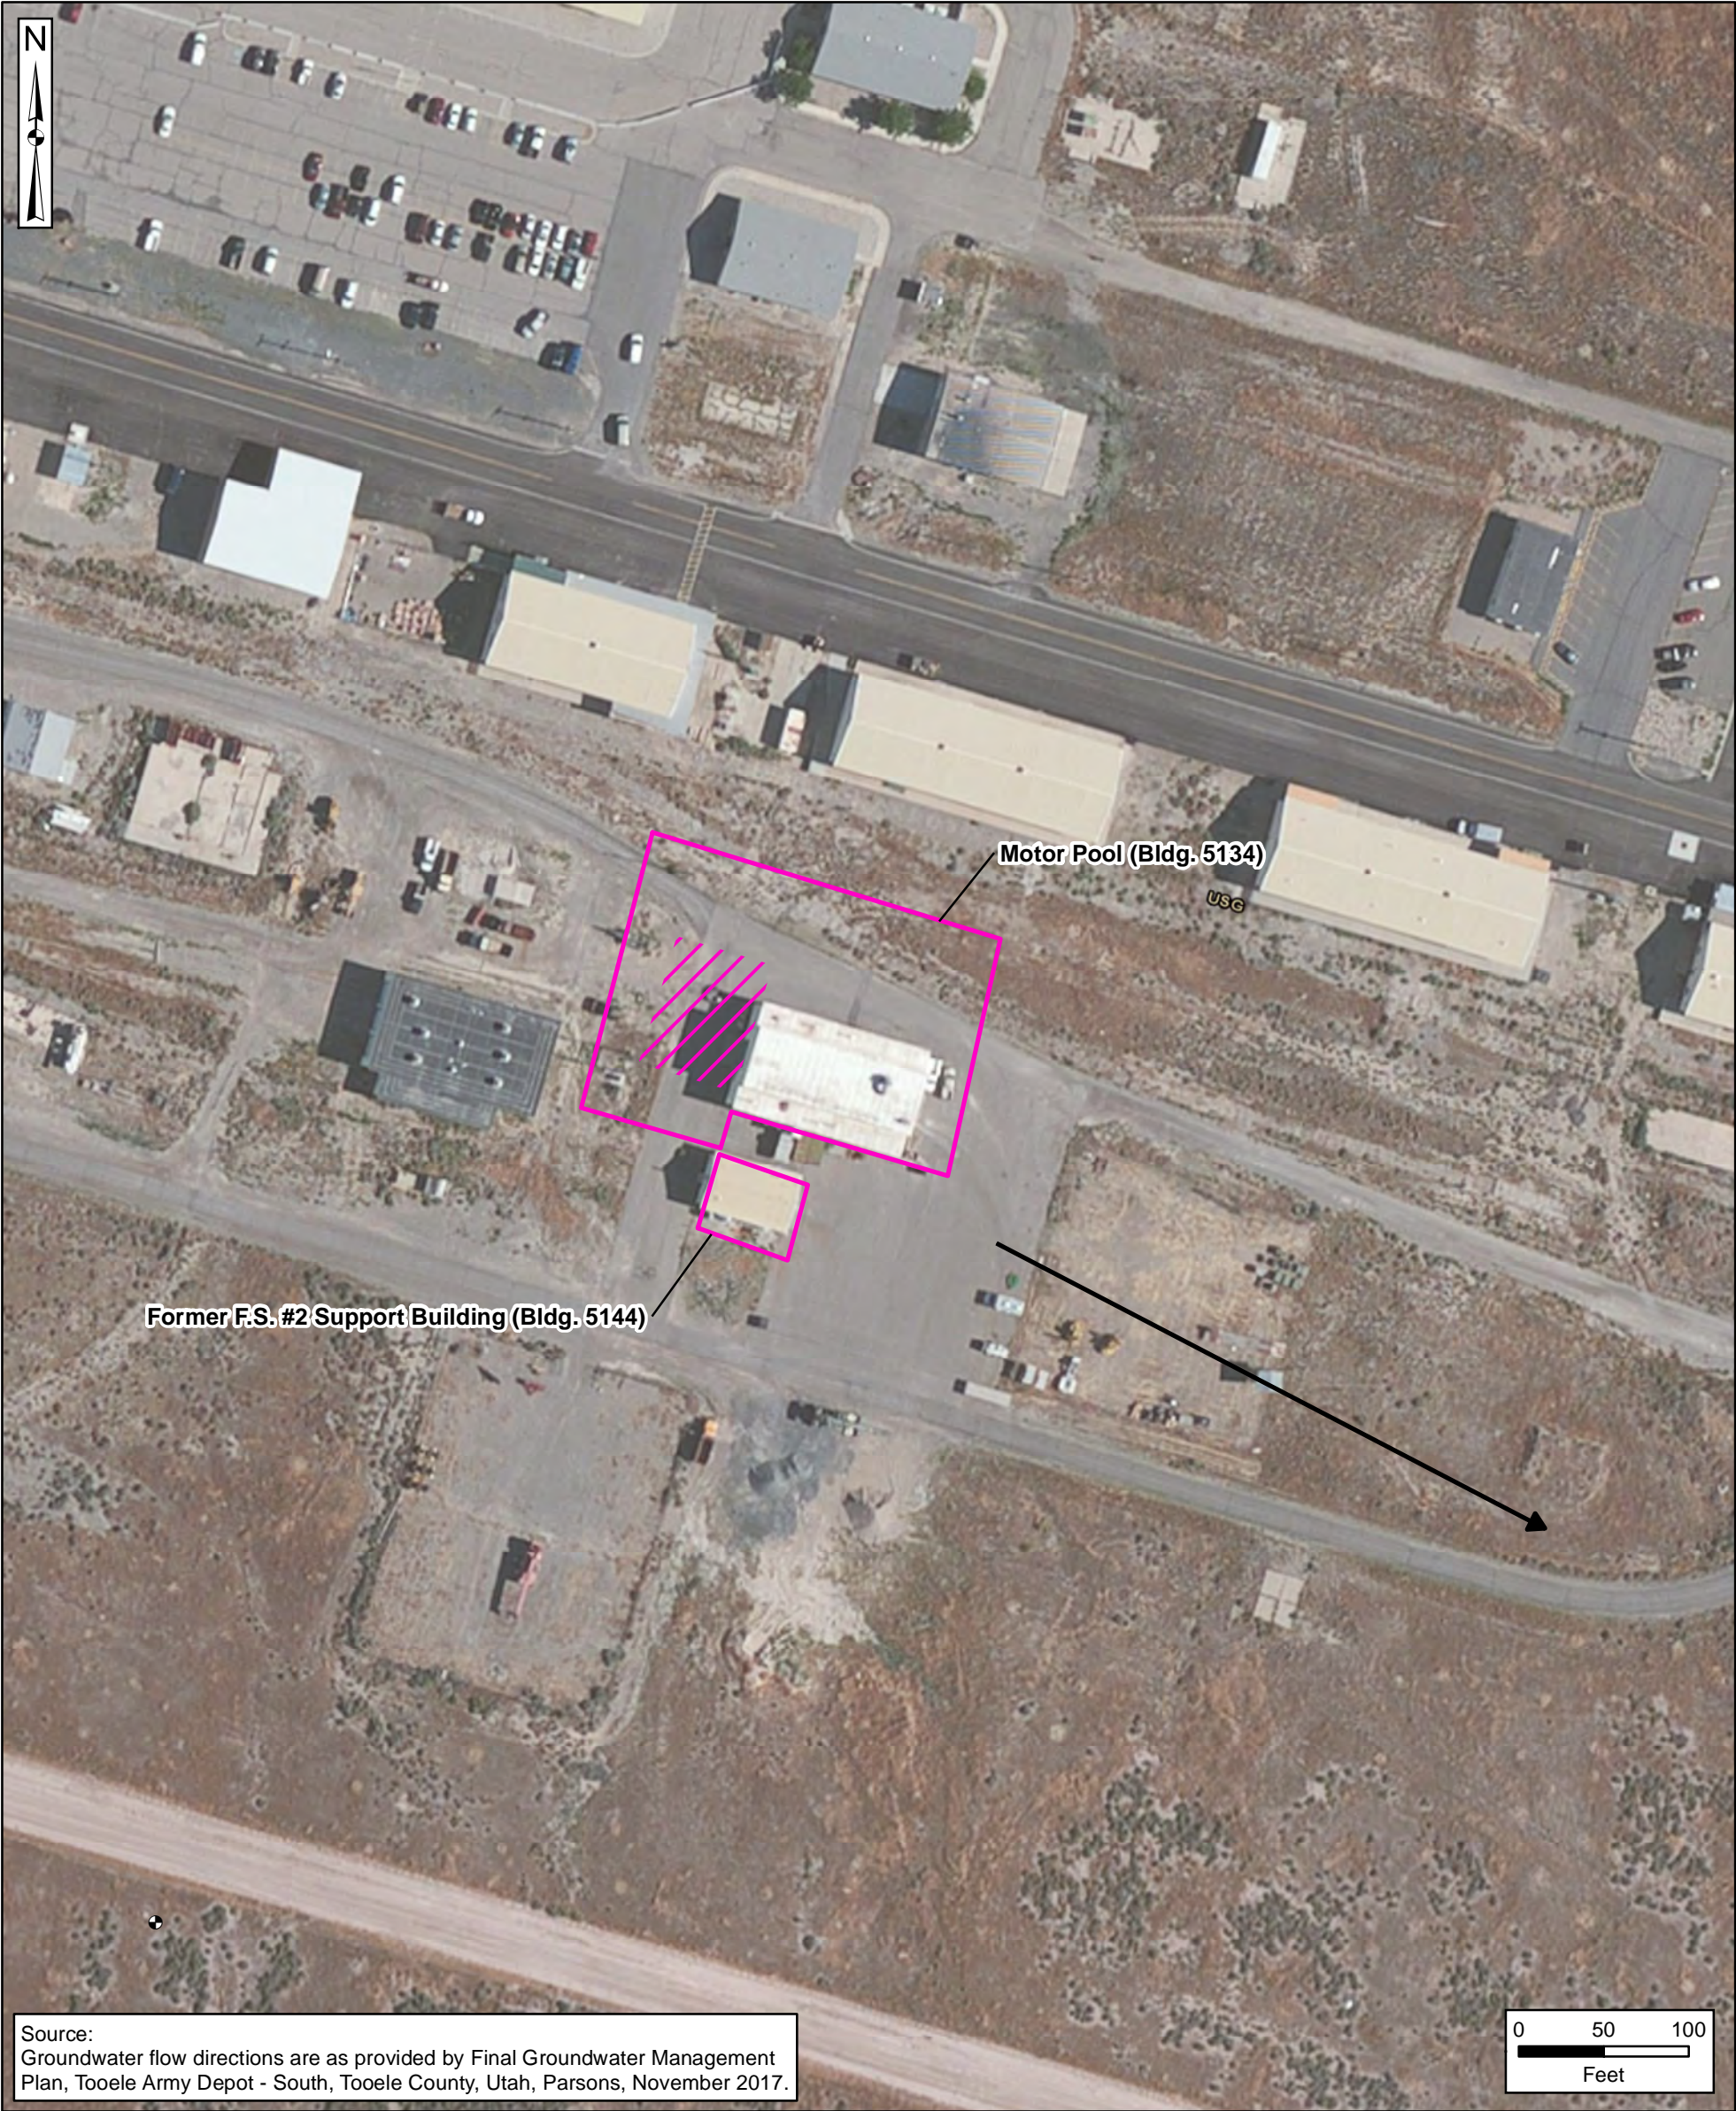
Figure 5-6  
Aerial Photo of Motor Pool (Building 5134), and Former  
Fire Station #2 Support Building (Building 5144) AOPIs

The Motor Pool (Building 5134) is identified as an AOPI following records research, personnel interviews, and site reconnaissance due to AFFF use. In the 1980s, the TEAD fire department provided a pail of AFFF to the maintenance crew for their use in testing a repair of the plumbing system on a fire engine. Reportedly 2.6 gallons of the AFFF in the container was sprayed to the west or northwest from the back apron (on the west side of Building 5134).

The Former Fire Station #2 Support Building (Building 5144) is identified as an AOPI following records research, personnel interviews, and site reconnaissance due to AFFF use and storage. This building was used to house/store one brush truck, hoses, AFFF, and other items for Fire Station #2. The building has no floor drains. TEAD fire department staff are unaware of any historical AFFF leaks or spills inside or outside of this building, and trucks were not filled there with AFFF. In 2013, Fire Station #2 was reassigned Building 5118 as their support building.

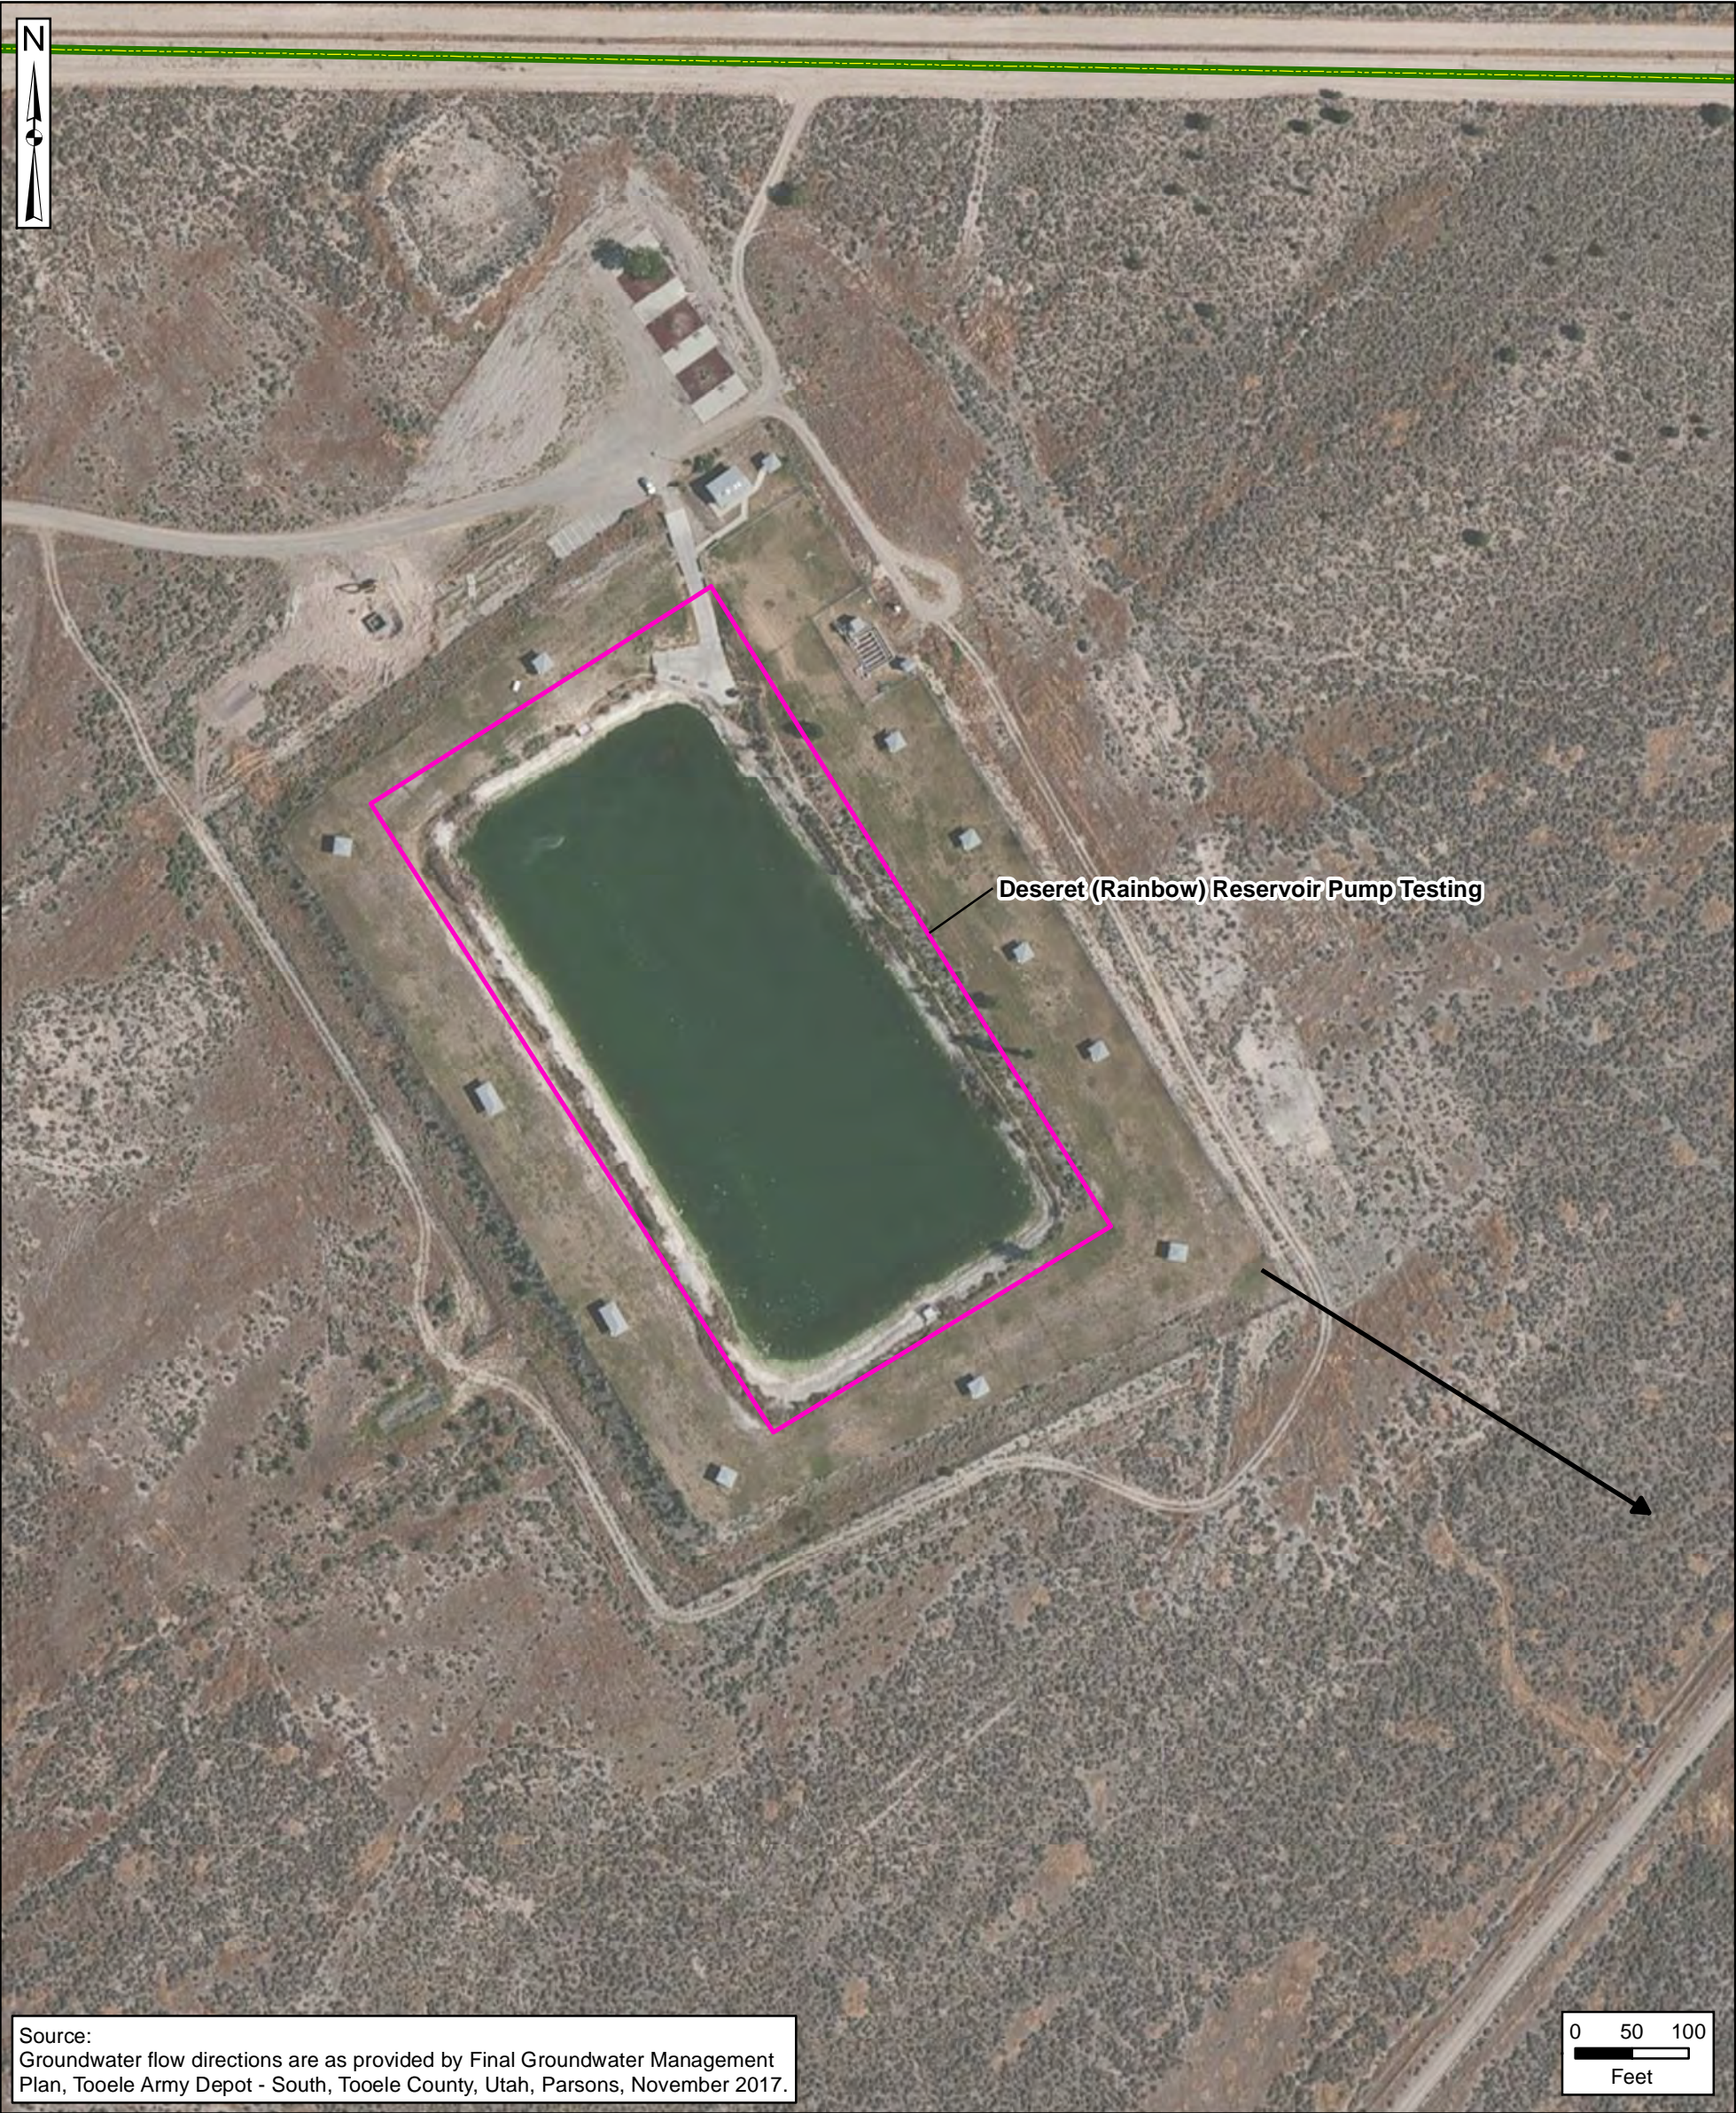
Figure 5-8  
Aerial Photo of Deseret (Rainbow)  
Reservoir Pump Testing AOPI

The Deseret (Rainbow) Reservoir Pump Testing AOPI does not overlap with IRP sites and consists of the reservoir. **Figure 5-8** shows the aerial extent of this AOPI.

Source:  
Groundwater flow directions are as provided by Final Groundwater Management  
Plan, Tooele Army Depot - South, Tooele County, Utah, Parsons, November 2017.
