**SITE INSPECTION REPORT FOR PER- AND
POLYFLUOROALKYL SUBSTANCES AT
TOOELE ARMY DEPOT – NORTH BRAC
TOOELE, UTAH**

**Final
November 2023**

**Contract Number W912DR-18-D-0003
Delivery Order Number W912DR21F0140**

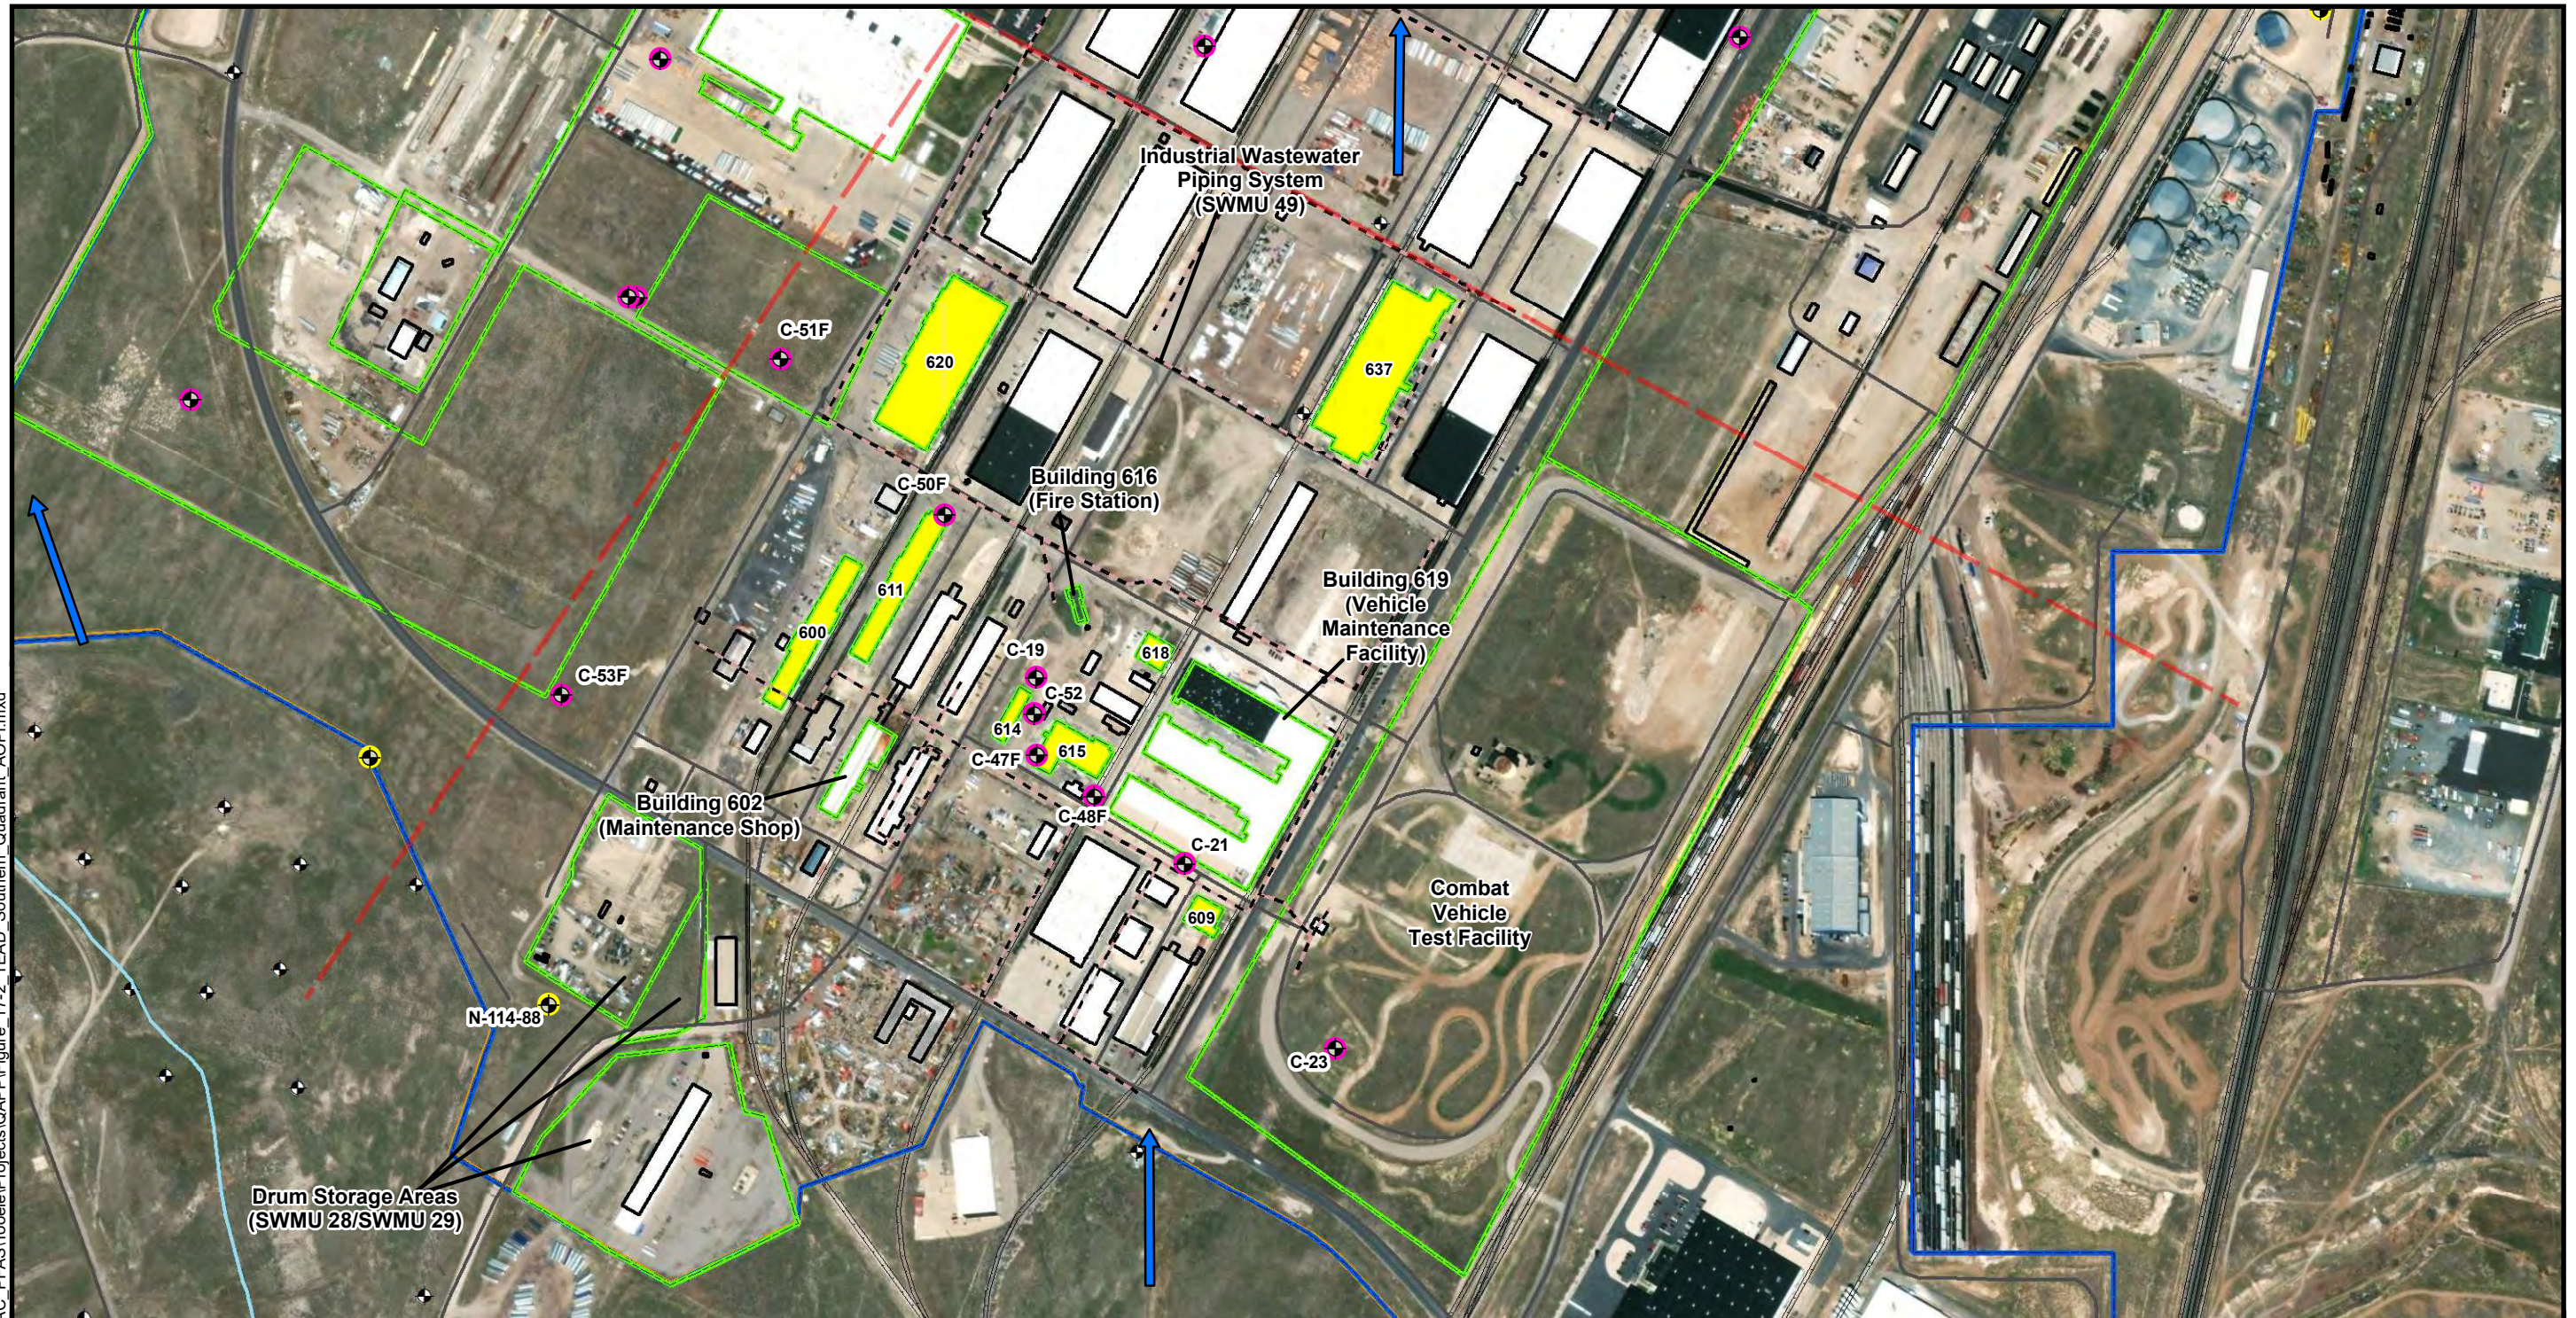
SOUTH QUADRANT AOPI SAMPLE LOCATIONS TOOELE ARMY DEPOT – NORTH TOOELE, UTAH	
FIGURE 6-1	DATE: 6/30/2023

Notes:
 1. Background Imagery: ESRI World Imagery (Vivid/Maxar, 11/2022).
 2. USGS National Hydrography Dataset (NHD).
 3. Labeled sample locations represent south quadrant sample plan and sample count.

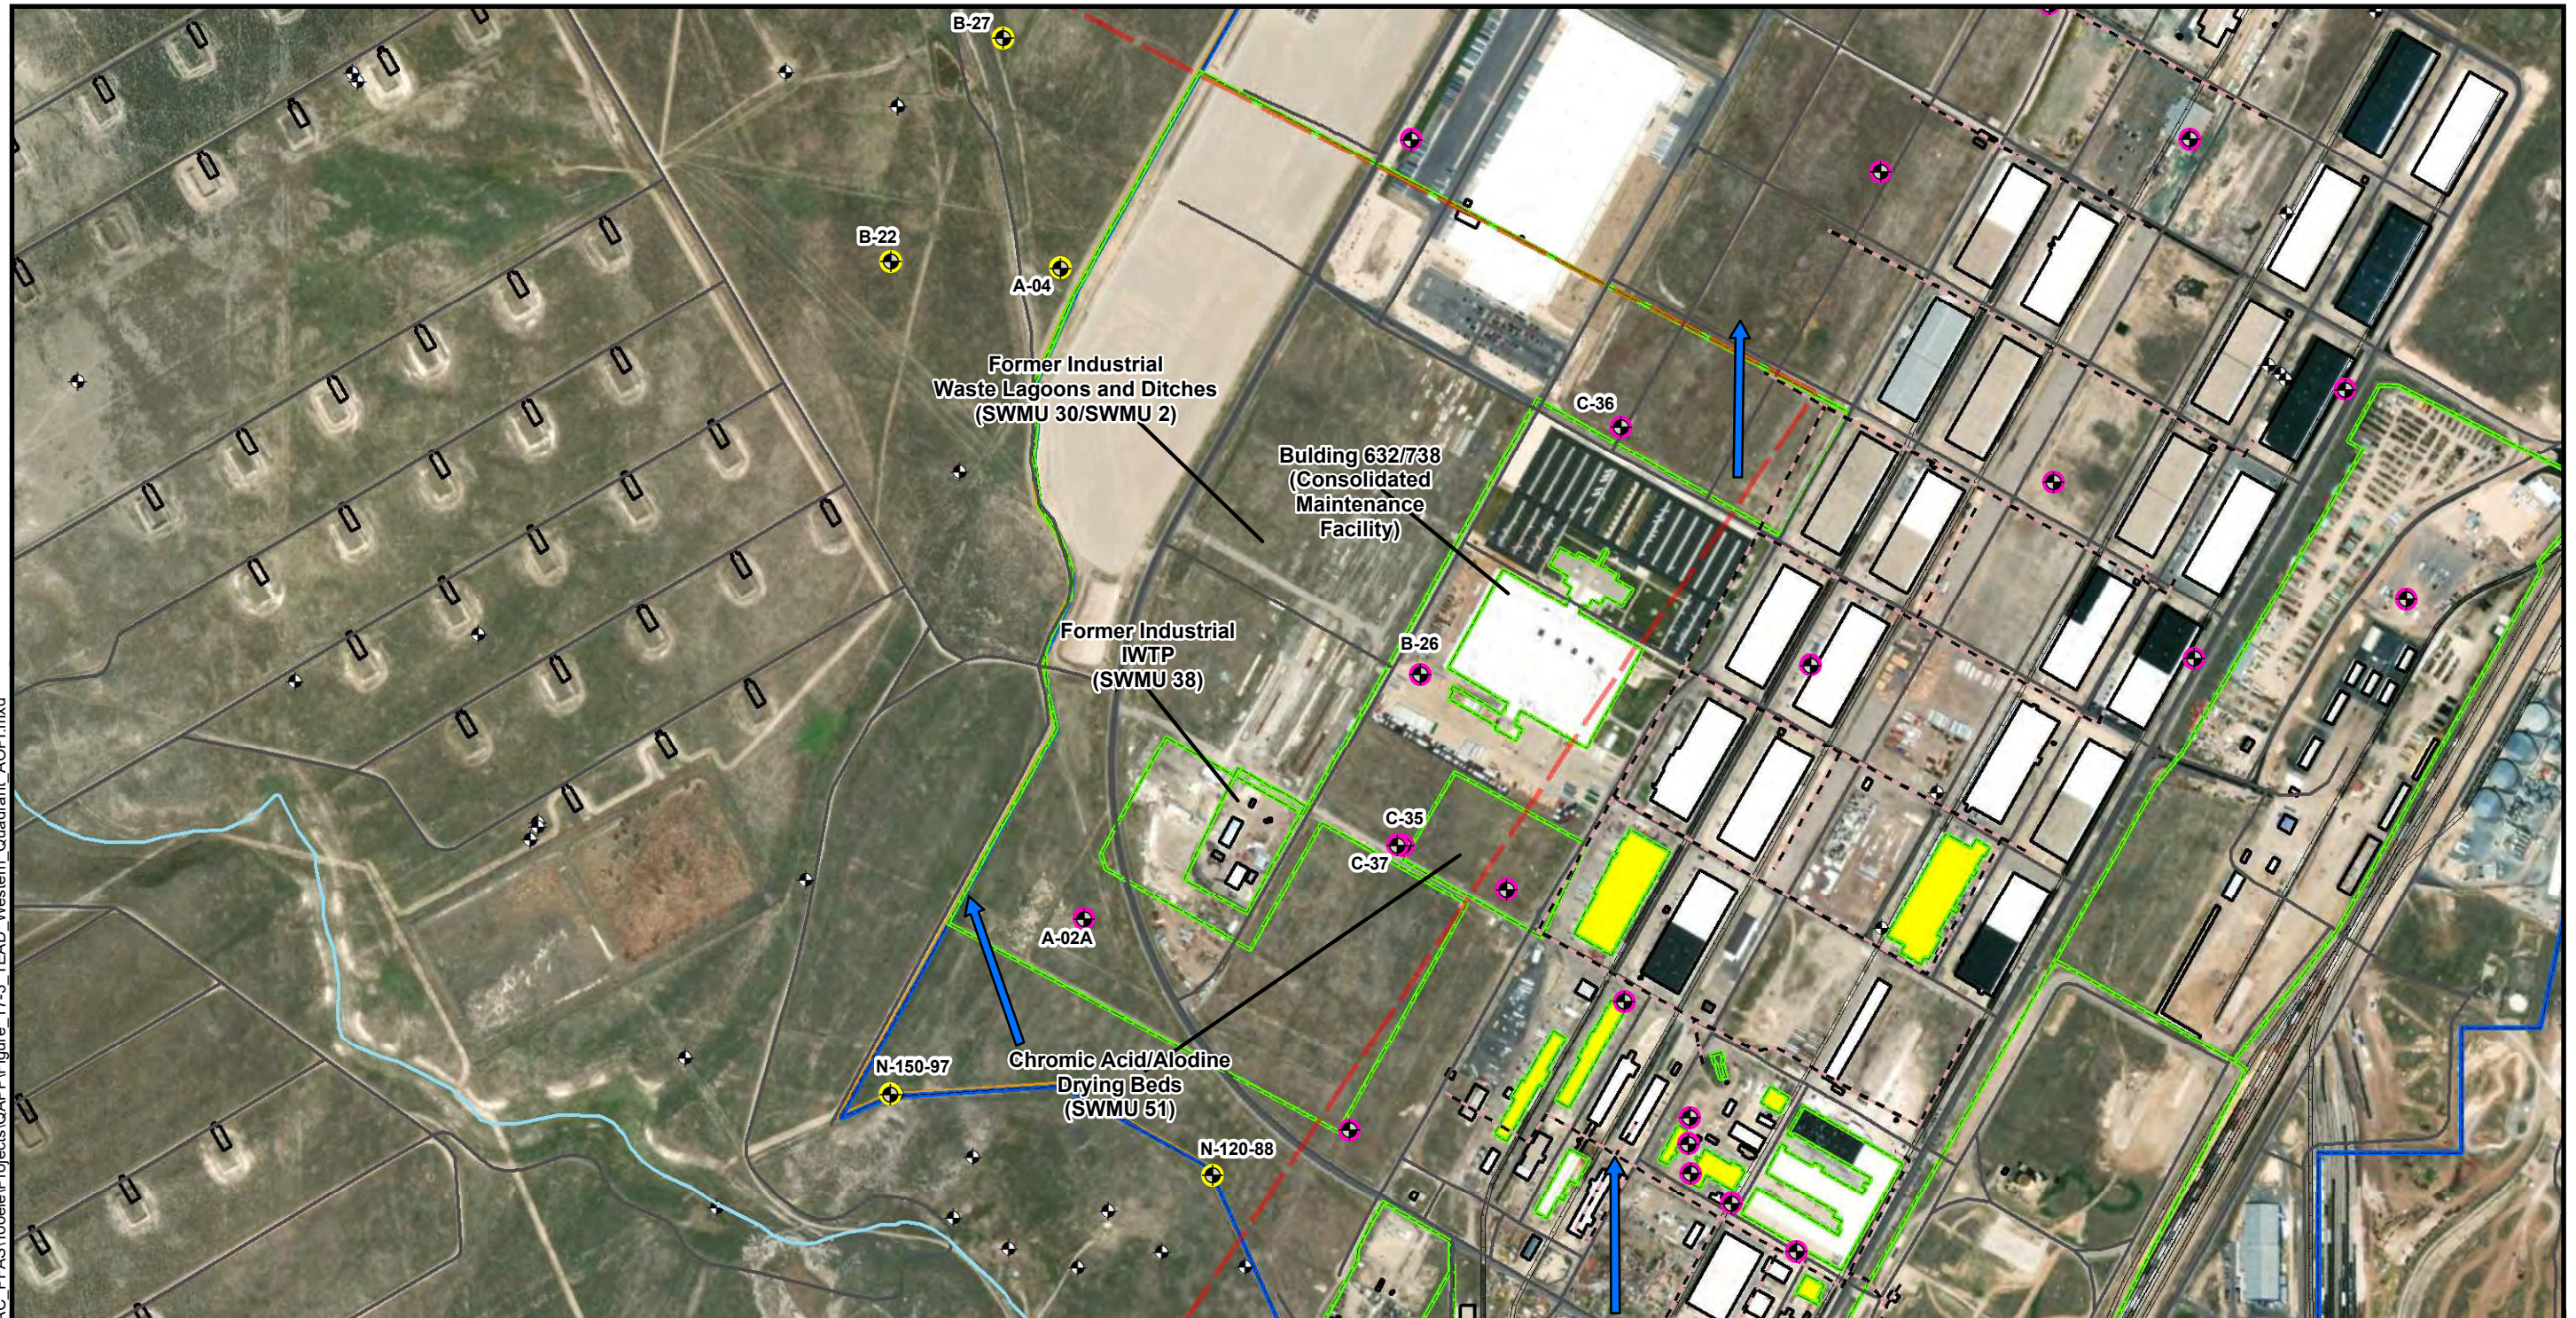
Figure 6-4. Human Health CSM for Building 619 (Vehicle Maintenance Facility) AOPI

Figure 6-4 presents the CSM for the Building 619 AOPI.
