FINAL PRELIMINARY ASSESSMENT AND SITE INSPECTION OF PER- AND POLYFLUOROALKYL SUBSTANCES

Tobyhanna Army Depot, Pennsylvania

September 2022

Contract No.: W912DR-18-D-0004

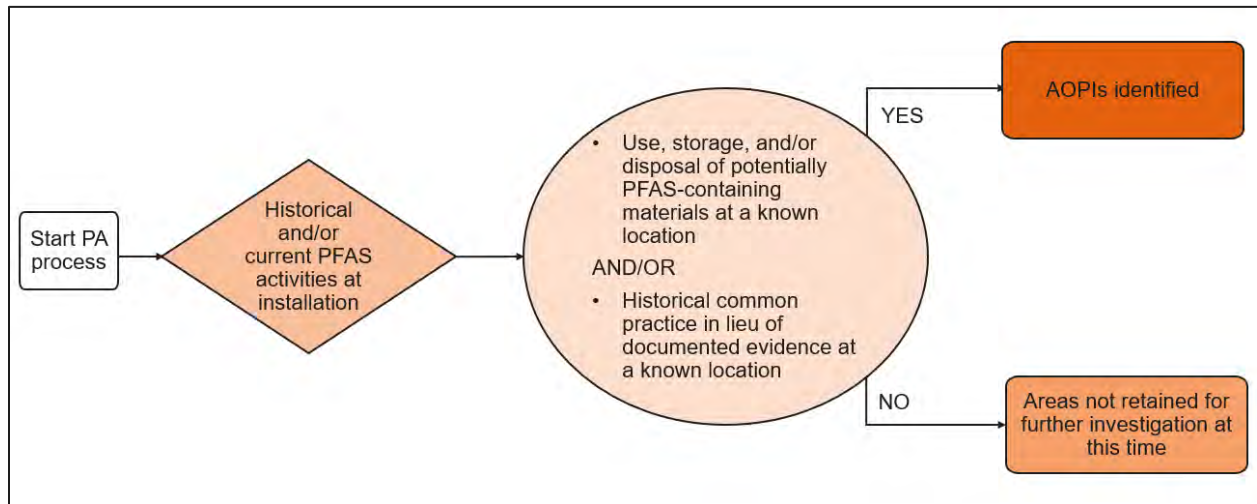
Figure 5-1: AOPI Decision Flowchart

The preliminary locations evaluated for potential use, storage, and/or disposal of PFAS-containing materials at TYAD, were further refined during the PA process and identified either as an area not retained for further investigation or as an AOPI. In accordance with the established process for the PA/SI, seven areas have been identified as AOPIs. The process used for refining these areas is presented on **Figure 5-1**, below.

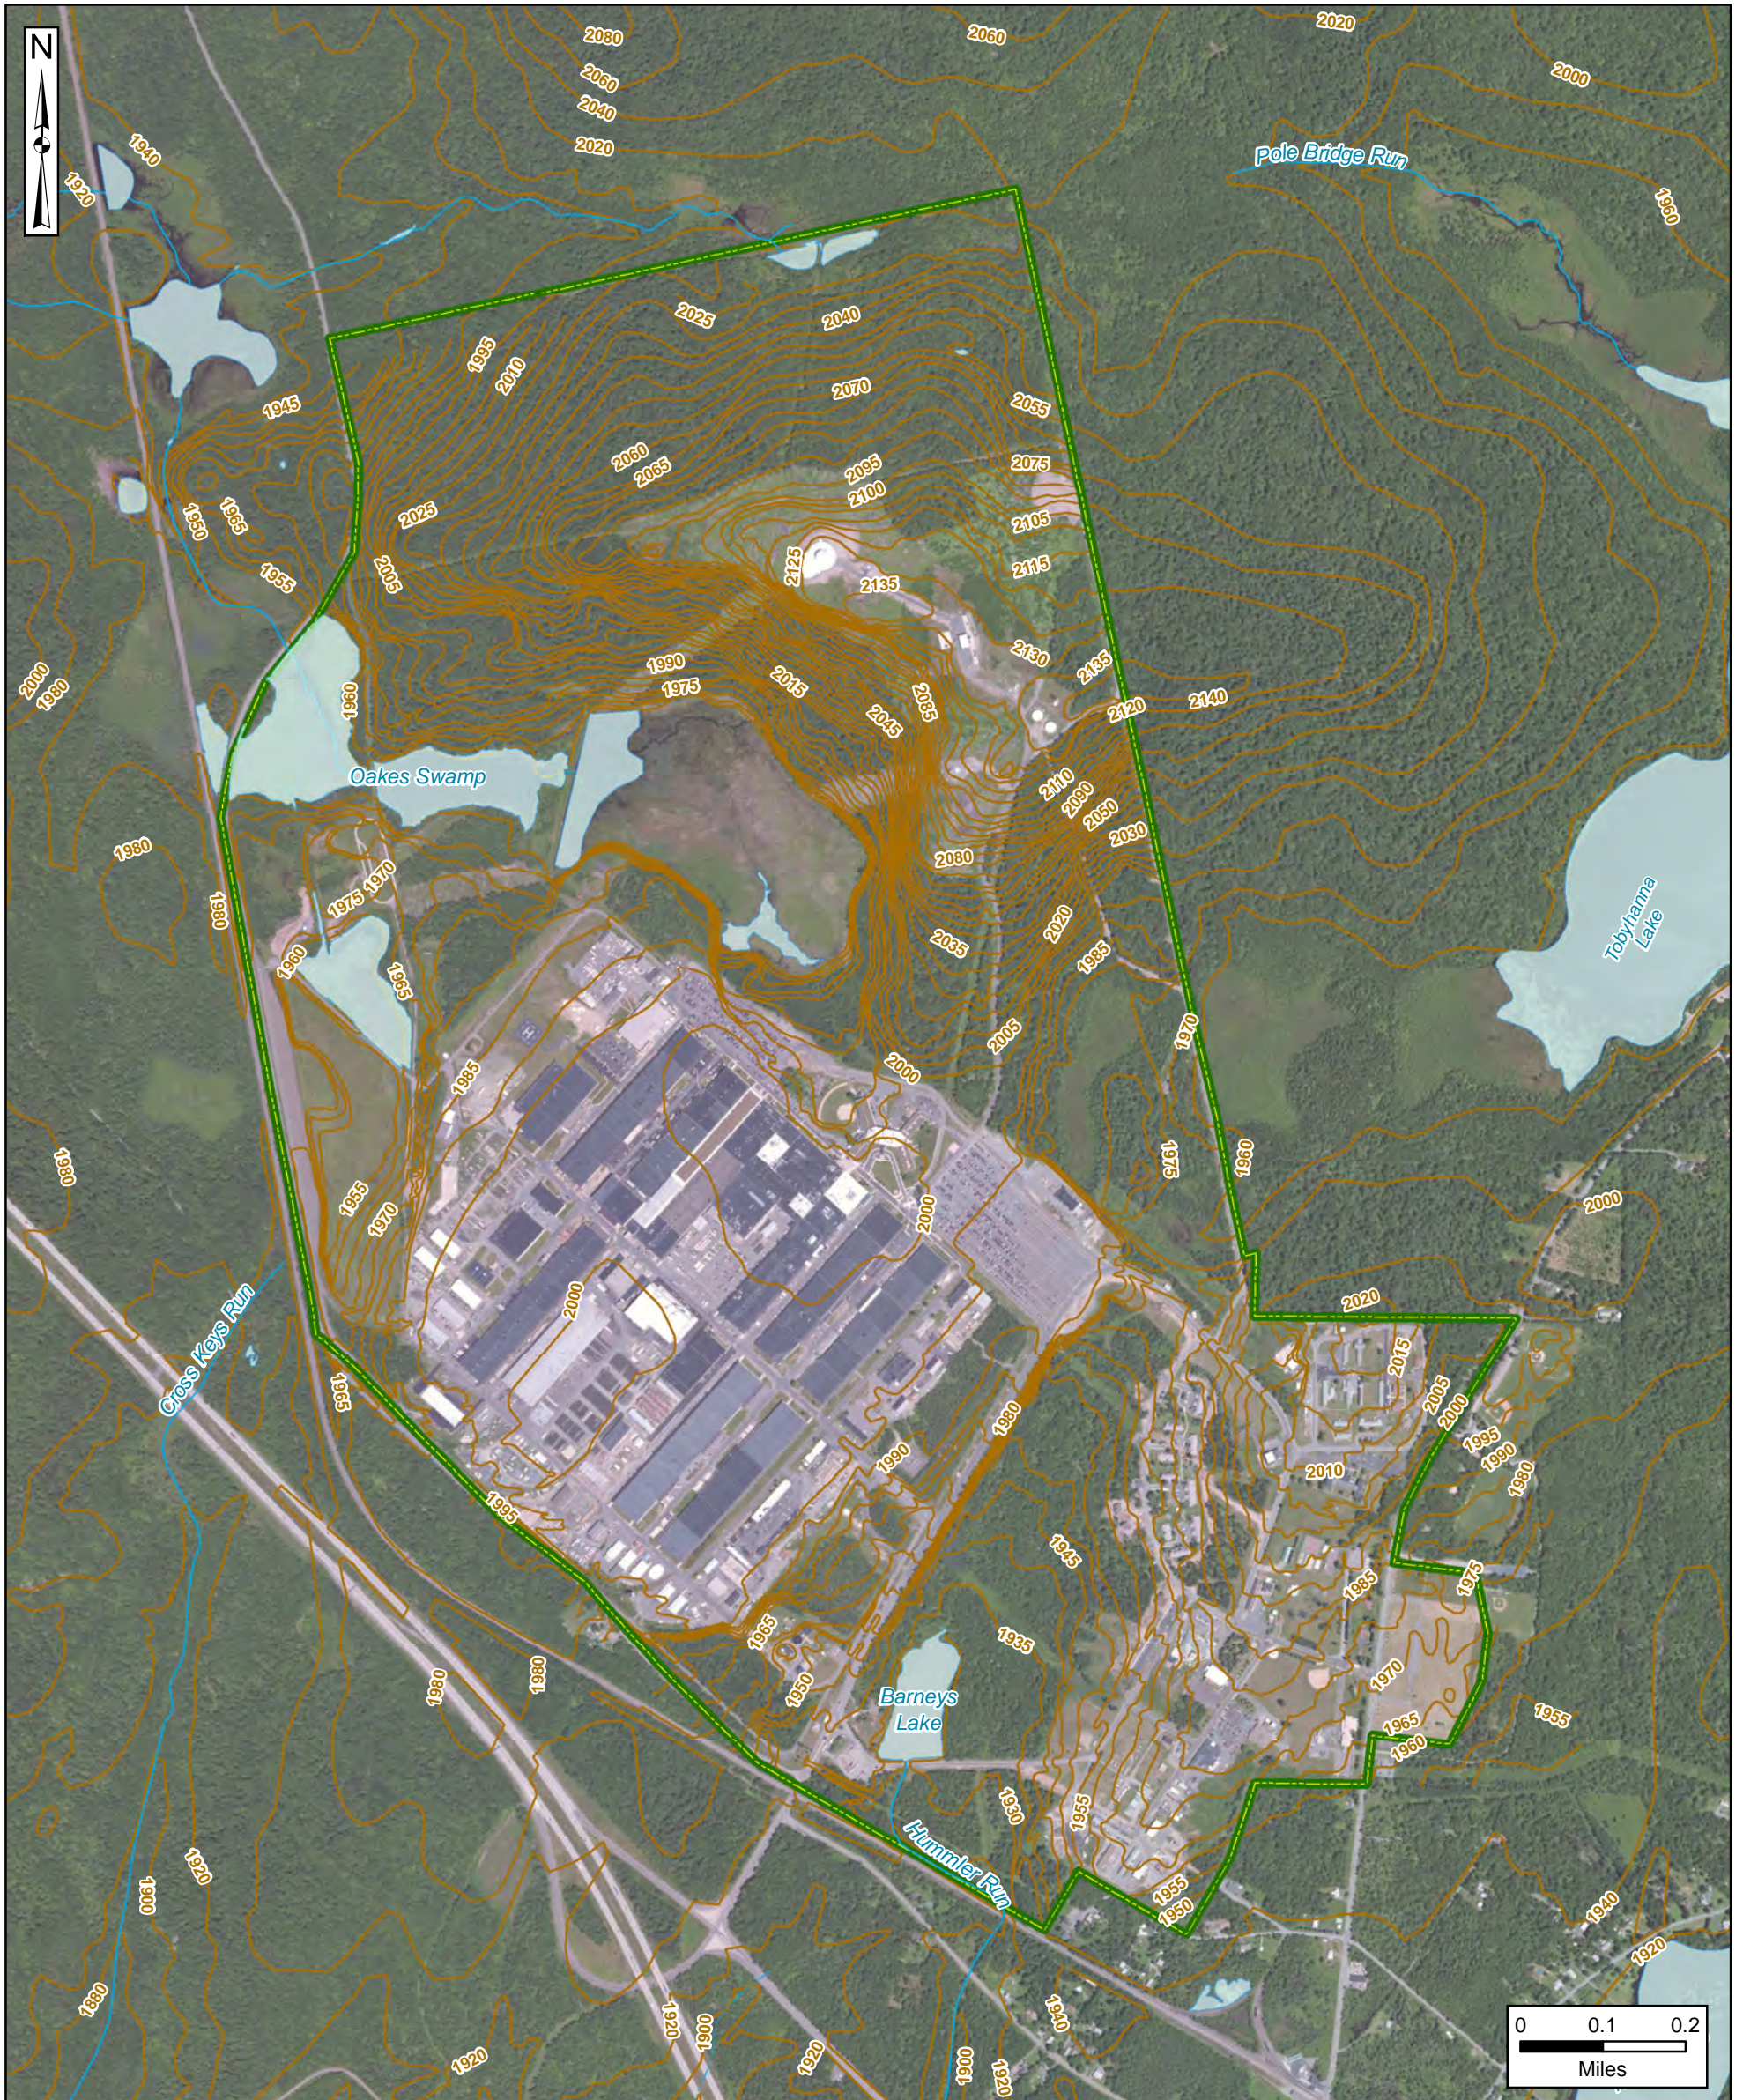
**Figure 2-3
Site Topography**

TYAD lies in the Pocono Mountains on the Allegheny Plateau west of the Appalachian Ridge. Within TYAD, relief is most pronounced in the northwestern half of the site, where Powder Smoke Ridge trends across the site. At the southwest base of the ridgeline in a bowl-like depression is Oakes Swamp. The southeastern portion of the site includes TYAD buildings and Barney's Lake to the far south. Overall, elevations range from 2,141 feet on Powder Smoke Ridge near Border Drive down to 1,925 feet near Hummler Run south of Barney's Lake (**Figure 2-3**) (Biohabitats, Inc. 2013).

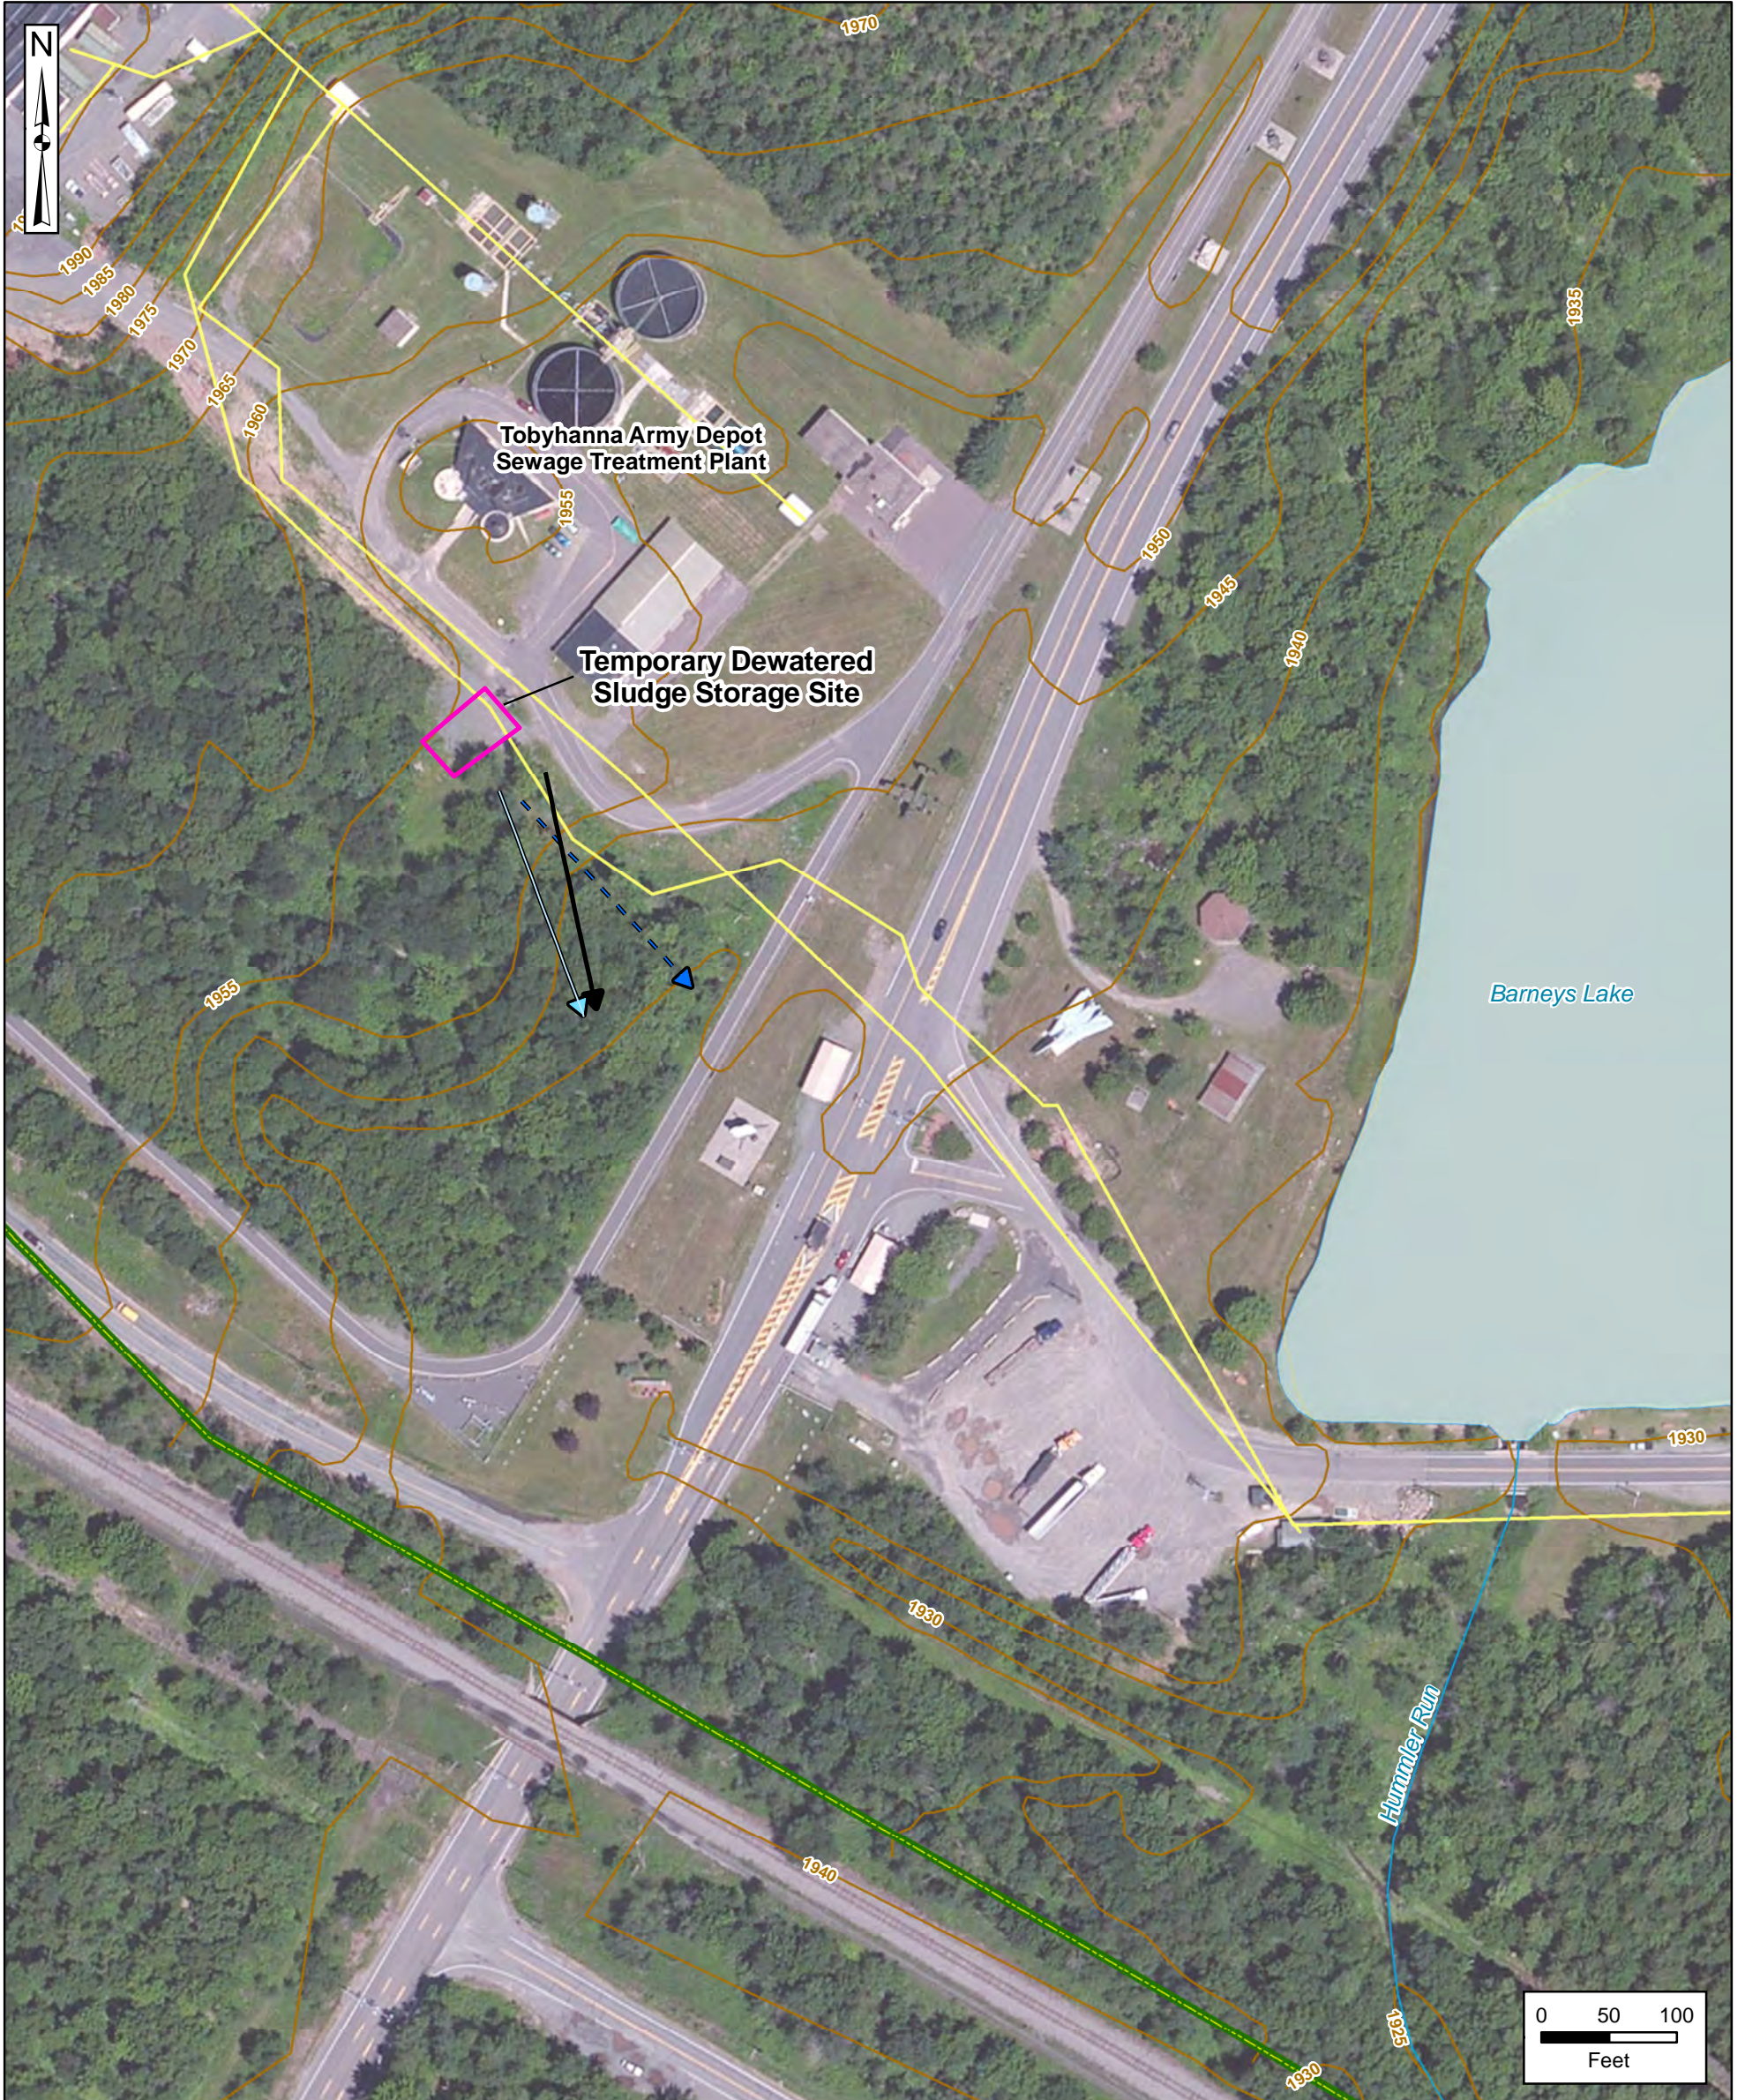
Figure 5-6
Aerial Photo of Temporary Dewatered Sludge Storage Site

The AOPI is located west of Barney's Lake, just south of the industrial area of TYAD. The AOPI is located proximal to the current STP (industrial use) (**Figure 5-6**). Groundwater flows to the southeast towards Barney's Lake.

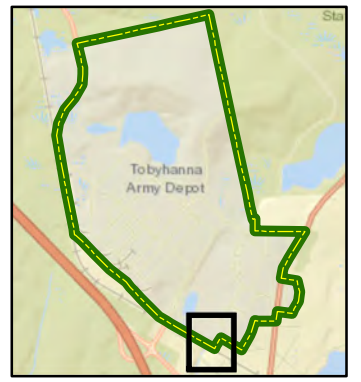
Figure 5-8
Aerial Photo of Area B Former Drum Storage Area (OU-1)

The AOPI is located in the southern portion of TYAD, proximal to the installation boundary. The AOPI is an active IRP site (industrial use) (**Figure 5-8**). Groundwater flows to the southeast. As described in **Section 2.12**, PFOS, PFOA, and PFBS were detected in groundwater monitoring wells located downgradient of the AOPI (**Table 2-2** and **Figure 5-8**).

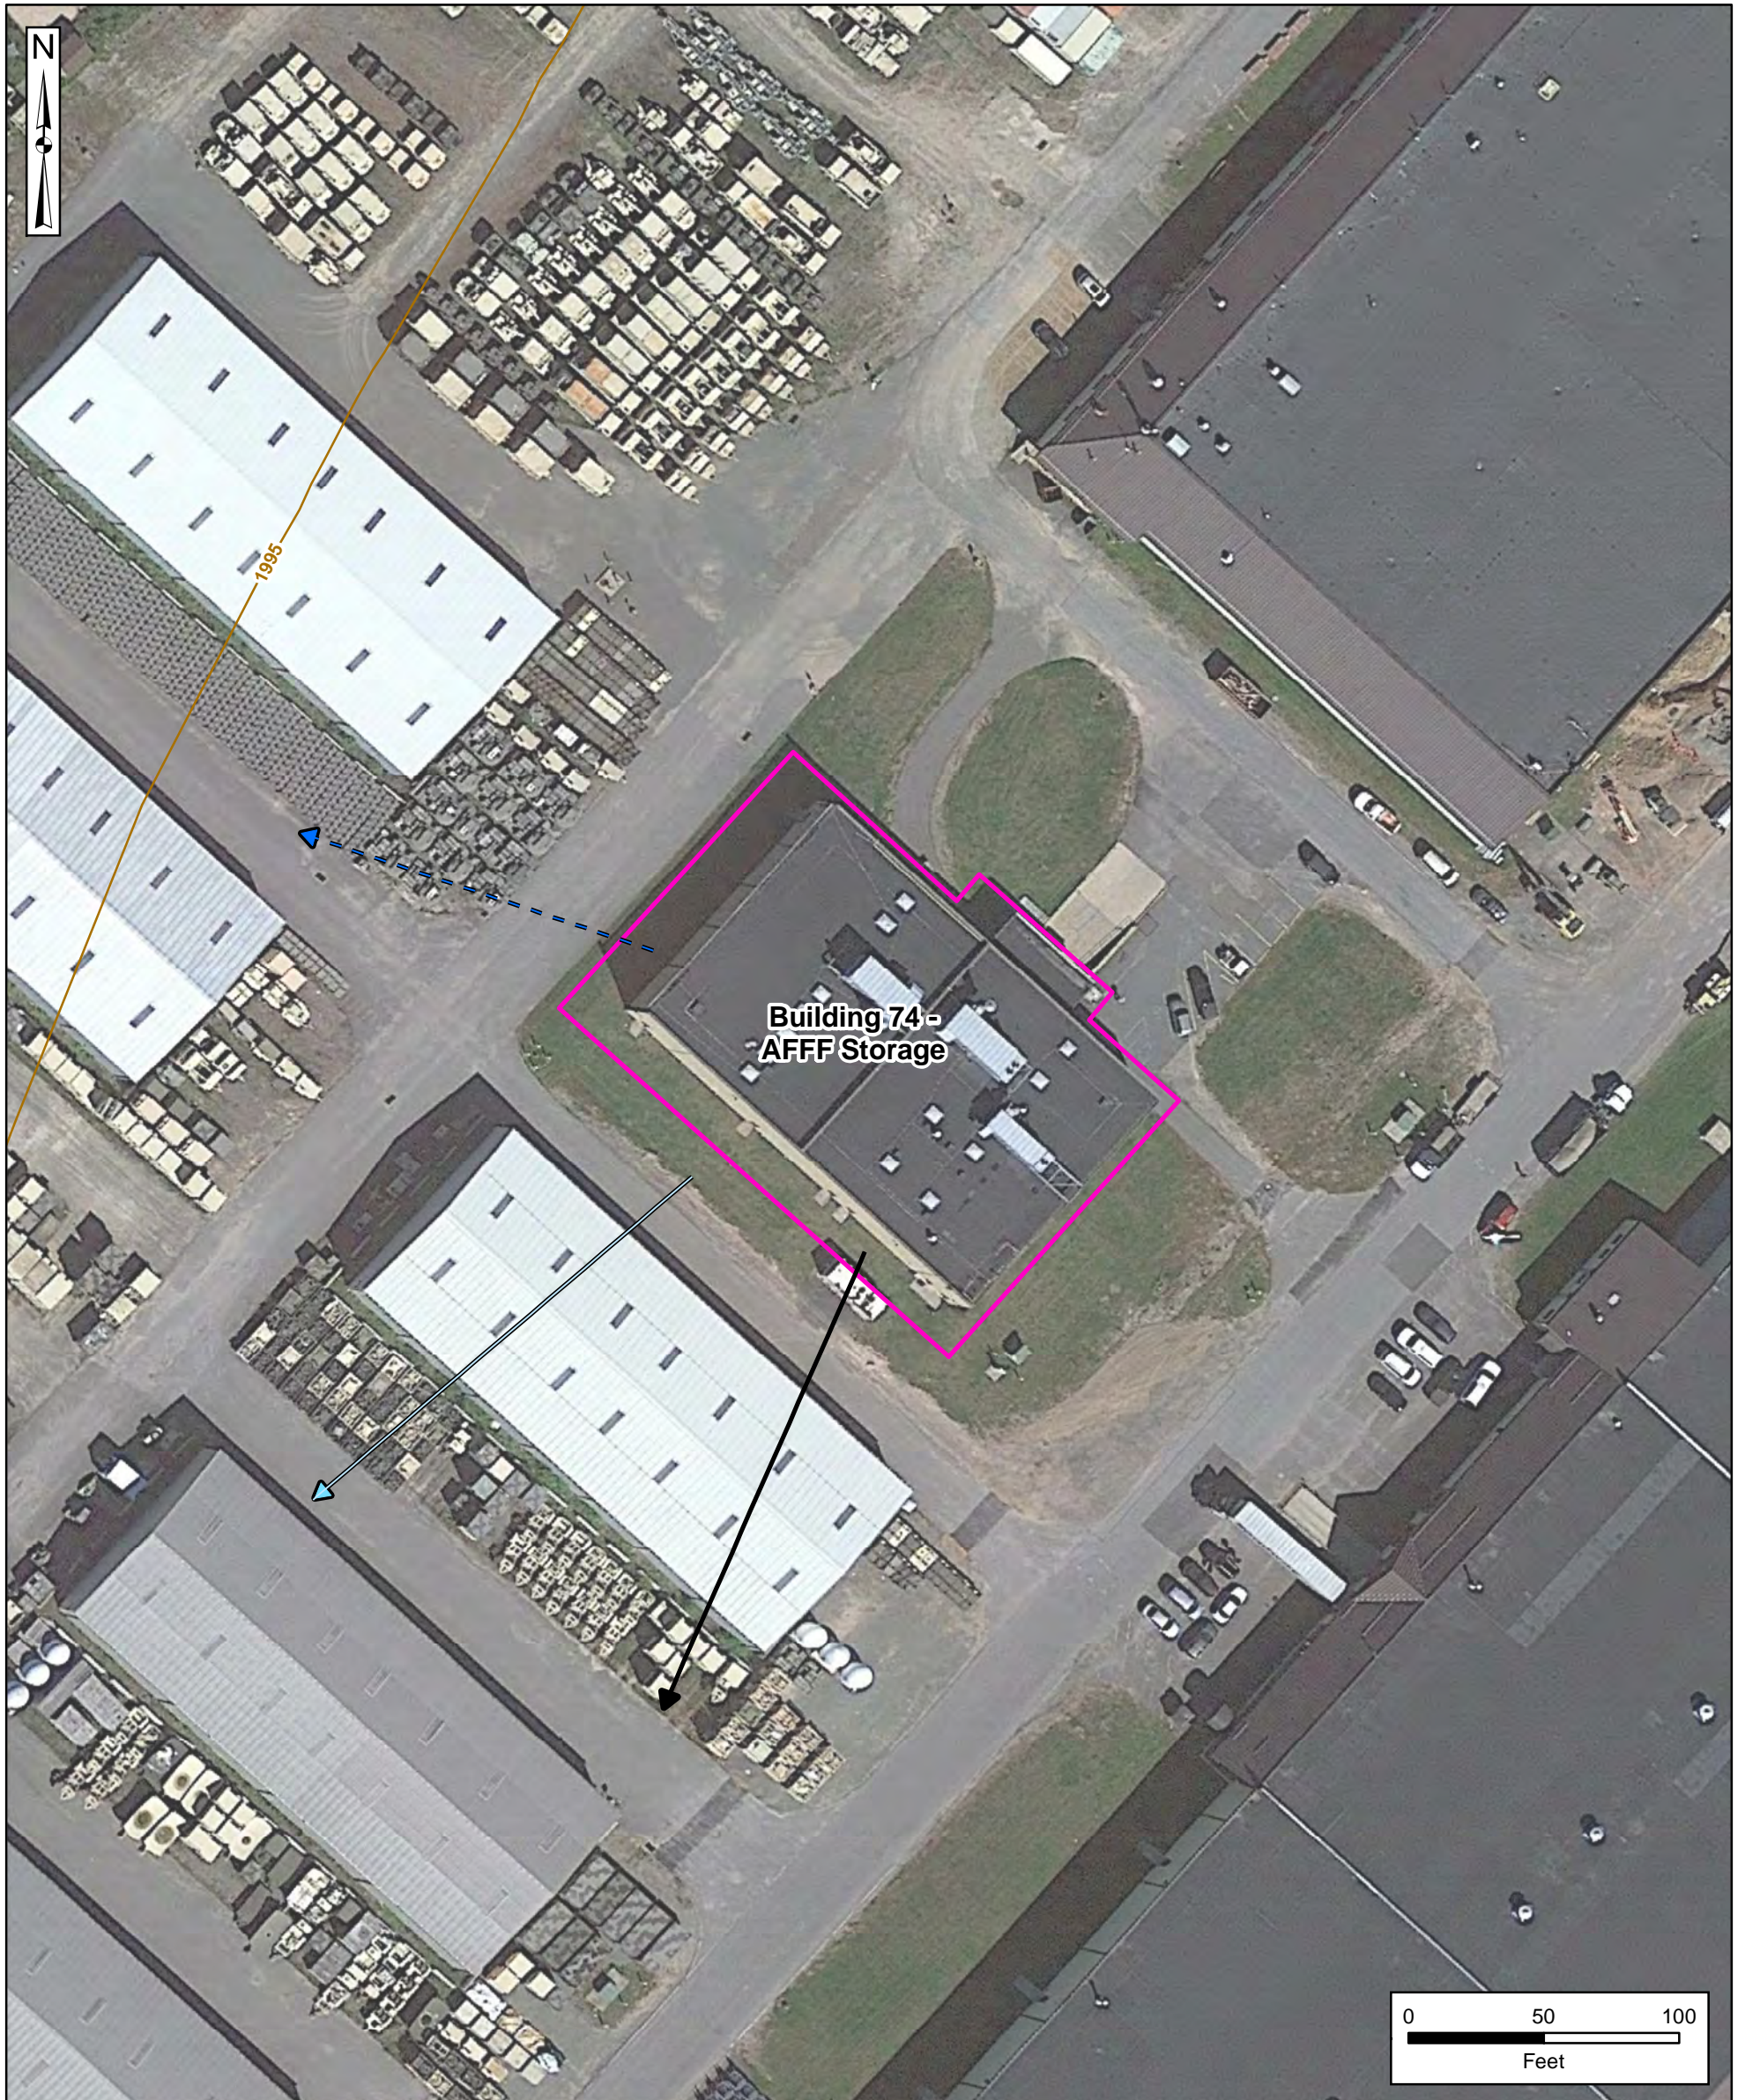
Figure 5-9
Aerial Photo of Building 74 - AFFF Storage

The AOPI is located in the northwestern portion of the industrial area at TYAD and is surrounded by other industrial use buildings (**Figure 5-9**). Groundwater at the AOPI is anticipated to flow to the south-southwest.

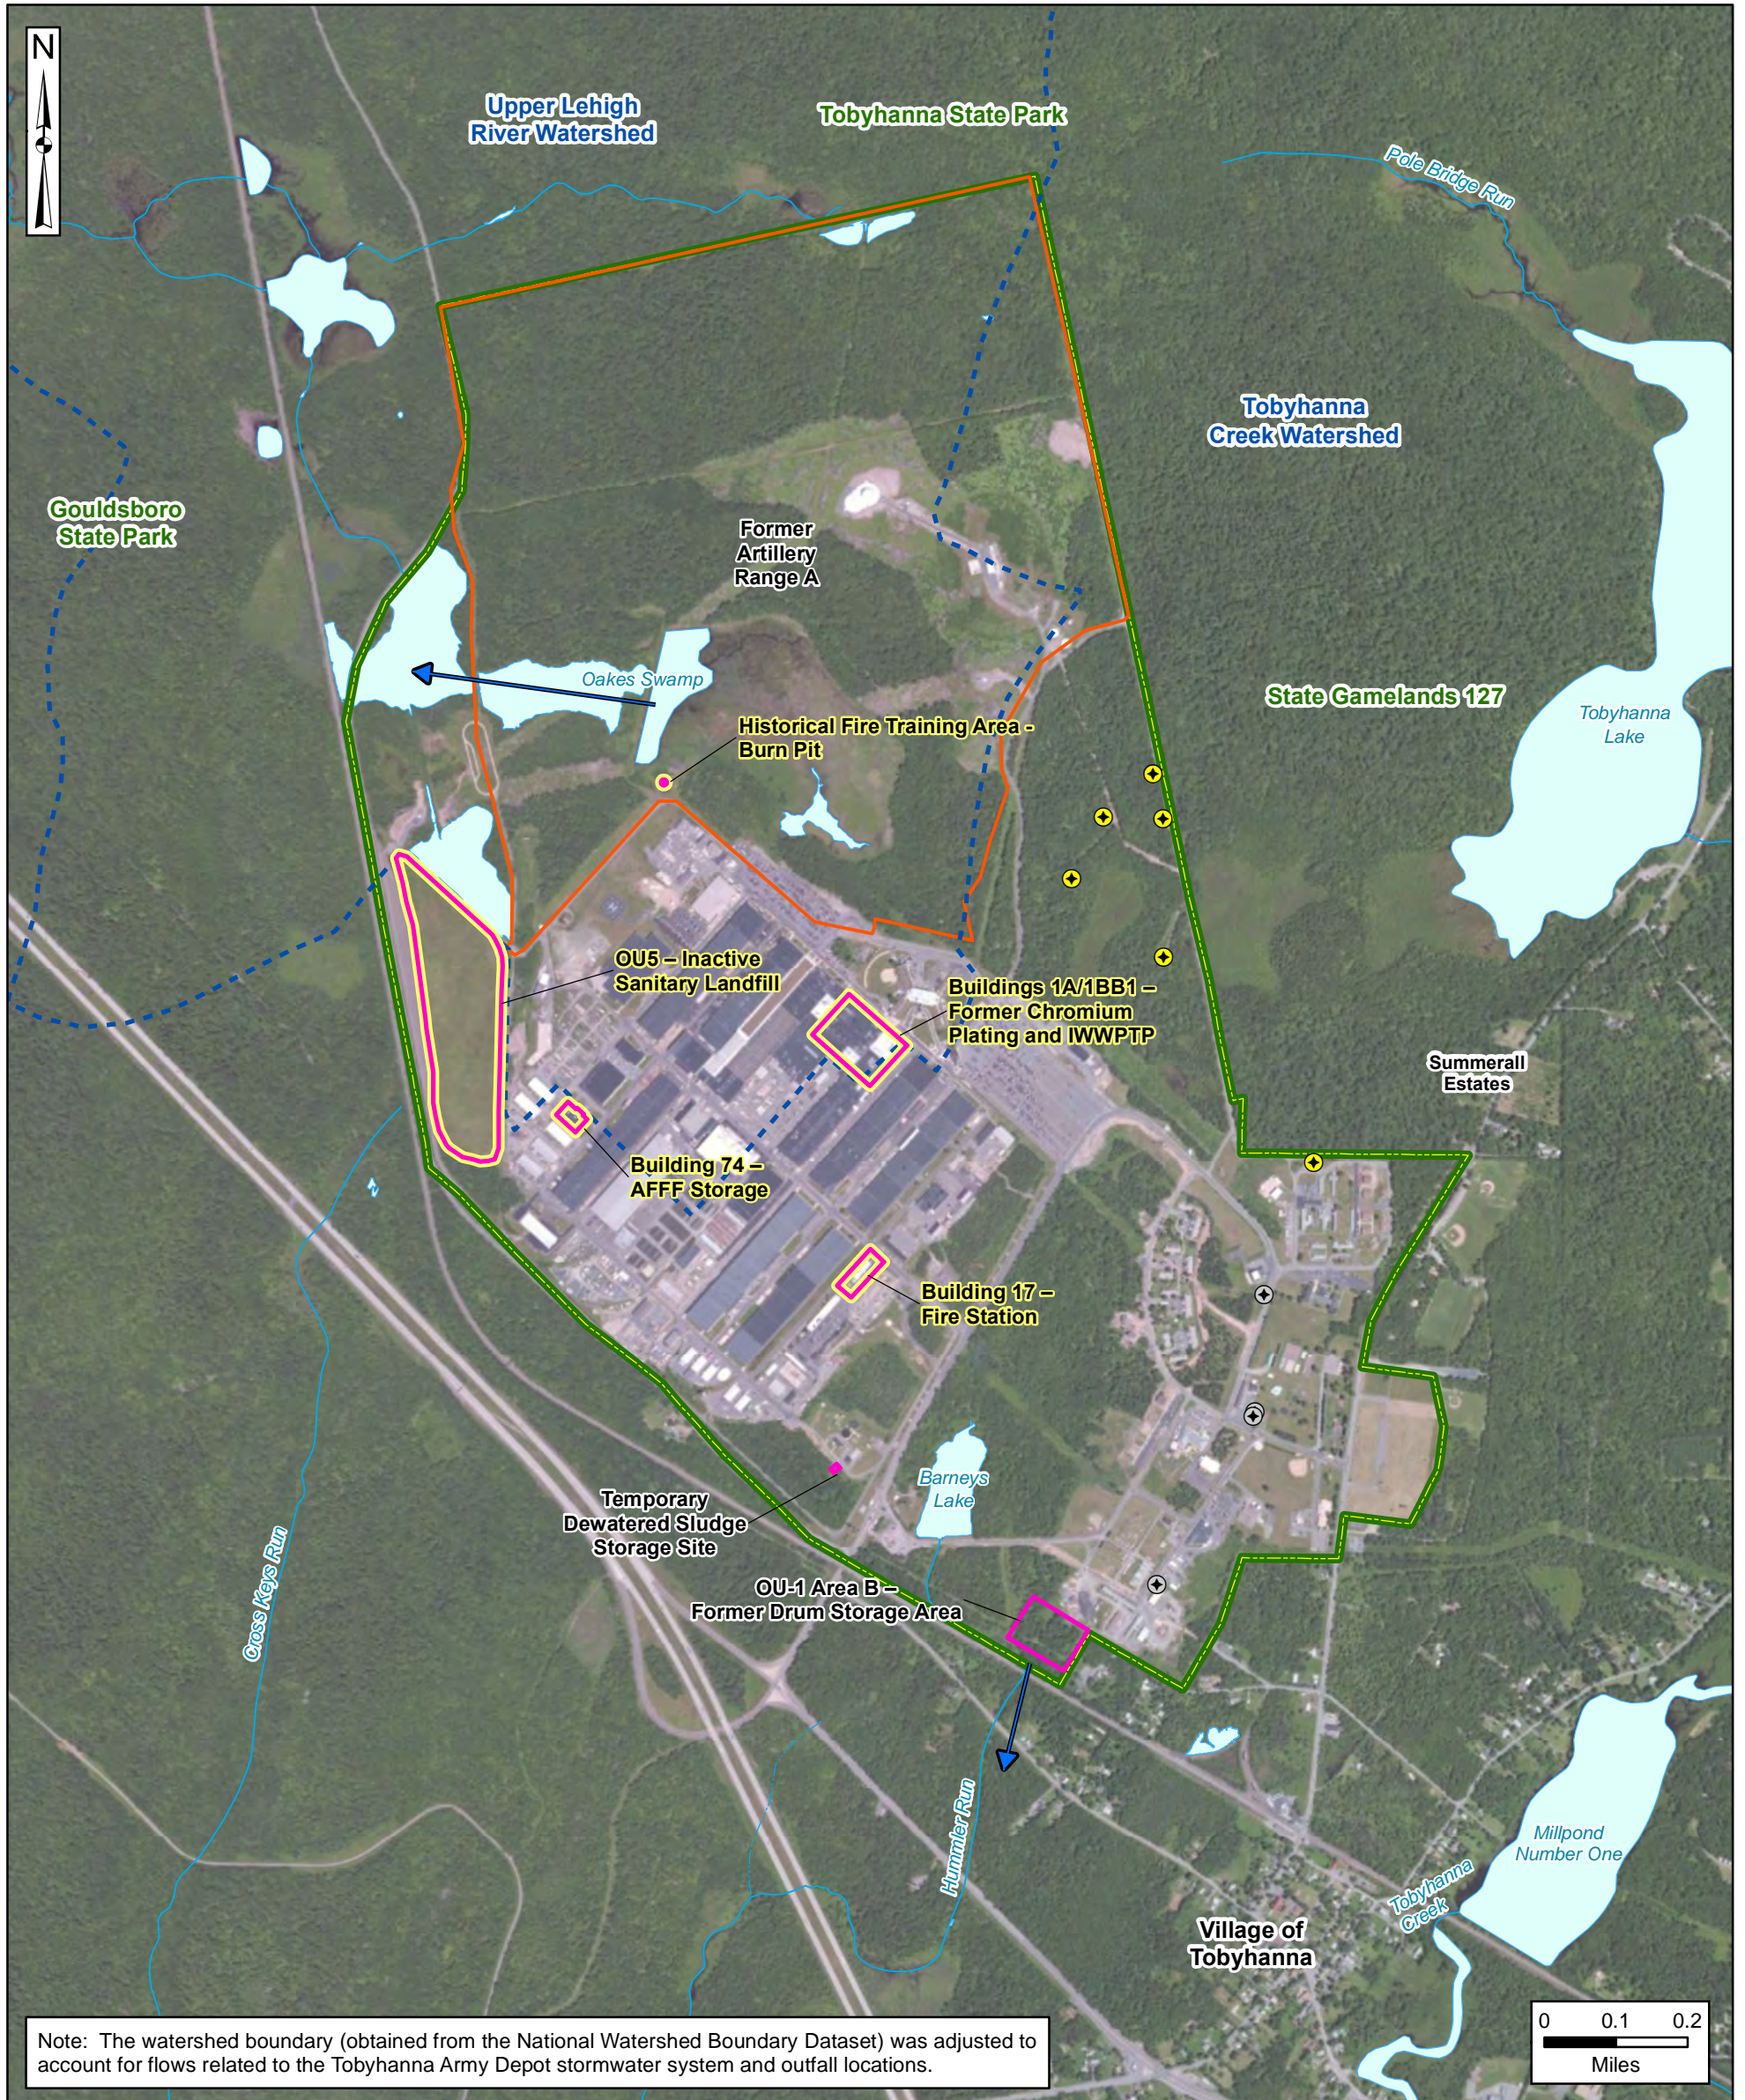
Figure 7-1
AOPI Locations and
OSD Risk Screening Level Exceedances

Note: The watershed boundary (obtained from the National Watershed Boundary Dataset) was adjusted to account for flows related to the Tobyhanna Army Depot stormwater system and outfall locations.
