FINAL PRELIMINARY ASSESSMENT AND SITE INSPECTION OF PER- AND POLYFLUOROALKYL SUBSTANCES

White Sands Missile Range, New Mexico

Prepared For:
U.S. Army Corps of Engineers, Baltimore District
2 Hopkins Plaza
Baltimore, Maryland 21201

July 2023

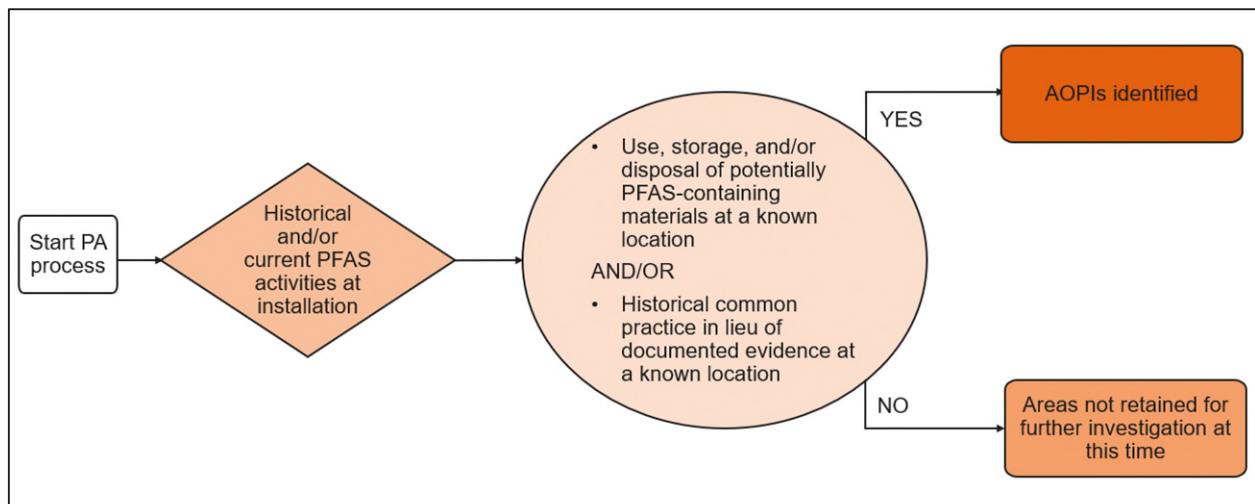
Figure 5-1: AOPI Decision Flowchart

The preliminary locations evaluated for potential use, storage, and/or disposal of PFAS-containing materials at WSMR, were further refined during the PA process and identified either as an area not retained for further investigation or as an AOPI. In accordance with the established process for the PA/SI, 19 areas have been identified as AOPIs. The process used for refining these areas is presented on **Figure 5-1**, below.

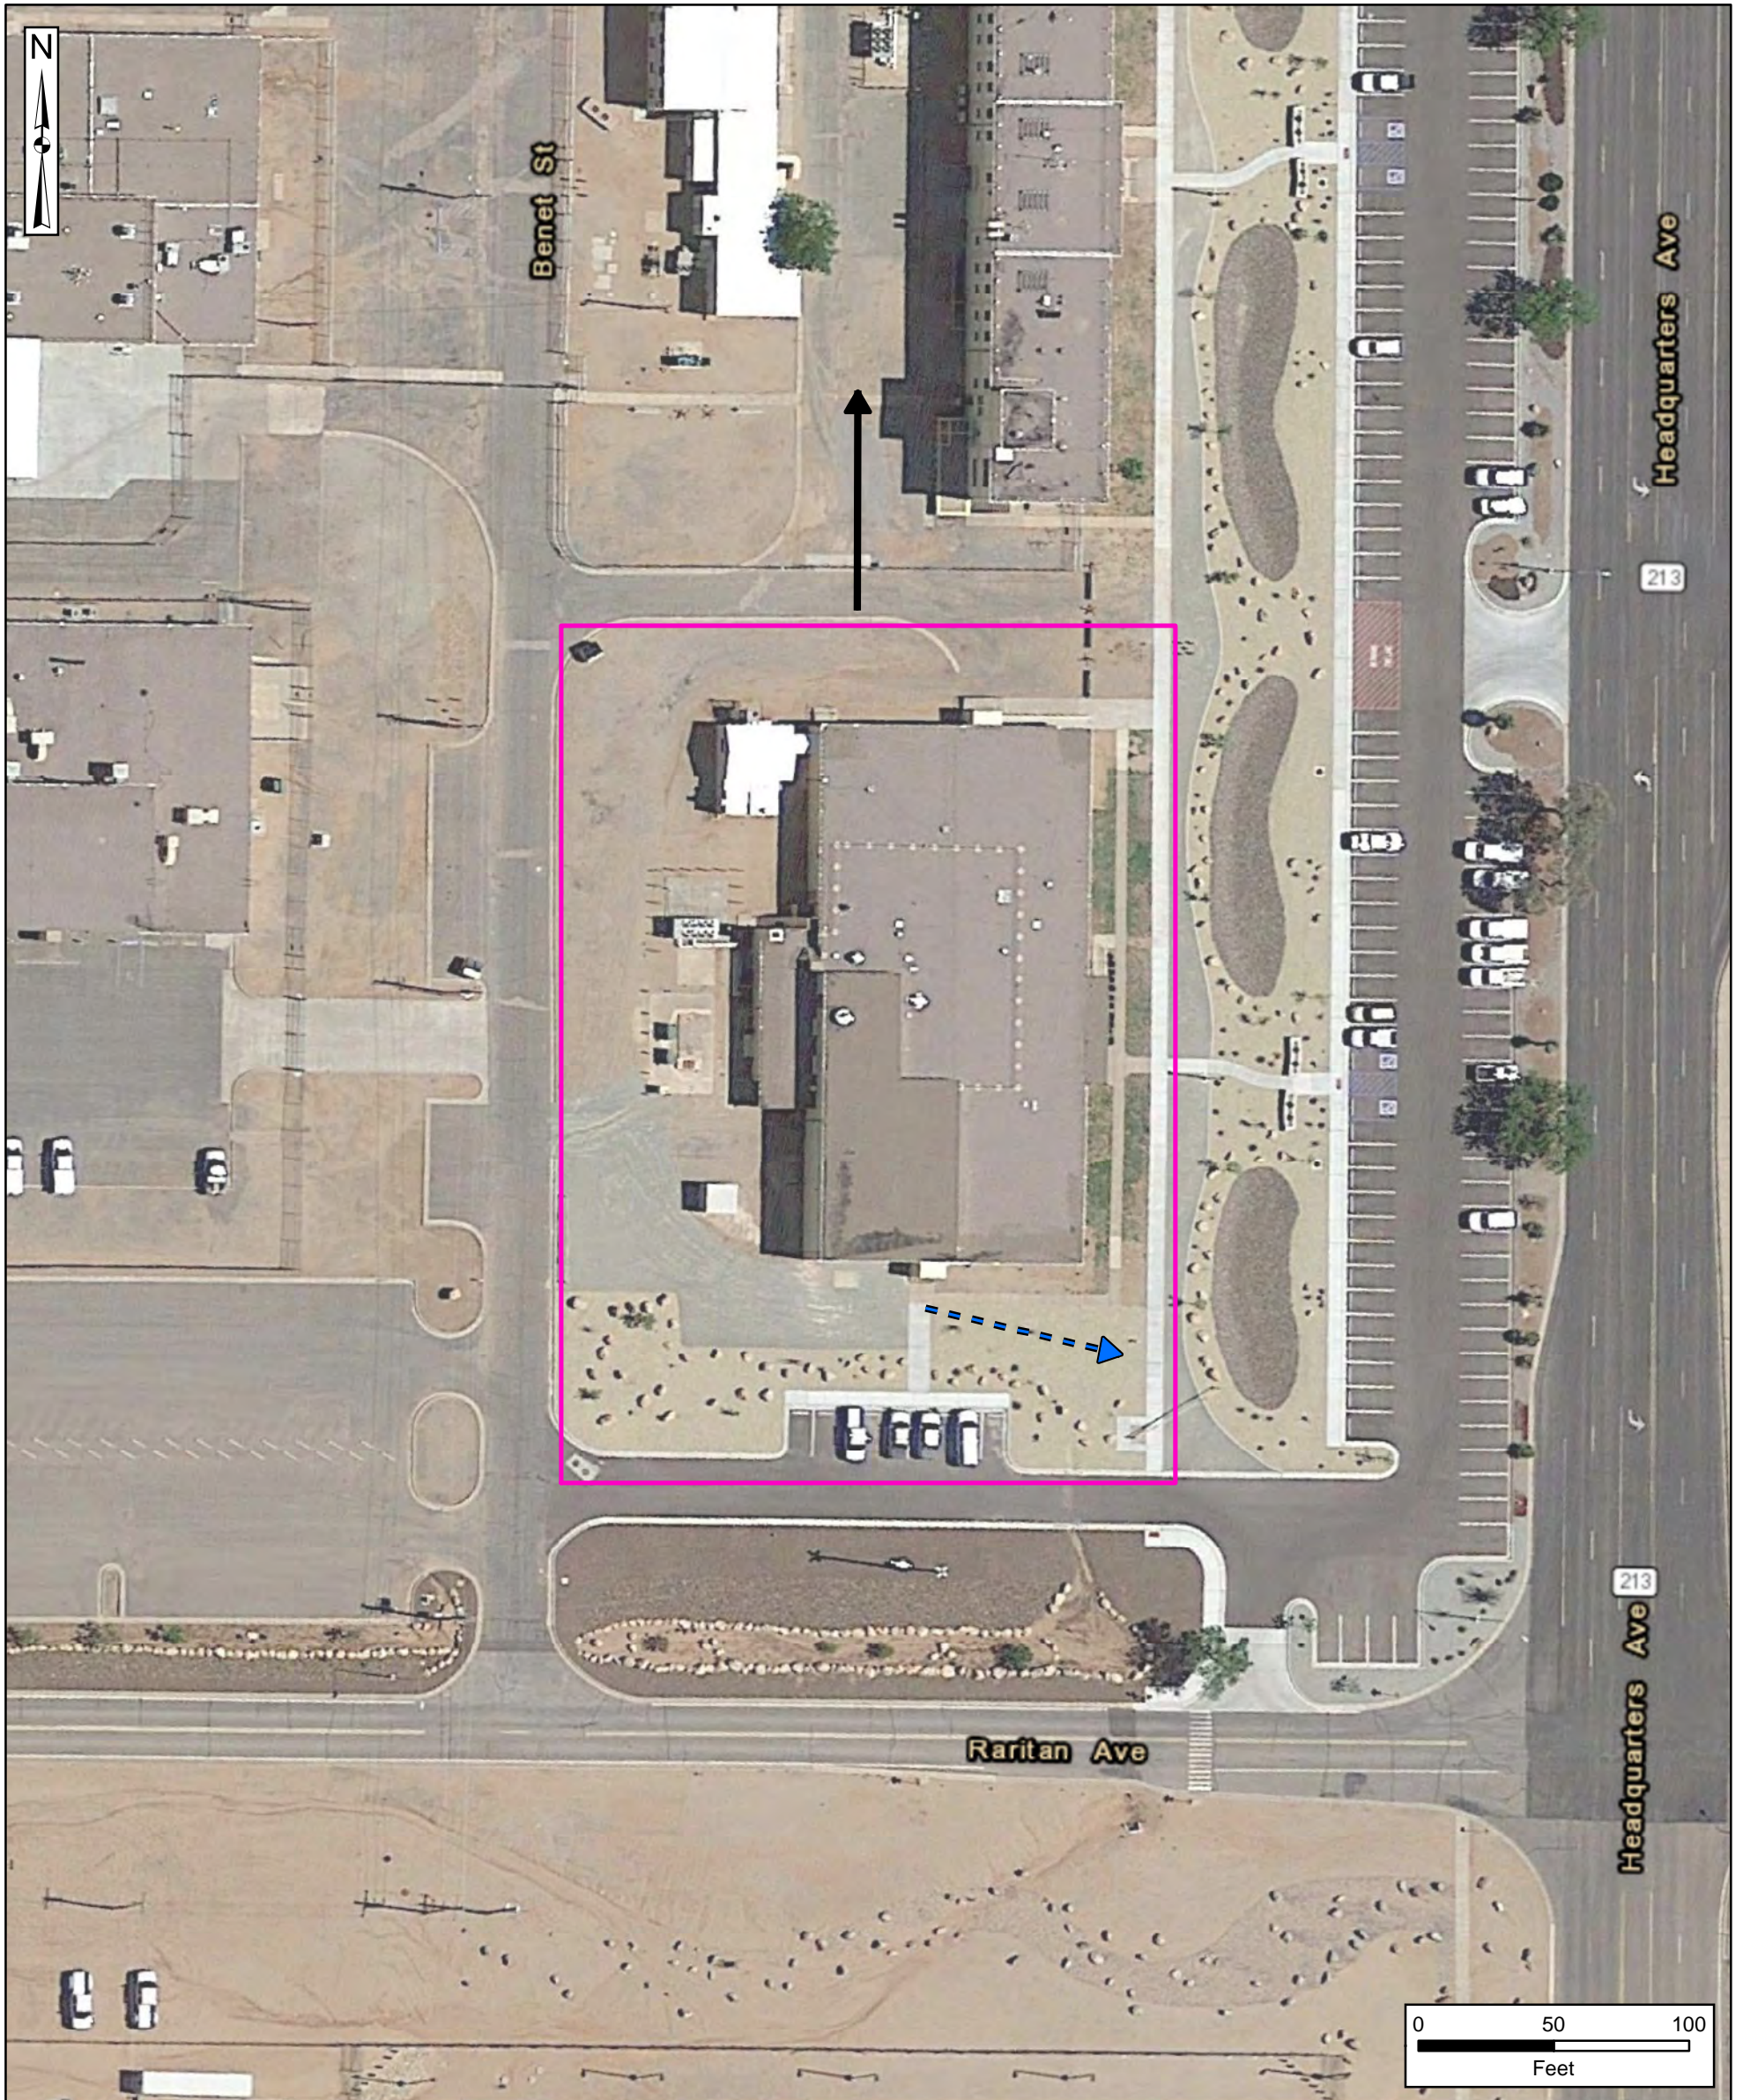
Figure 5-7
Aerial Photo of Photo Processing Lab
(Building 1621) (SWMUs 1-7)

An aerial photograph of the PPL (SWMUs 1-7) is provided on **Figure 5-7**. The AOPI is a building located in a flat, unpaved area. Immediately adjacent and to the east is a paved parking lot.

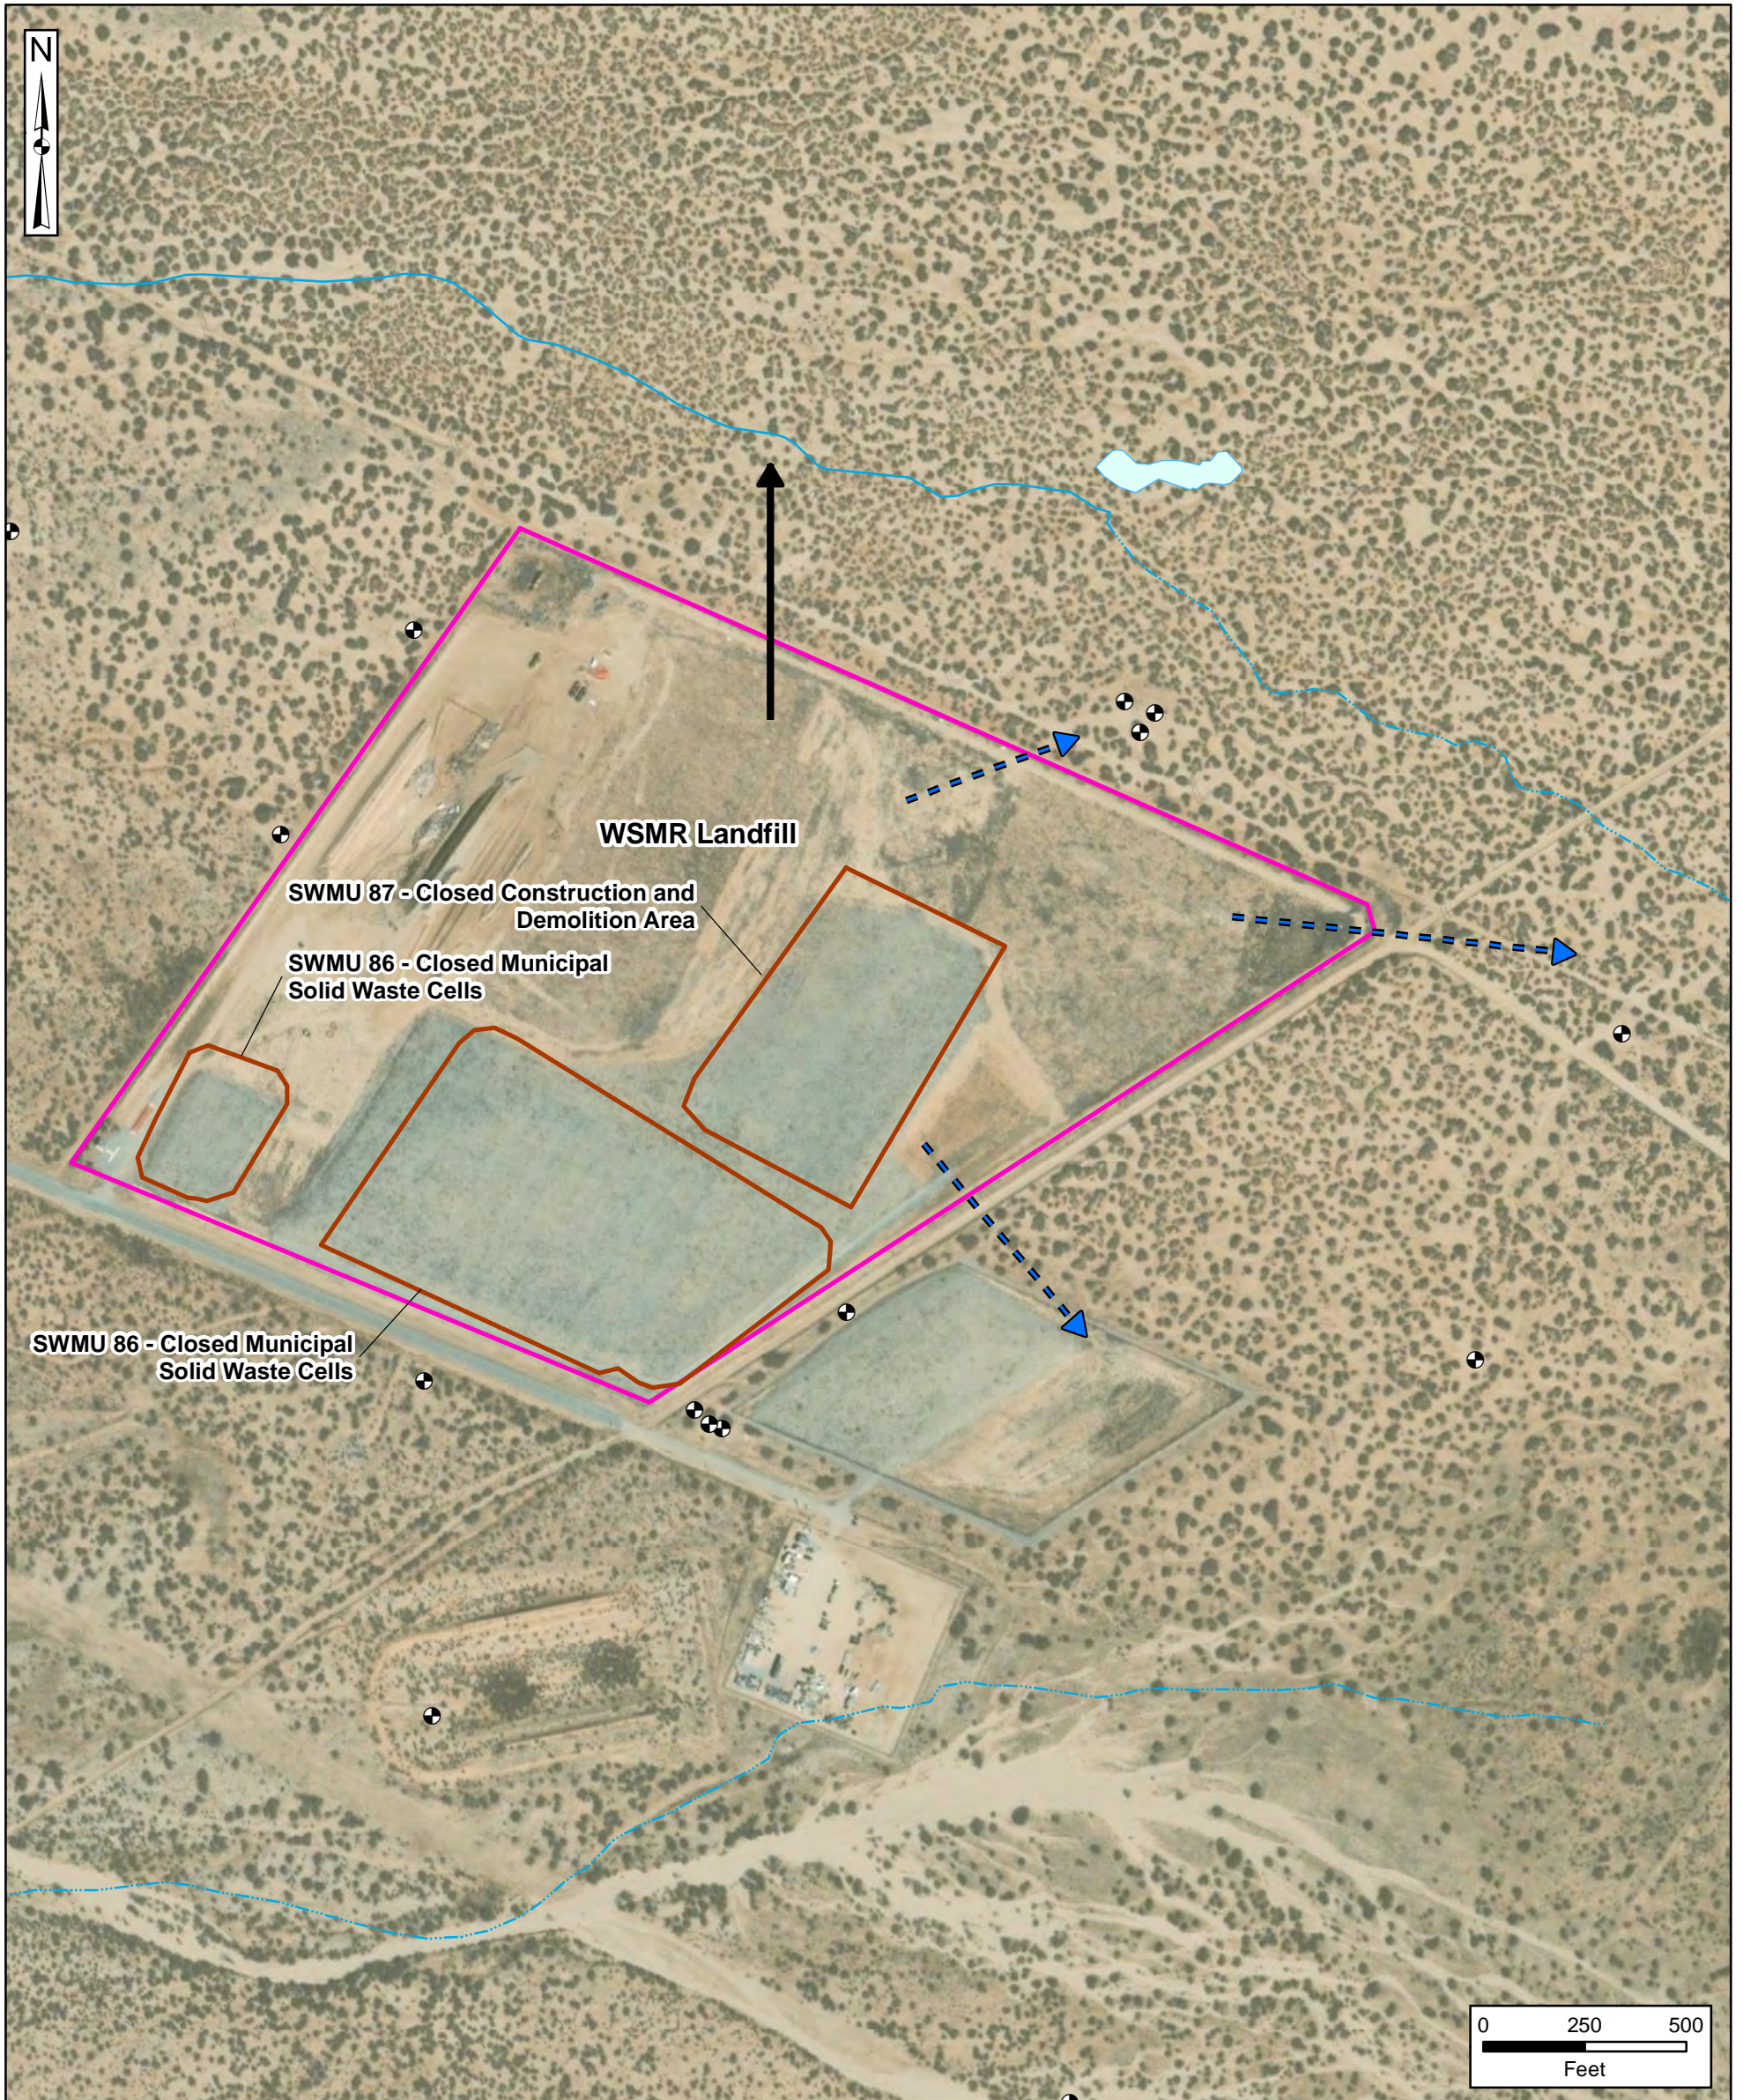
Figure 5-11
Aerial Photo of
WSMR Landfill (SWMUs 86-87)

An aerial photograph of WSMR Landfill is provided on **Figure 5-11**. The area is lightly vegetated without any pavement present.

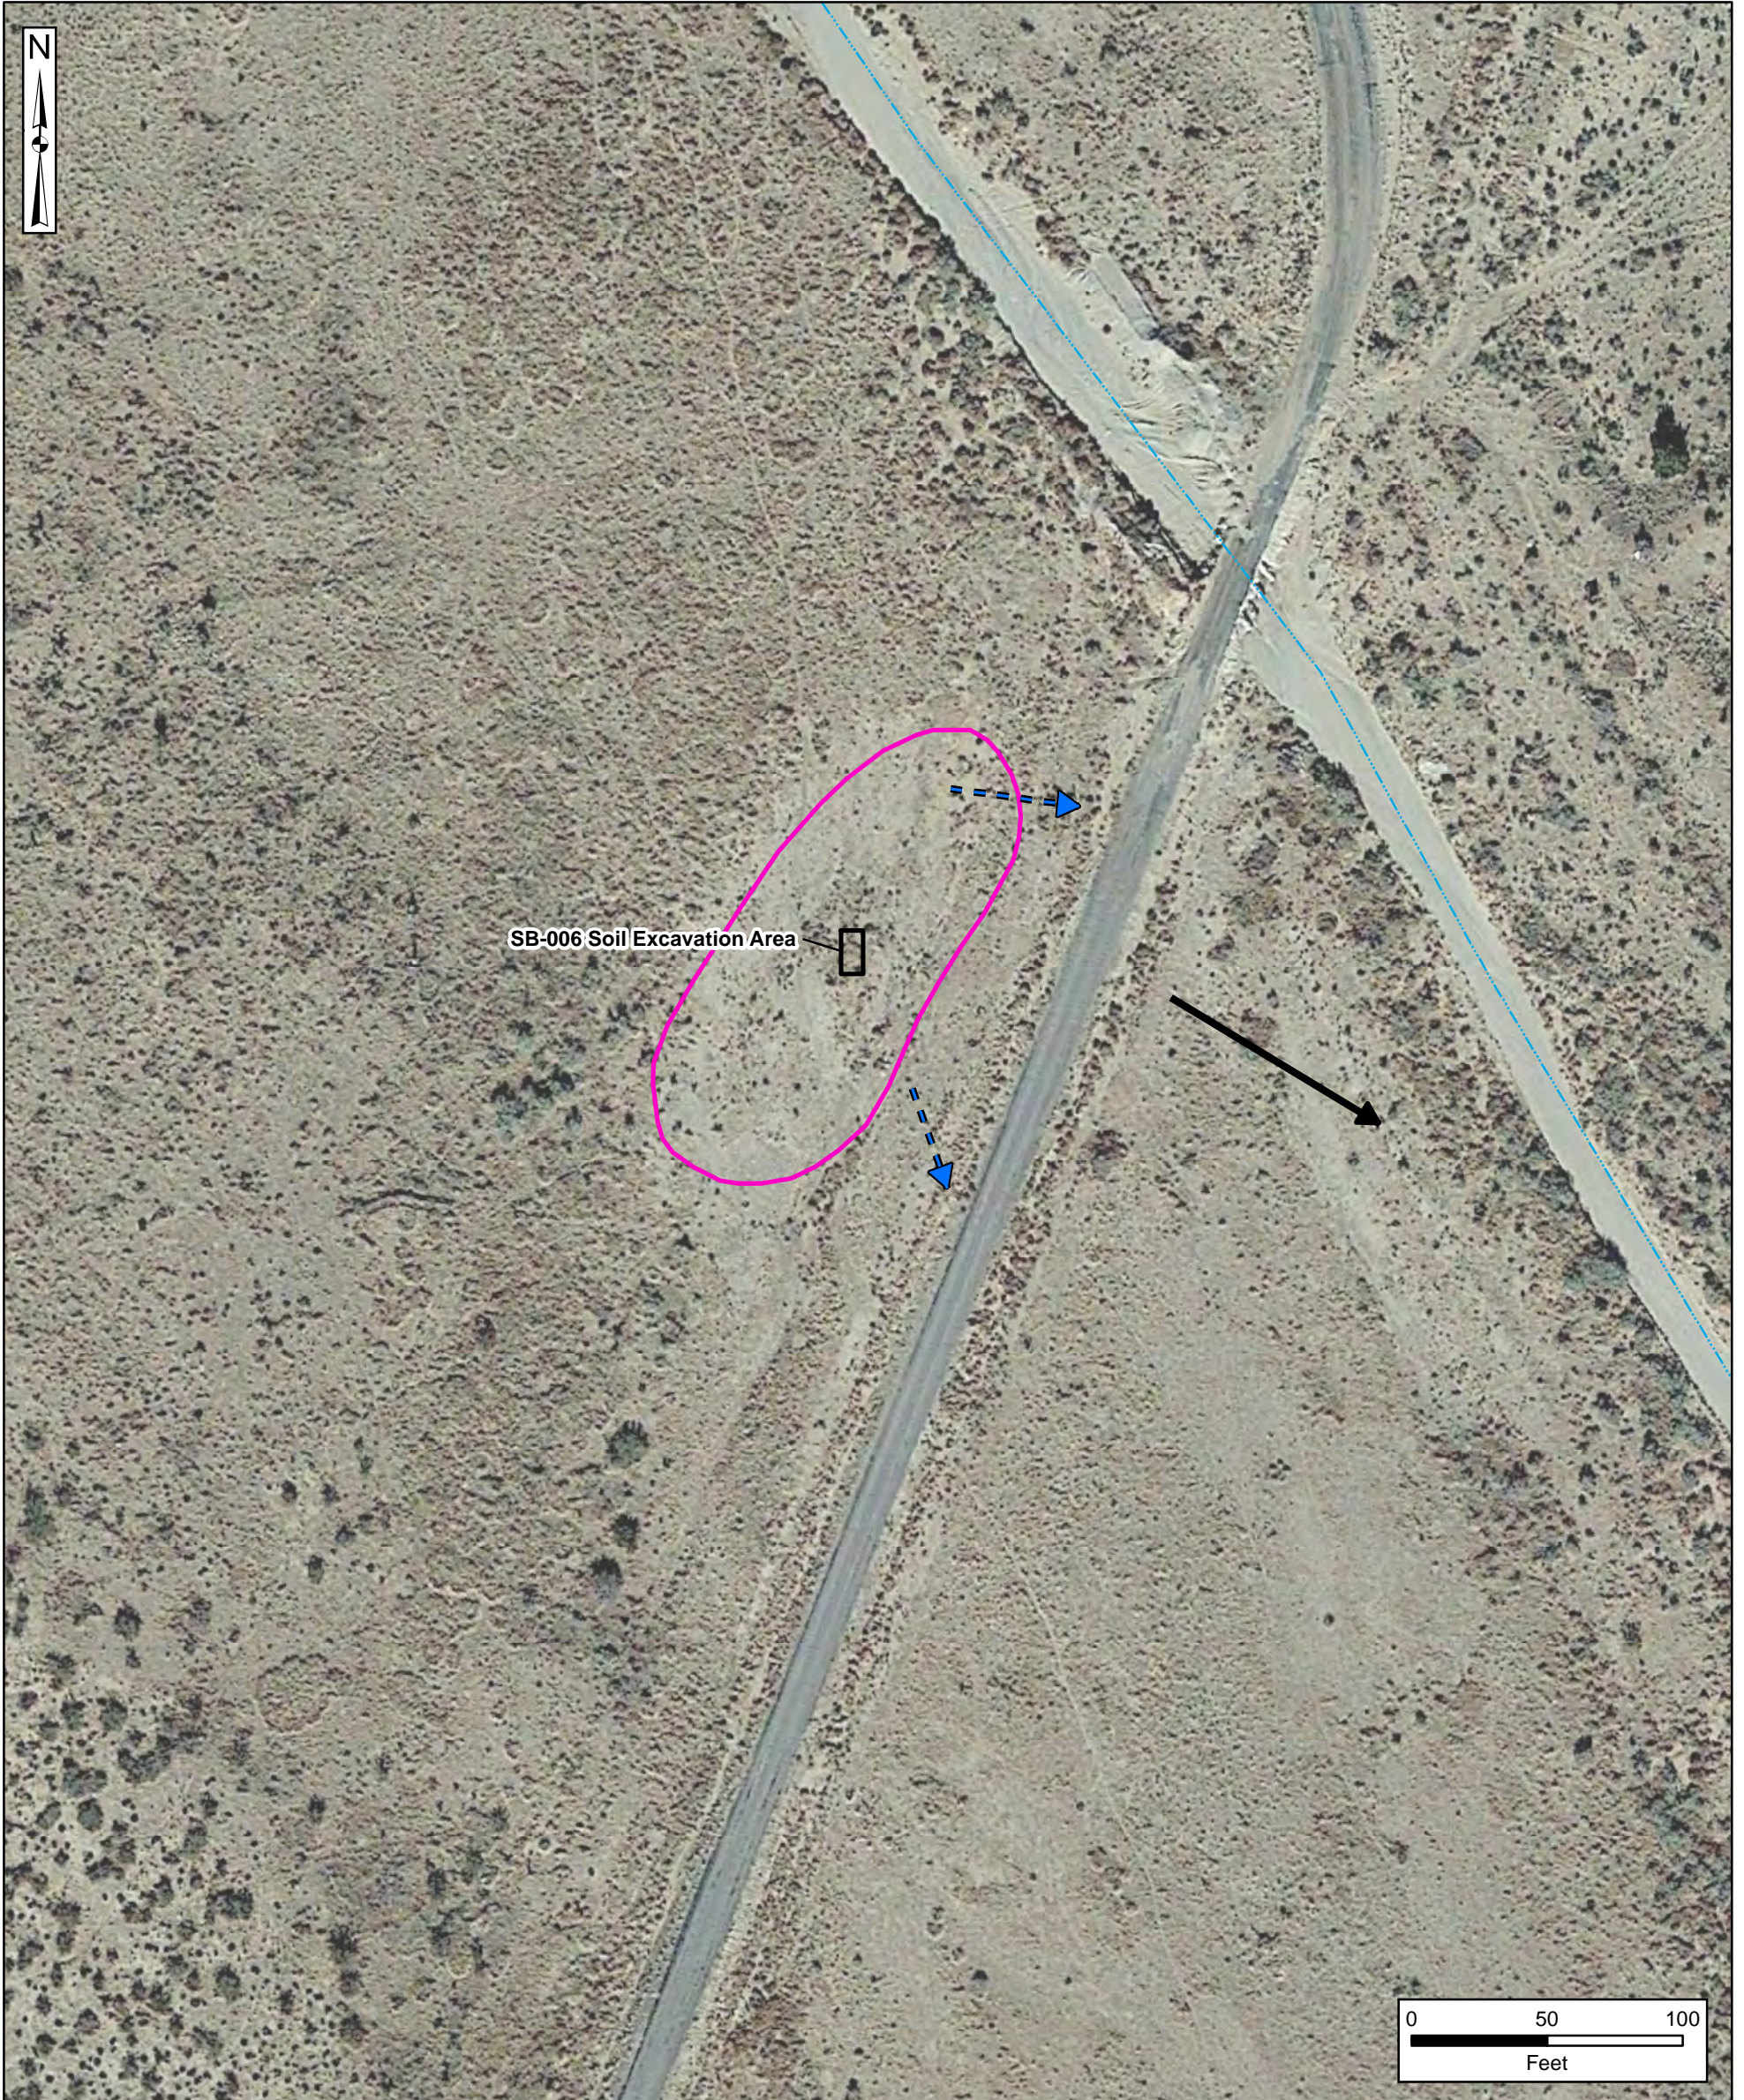
Figure 5-16
Aerial Photo of Stallion Range Center
Former Firefighting Training Area (SWMU-162)

An aerial photograph of SRC FFTA (SWMU-162) is provided on **Figure 5-16**. The AOPI is located on a flat, unpaved surface without structures present.

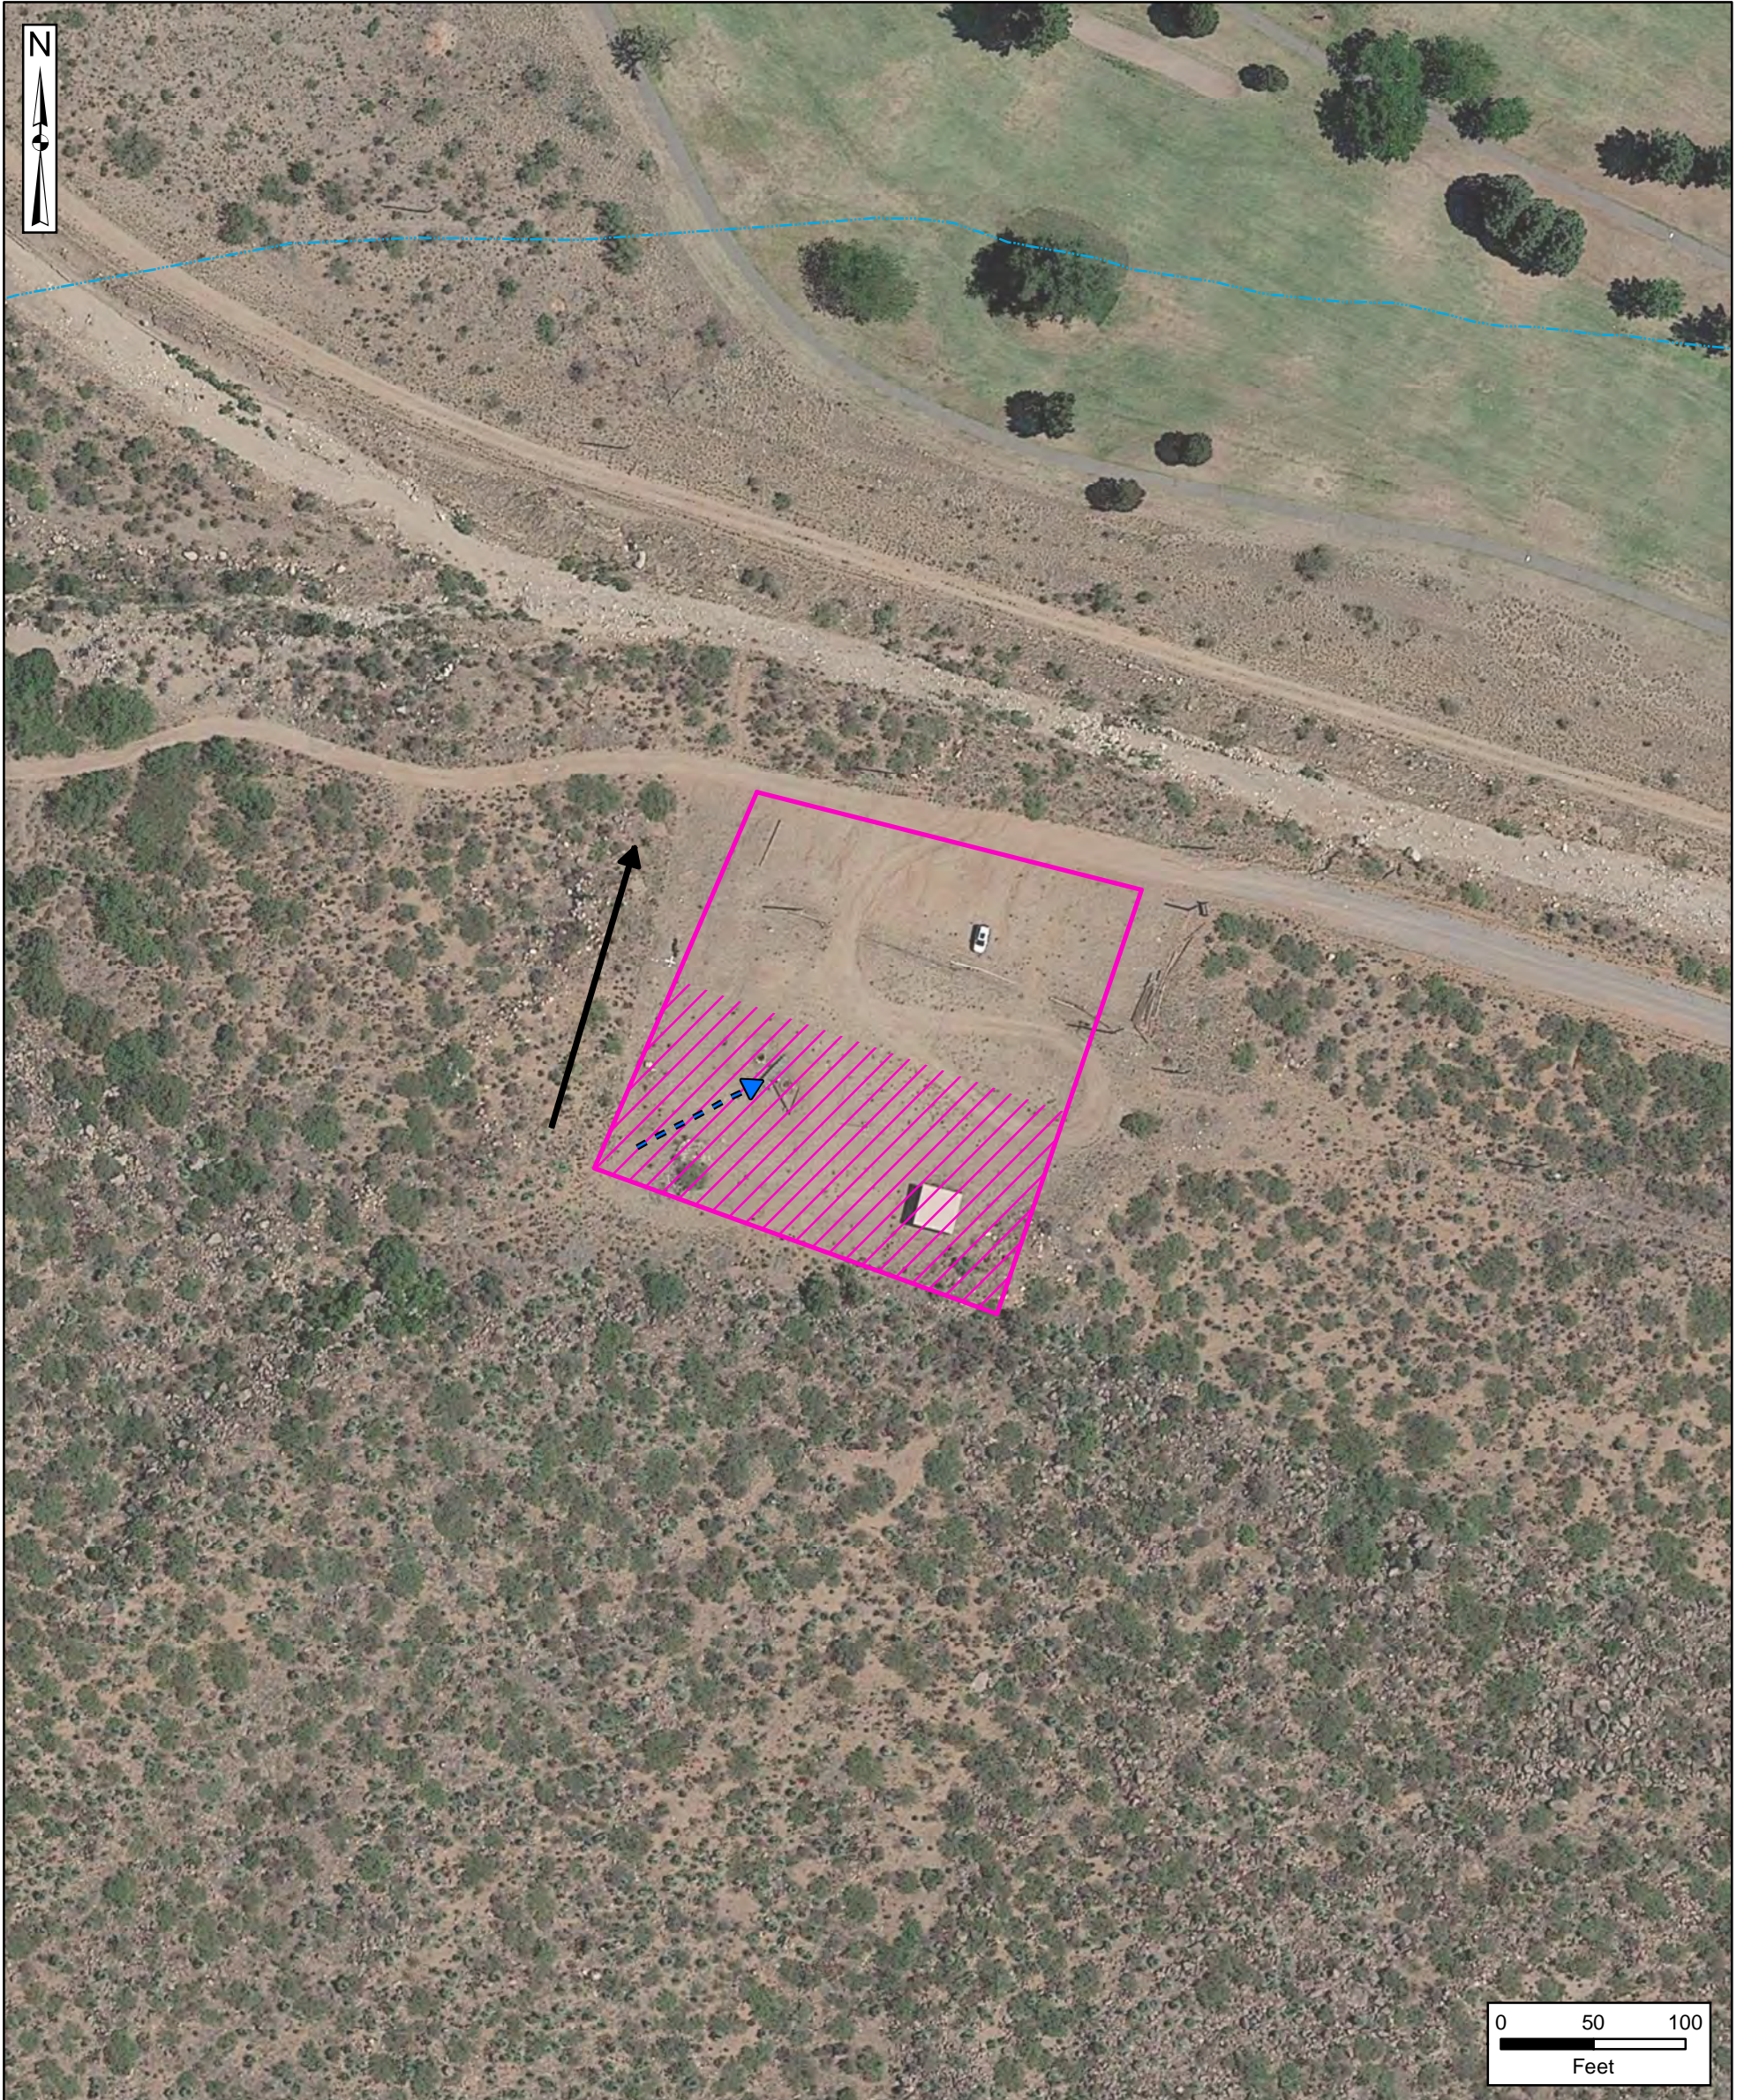
Figure 5-18
Aerial Photo of
Camp Tumbleweed Fire Training Area

An aerial photograph of Camp Tumbleweed FTA is provided on **Figure 5-18**. The area is lightly vegetated without any pavement present and a covered picnic area.
