# FINAL PRELIMINARY ASSESSMENT AND SITE INSPECTION OF PER- AND POLYFLUOROALKYL SUBSTANCES

## Fort Wainwright, Alaska

March 2022

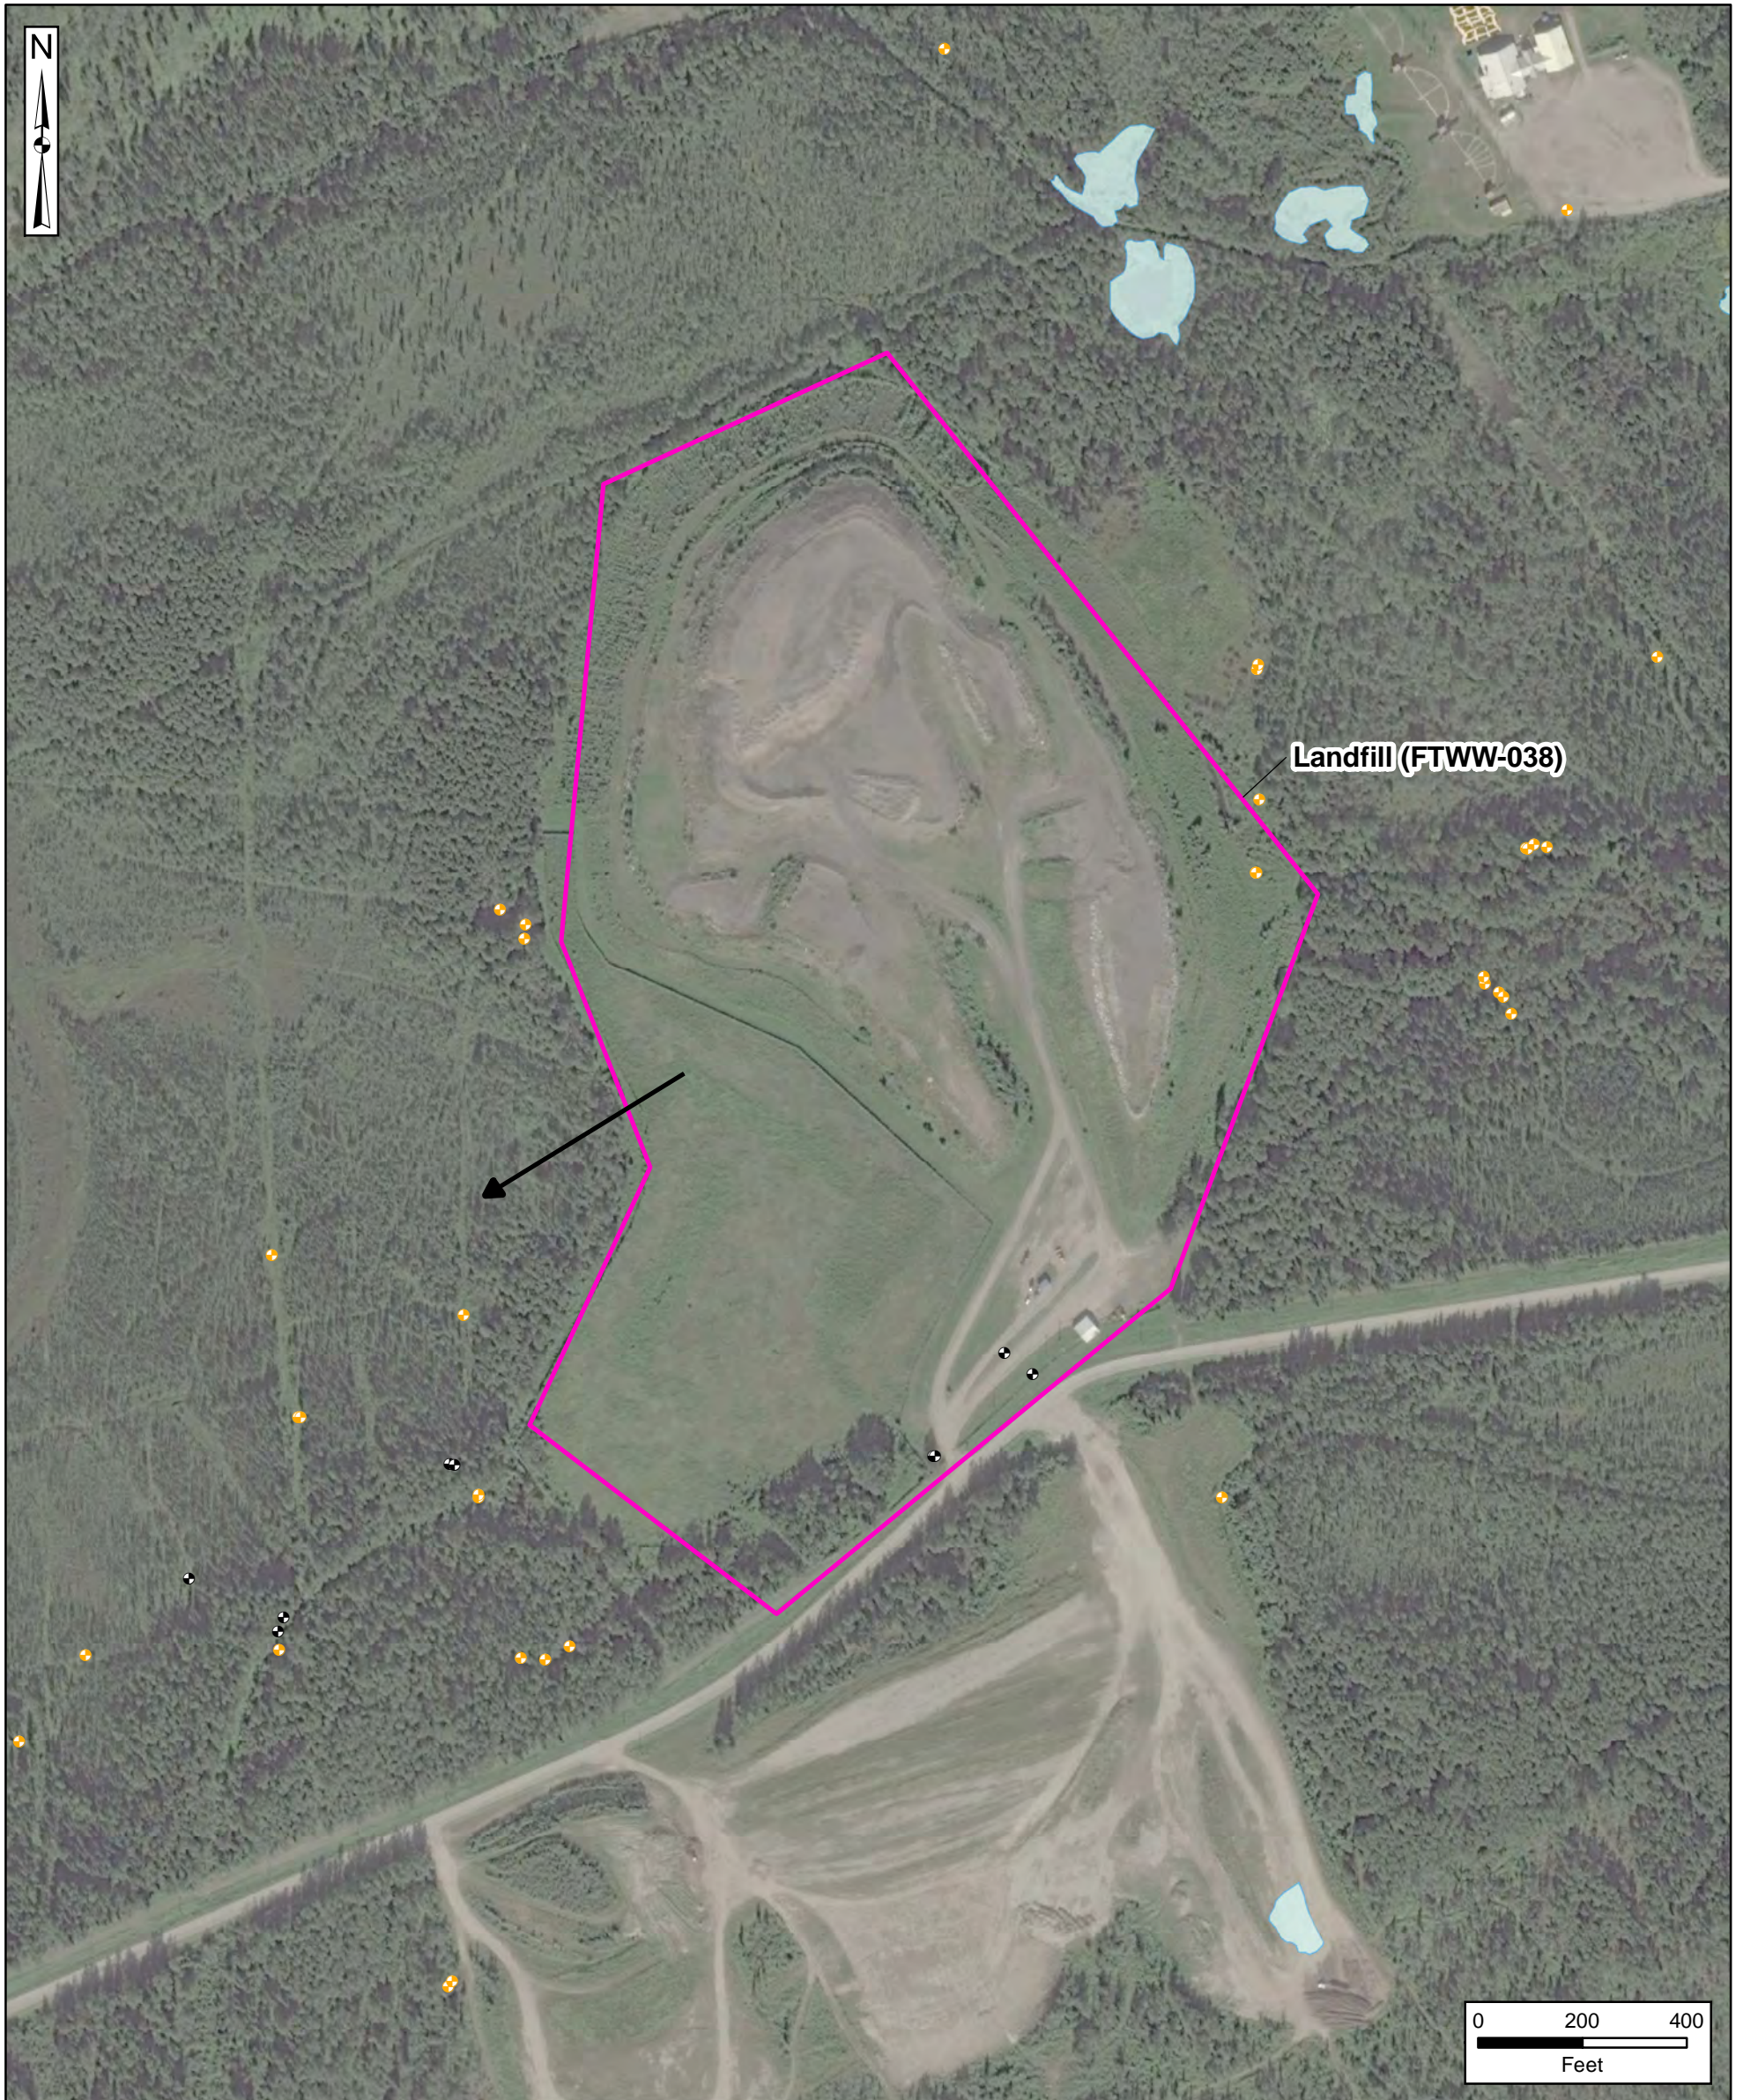
**Figure 5-8**  
**Aerial Photo of**  
**Landfill (FTWW-038) AOPI**

The Landfill is included in the IRP site identified as FTWW-038 (and Operable Unit 4), investigated for the landfill plume. Landfills in this area were filled with unsegregated waste, burned and covered. Historical documents indicate that the landfill has operated since the mid-1950s, is unlined and unbermed, and does not have a leachate collection system. The Landfill is built up topographically higher than the surrounding terrain and is partially constructed within a wetland and on top of discontinuous permafrost. Sampling results from this area in 1994 indicated elevated levels of volatile organic compounds, semi-volatile organic compounds, and metals in groundwater. Discharge to the Chena River and transport to downgradient wells from this AOPI are of concern. The Landfill is approximately 0.6 mile from the Chena River. Monitored natural attenuation and cap inspections will continue for the foreseeable future (FTWW 2017).

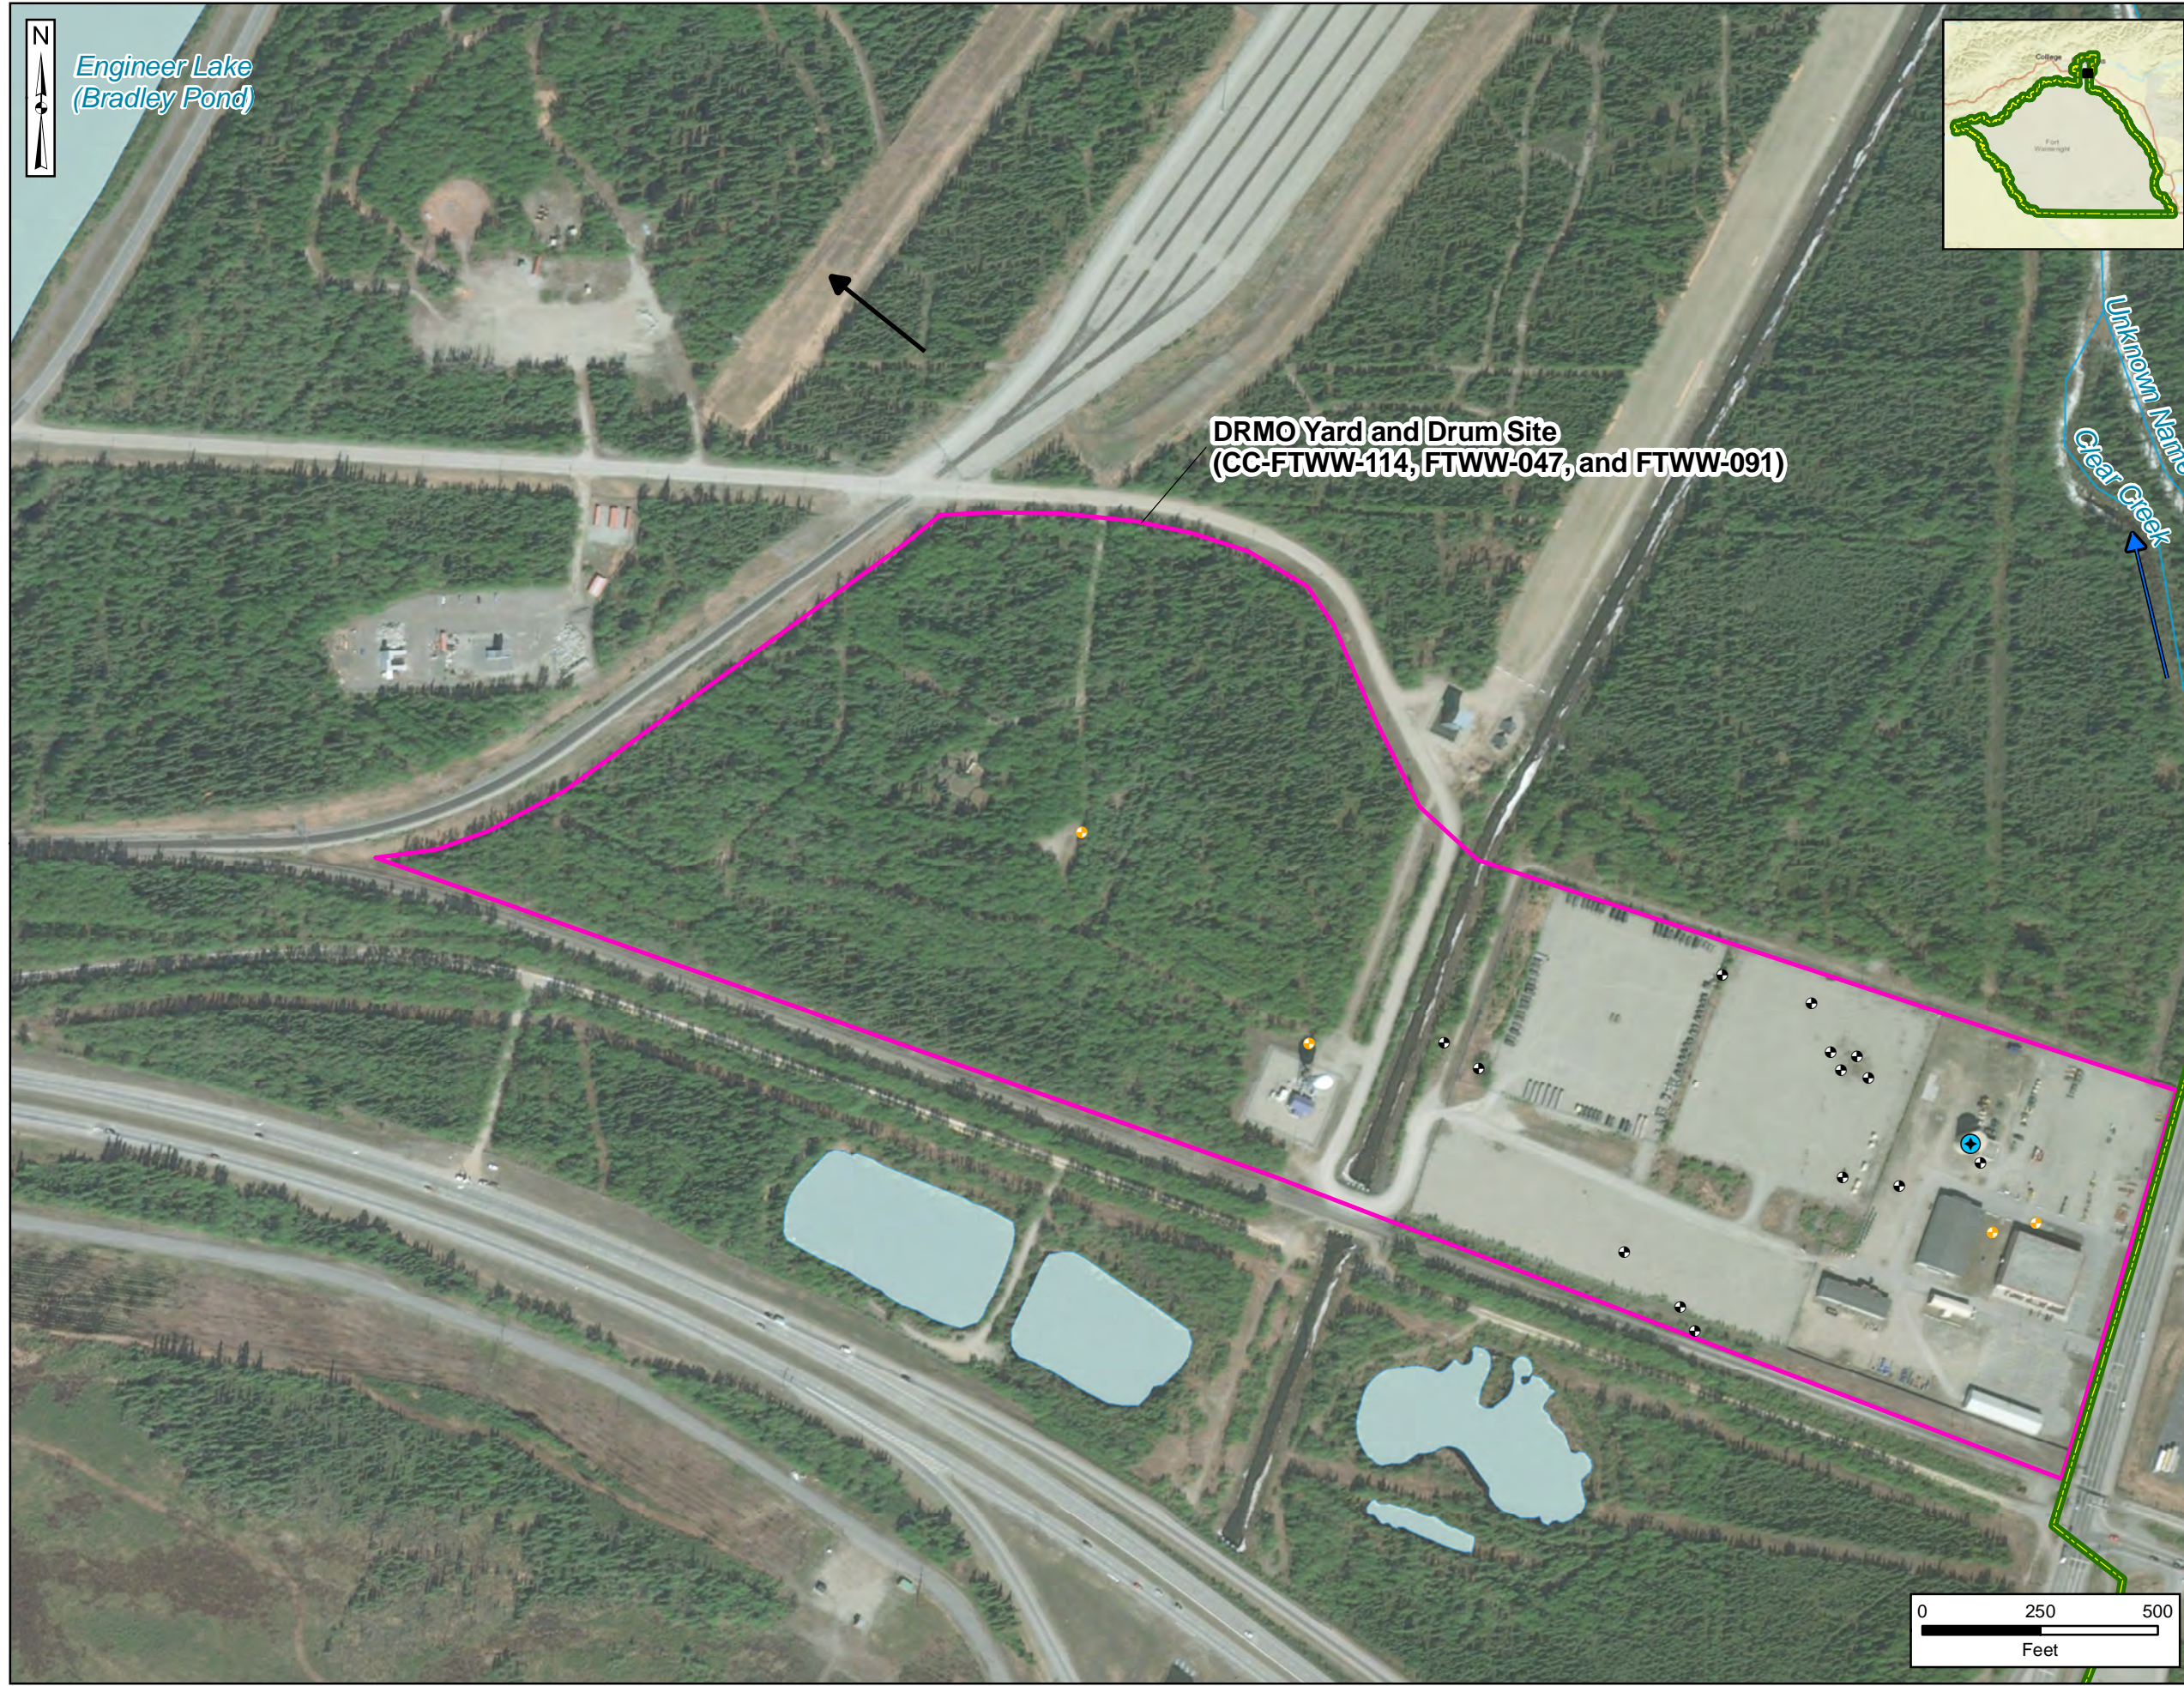
**Figure 5-10**  
**Aerial Photo of**  
**North Refueling AOPI**

The North Refueling area (**Figure 5-10**) was identified as an AOPI after PFOS, PFOA, and PFBS were detected in a sample collected in April 2019 at an unnamed well in the area (**Table 2-1**). The well is reportedly a supply well for the Alaska Fire Service Mix Plant and is used by the BLM for fire retardant. It is suspected the detected results may be impacts from down-hole equipment; however, the dedicated pump is not removable. The area has previously been referred to as the BLM Hot Point Refueling Station. While ADEC has reported that fire training activities have been historically conducted at this site, the installation did not have additional details to provide regarding the site's history to confirm these reported activities. Buildings associated with the fueling facility were demolished in the 1990s, but other office, barracks, and housing structures exist in the adjacent area. The area of suspected AFFF use is a grassy area located to the northeast of the LAAF runways, approximately 0.5 mile from the Chena River. This AOPI boundary partially overlaps with IRP site FTWW-063 (02871.1040) North Refueling. This area (along with adjacent office and barracks structures) is considered light industrial/commercial use; however, the housing units adjacent to the area are considered residential use.
