**PRELIMINARY ASSESSMENT REPORT
OF PFAS
FORT WINGATE ARMY DEPOT (FWDA),
NEW MEXICO**

U.S. Army BRAC Branch DCS G-9

AAR Document Control: 230310-01-OPS-WINGATE

September 13, 2023

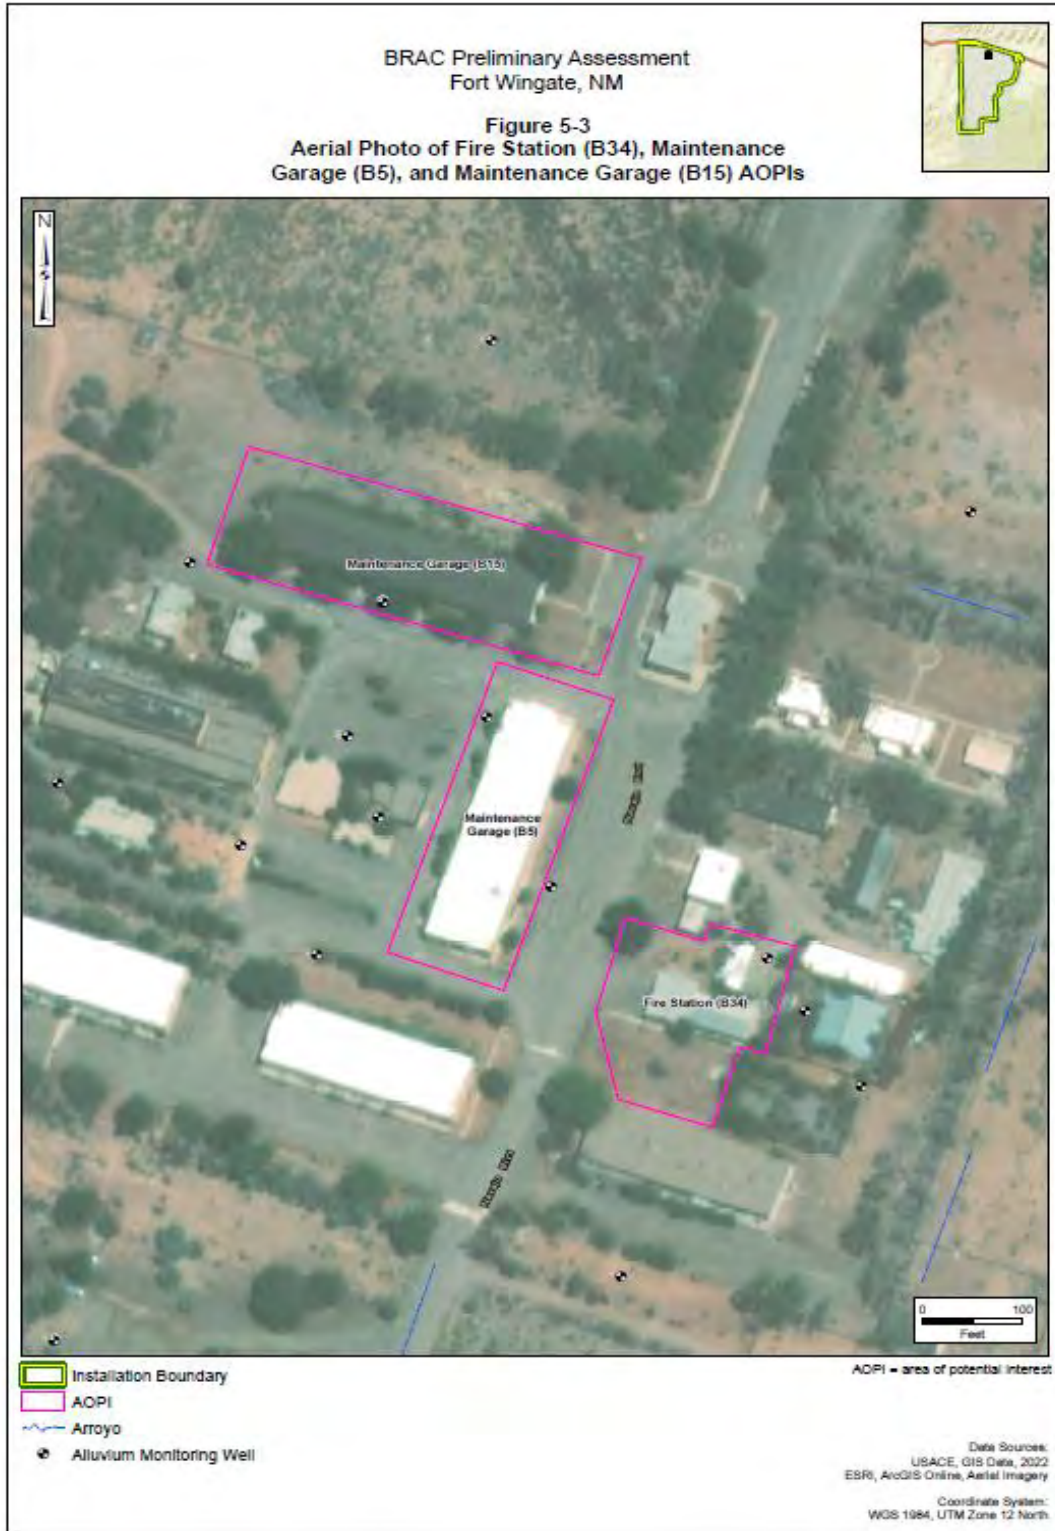
Figure 5-3: Aerial Photo of Fire Station (B34); Maintenance Garage (B5), and Maintenance Garage (B15) AOPIs

Location Name	AOPI	Recommendation	Rationale	Land Ownership
Fire Station Building 34	Yes	Further study in site inspection	Evidence of AFFF being utilized in this area includes interview statements and historical common practice of extinguishing materials for fuel-based fires to be AFFF during the period of use.	ARMY
Building 5 Maintenance Garage	Yes	Further study in site inspection	Probable PFAS containing fire vehicle maintenance and washing being conducted here.	ARMY
Building 15 Maintenance Garage	Yes	Further study in site inspection	Utilization for AFFF storage.	ARMY
Fire Training Ground	Yes	Further study in site inspection	Evidence of AFFF being utilized in this area includes interview statements and historical common practice of extinguishing materials for fuel-based fires to be AFFF during the period of use.	ARMY
Sewage Disposal Plant	Yes	Further study in site inspection	Suspected accumulation of PFAS-containing material from various sources through sanitary sewer system.	ARMY

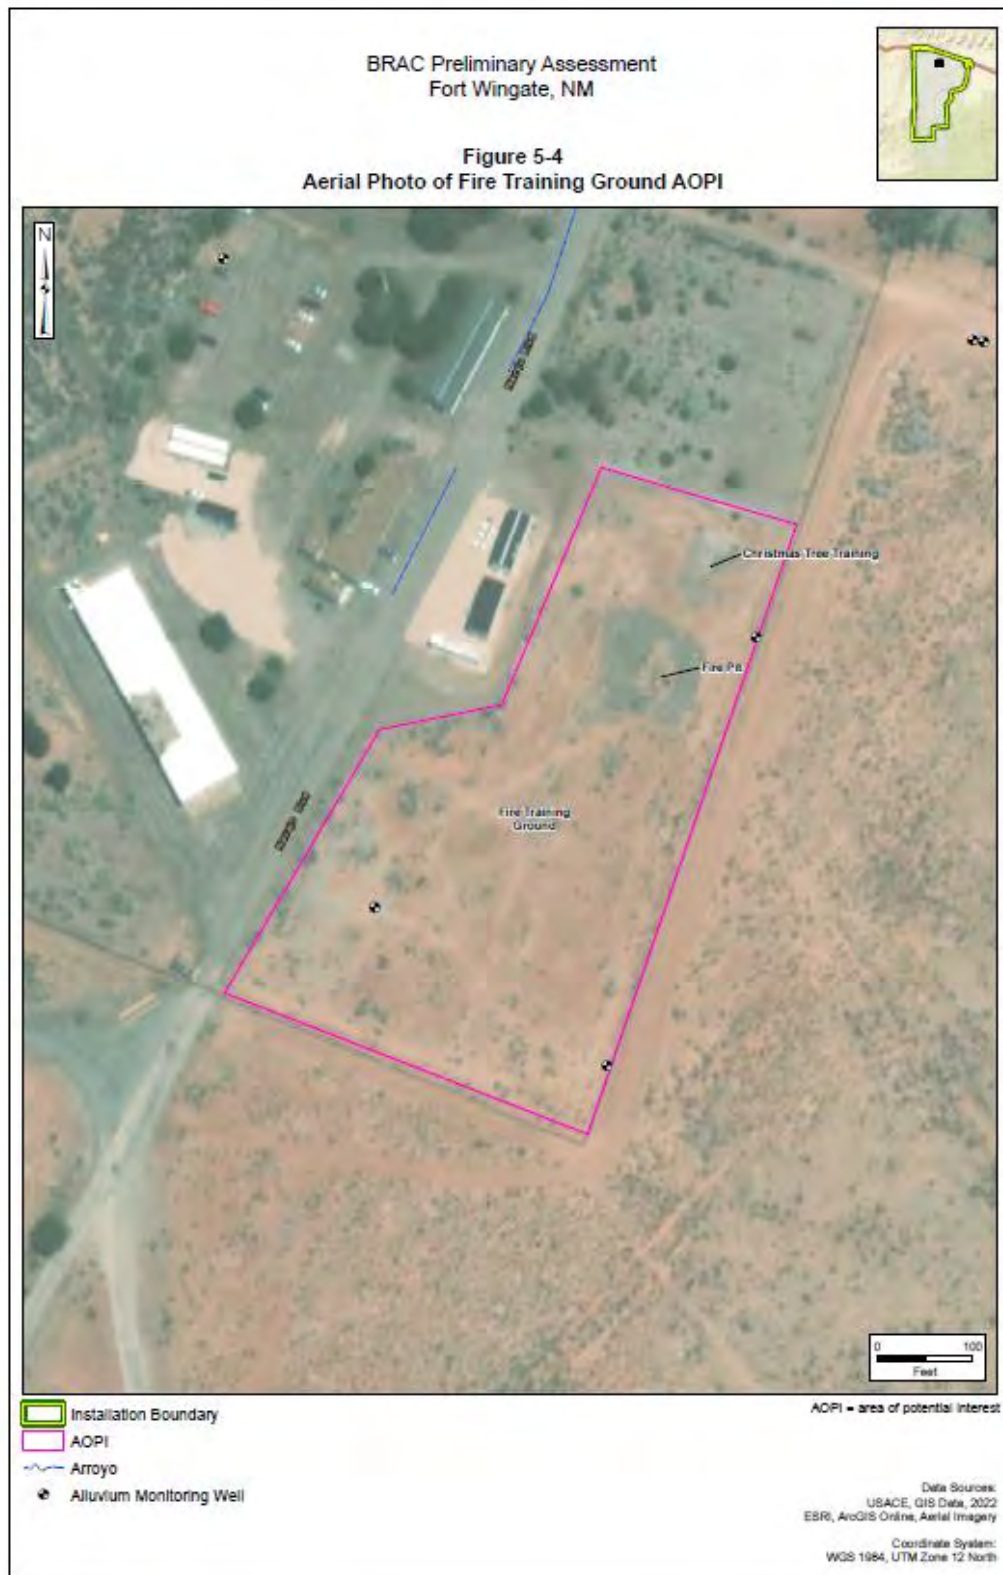
Figure 5-4: Aerial Photo of Fire Training Ground AOPI

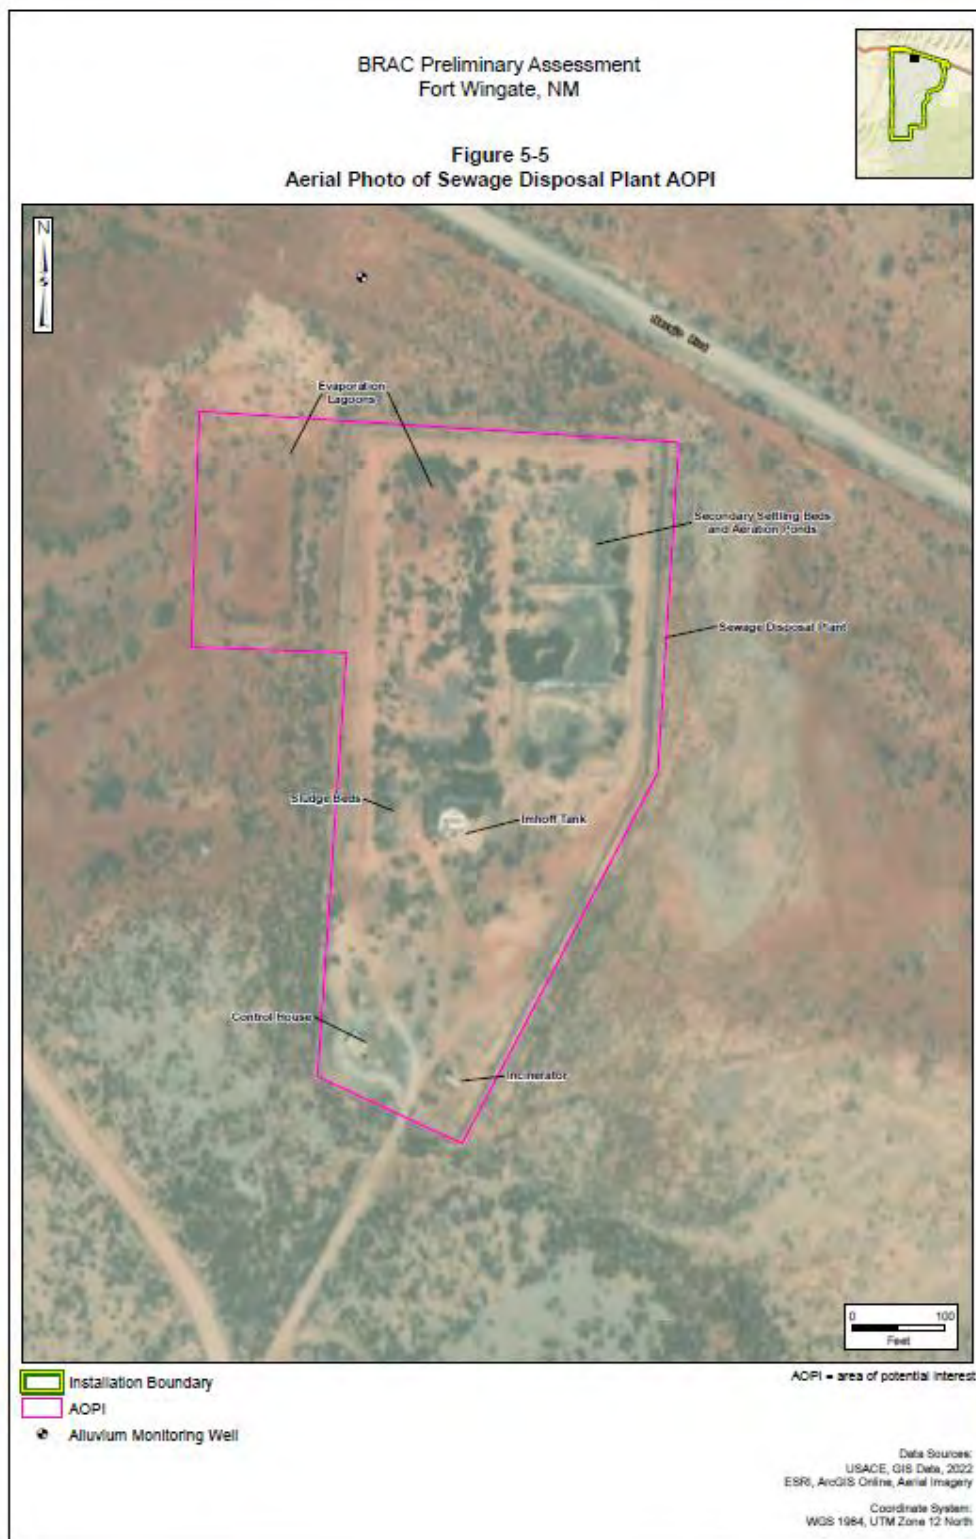
Figure 5-5: Aerial Photo of Sewage Disposal Plant AOP

Domestic sewage for the FWDA administrative area was collected through a sewer network and gravitationally drained to the now closed Sewage Disposal Plant northwest of the administrative area. There the sewage received treatment prior to being discharged to a surface drainage. The Sewage Disposal Plant had three stabilization ponds, an unlined evaporation-infiltration lagoon, and three sludge drying beds. A septic tank was constructed around 1954 and was added to provide basic treatment in the event that flow through the control house needed to be bypassed. It led through vitrified clay pipe towards an outfall to the north. The Sewage Disposal Plant ceased operations after 2013 (USACE Fort Worth District 2013).
