# FINAL PRELIMINARY ASSESSMENT AND SITE INSPECTION OF PER- AND POLYFLUOROALKYL SUBSTANCES

## Yuma Proving Ground, Arizona

Prepared For:  
U.S. Army Corps of Engineers, Baltimore District  
2 Hopkins Plaza  
Baltimore, MD 21201

PRELIMINARY ASSESSMENT/SITE INSPECTION OF PFAS AT YUMA PROVING GROUND, ARIZONA

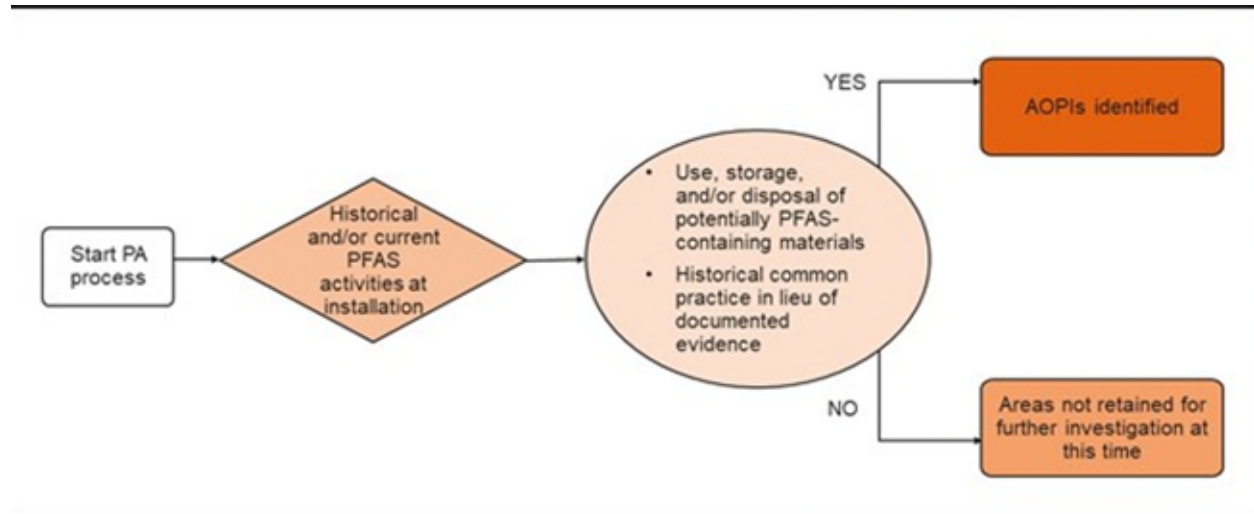
Figure 5--1: AOPI Decision Flowchart

The preliminary locations evaluated for potential use, storage and/or disposal of PFAS-containing materials at YPG were further refined during the PA process and identified either as an area not retained for further investigation or as an AOPI. In accordance with the established process for the PA/SI, 15 areas have been identified as AOPIs. The process used for refining these areas is presented on **Figure 5-1**, below.

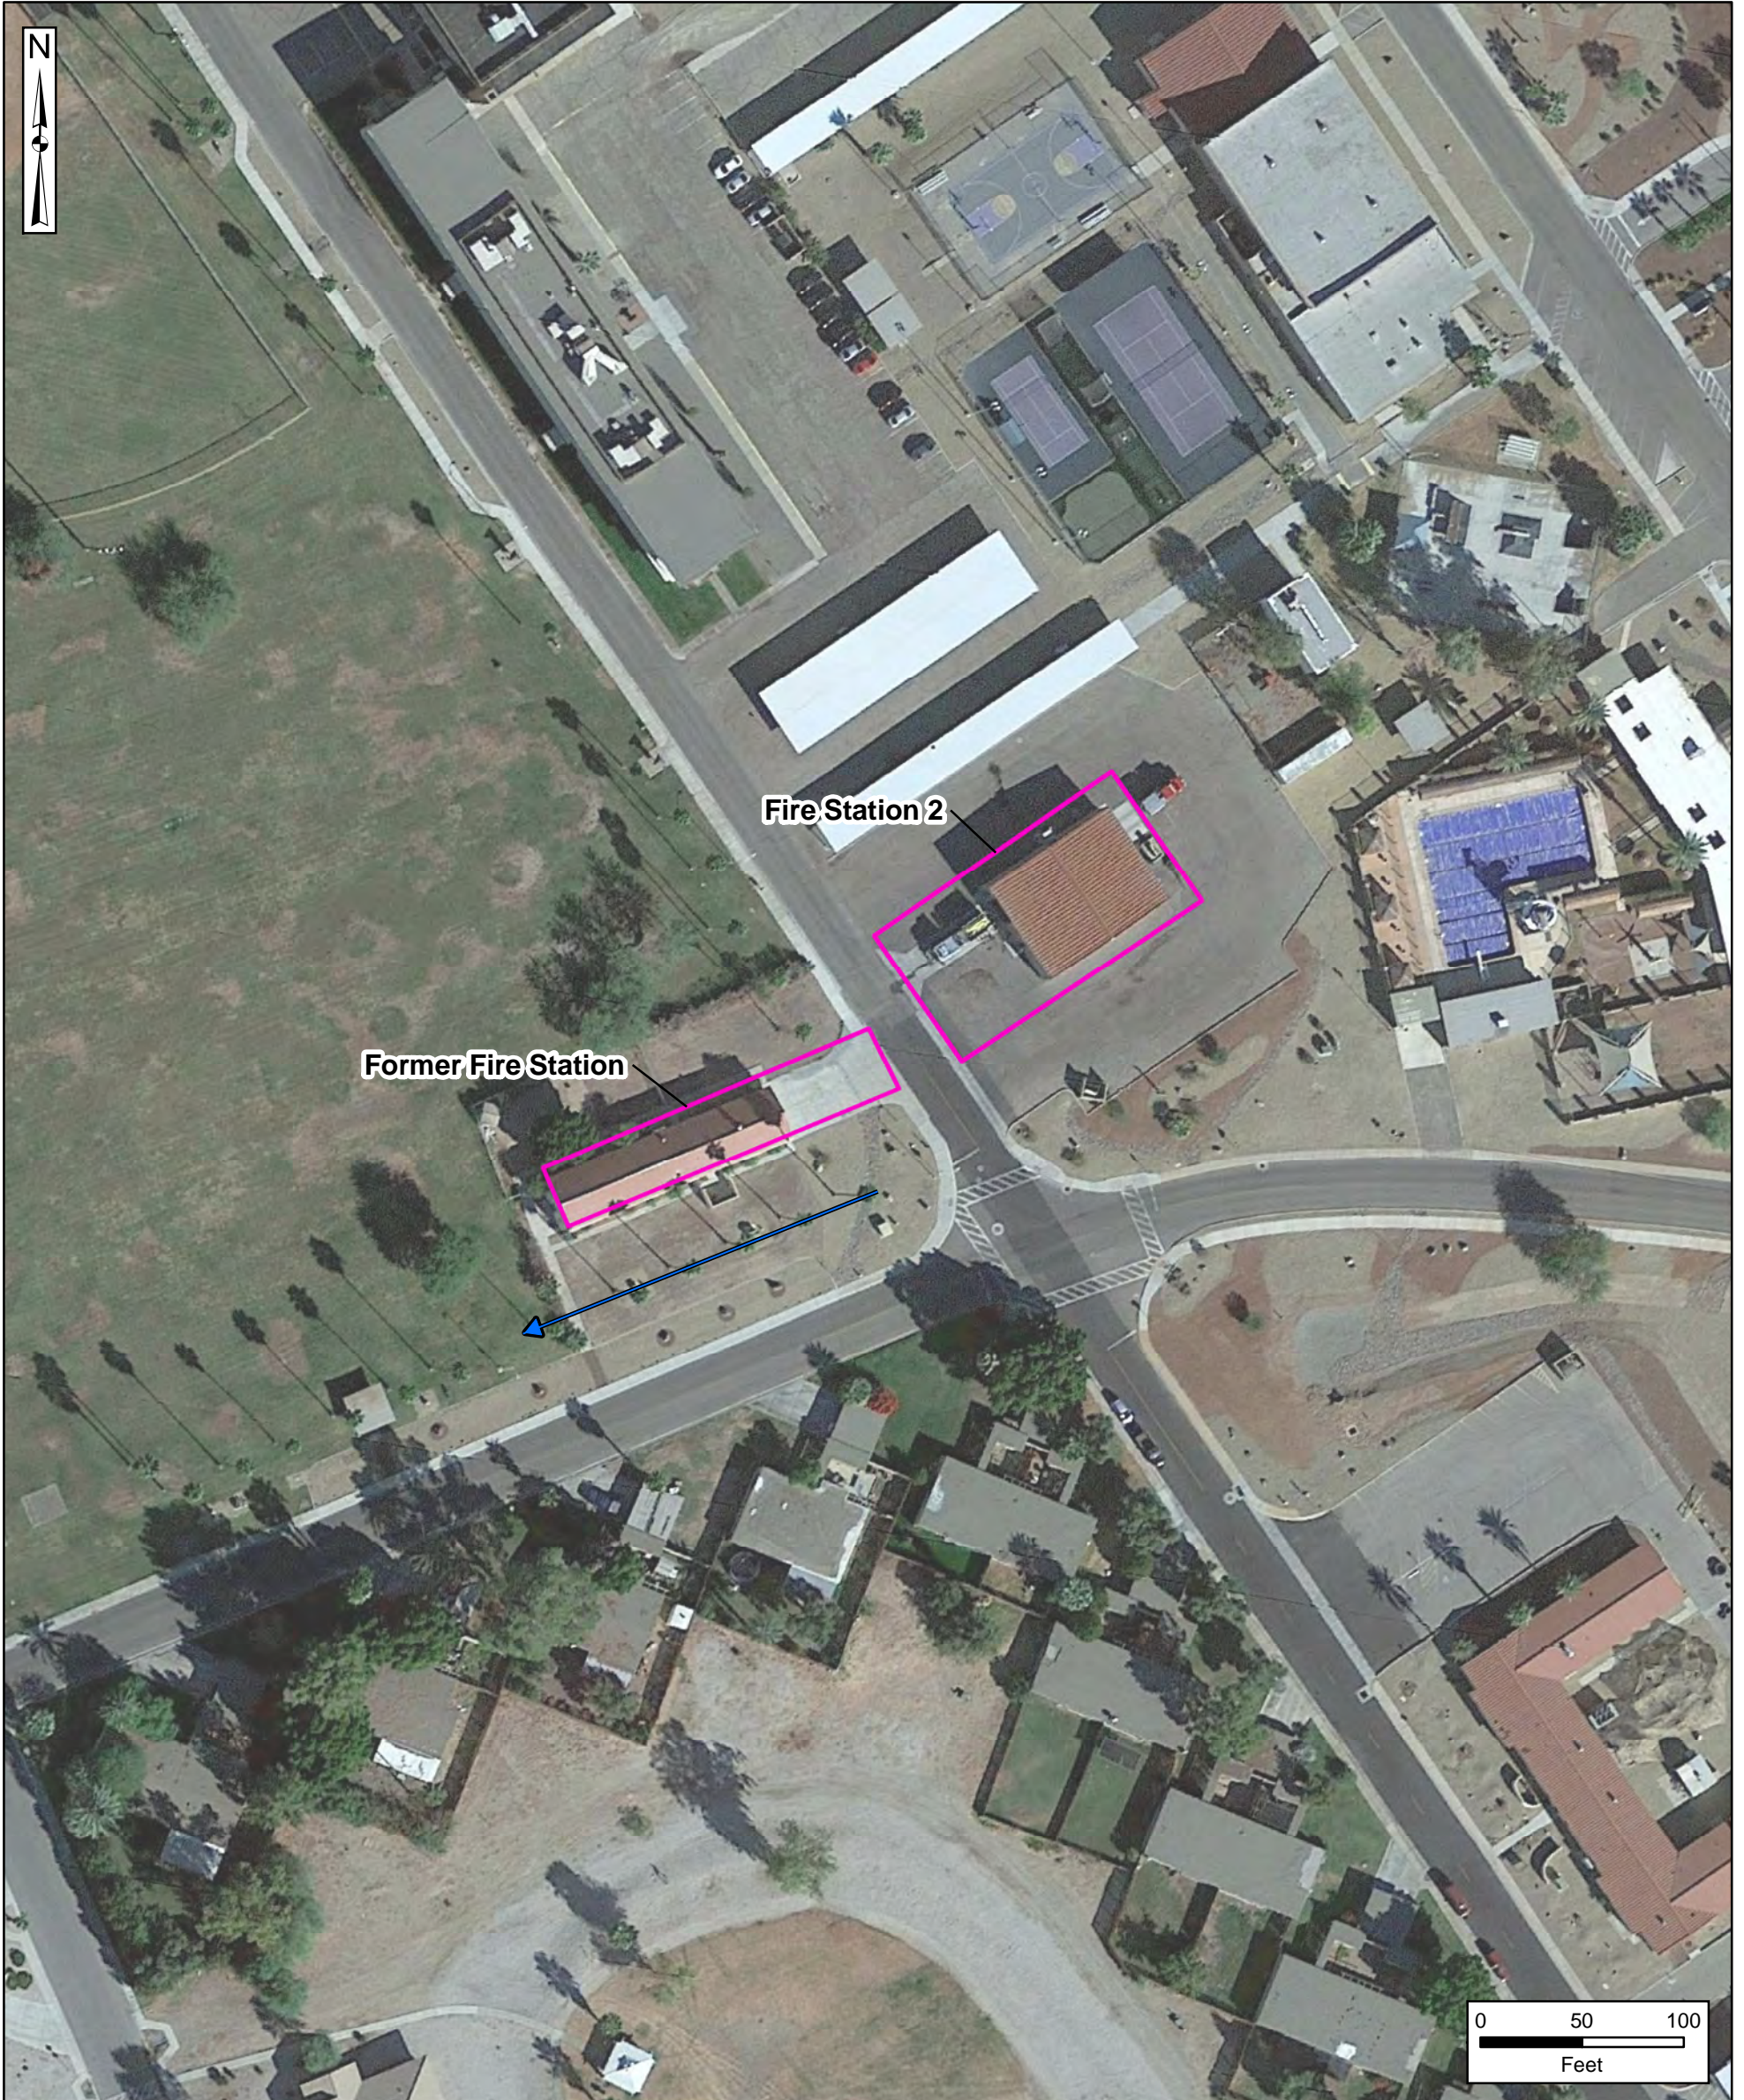
**Figure 5-4**  
**Aerial Photo of AOPIs**  
**Fire Station 2 and Former Fire Station**

- **Fire Station 2:** Shallow soil samples and a groundwater sample were collected from the north apron underneath cracked asphalt.
- **C-130 Fuel Spill Response:** Three shallow soil samples and one deep soil sample were collected off the edge of the associated concrete pad. A groundwater sample was collected from existing production Well B.

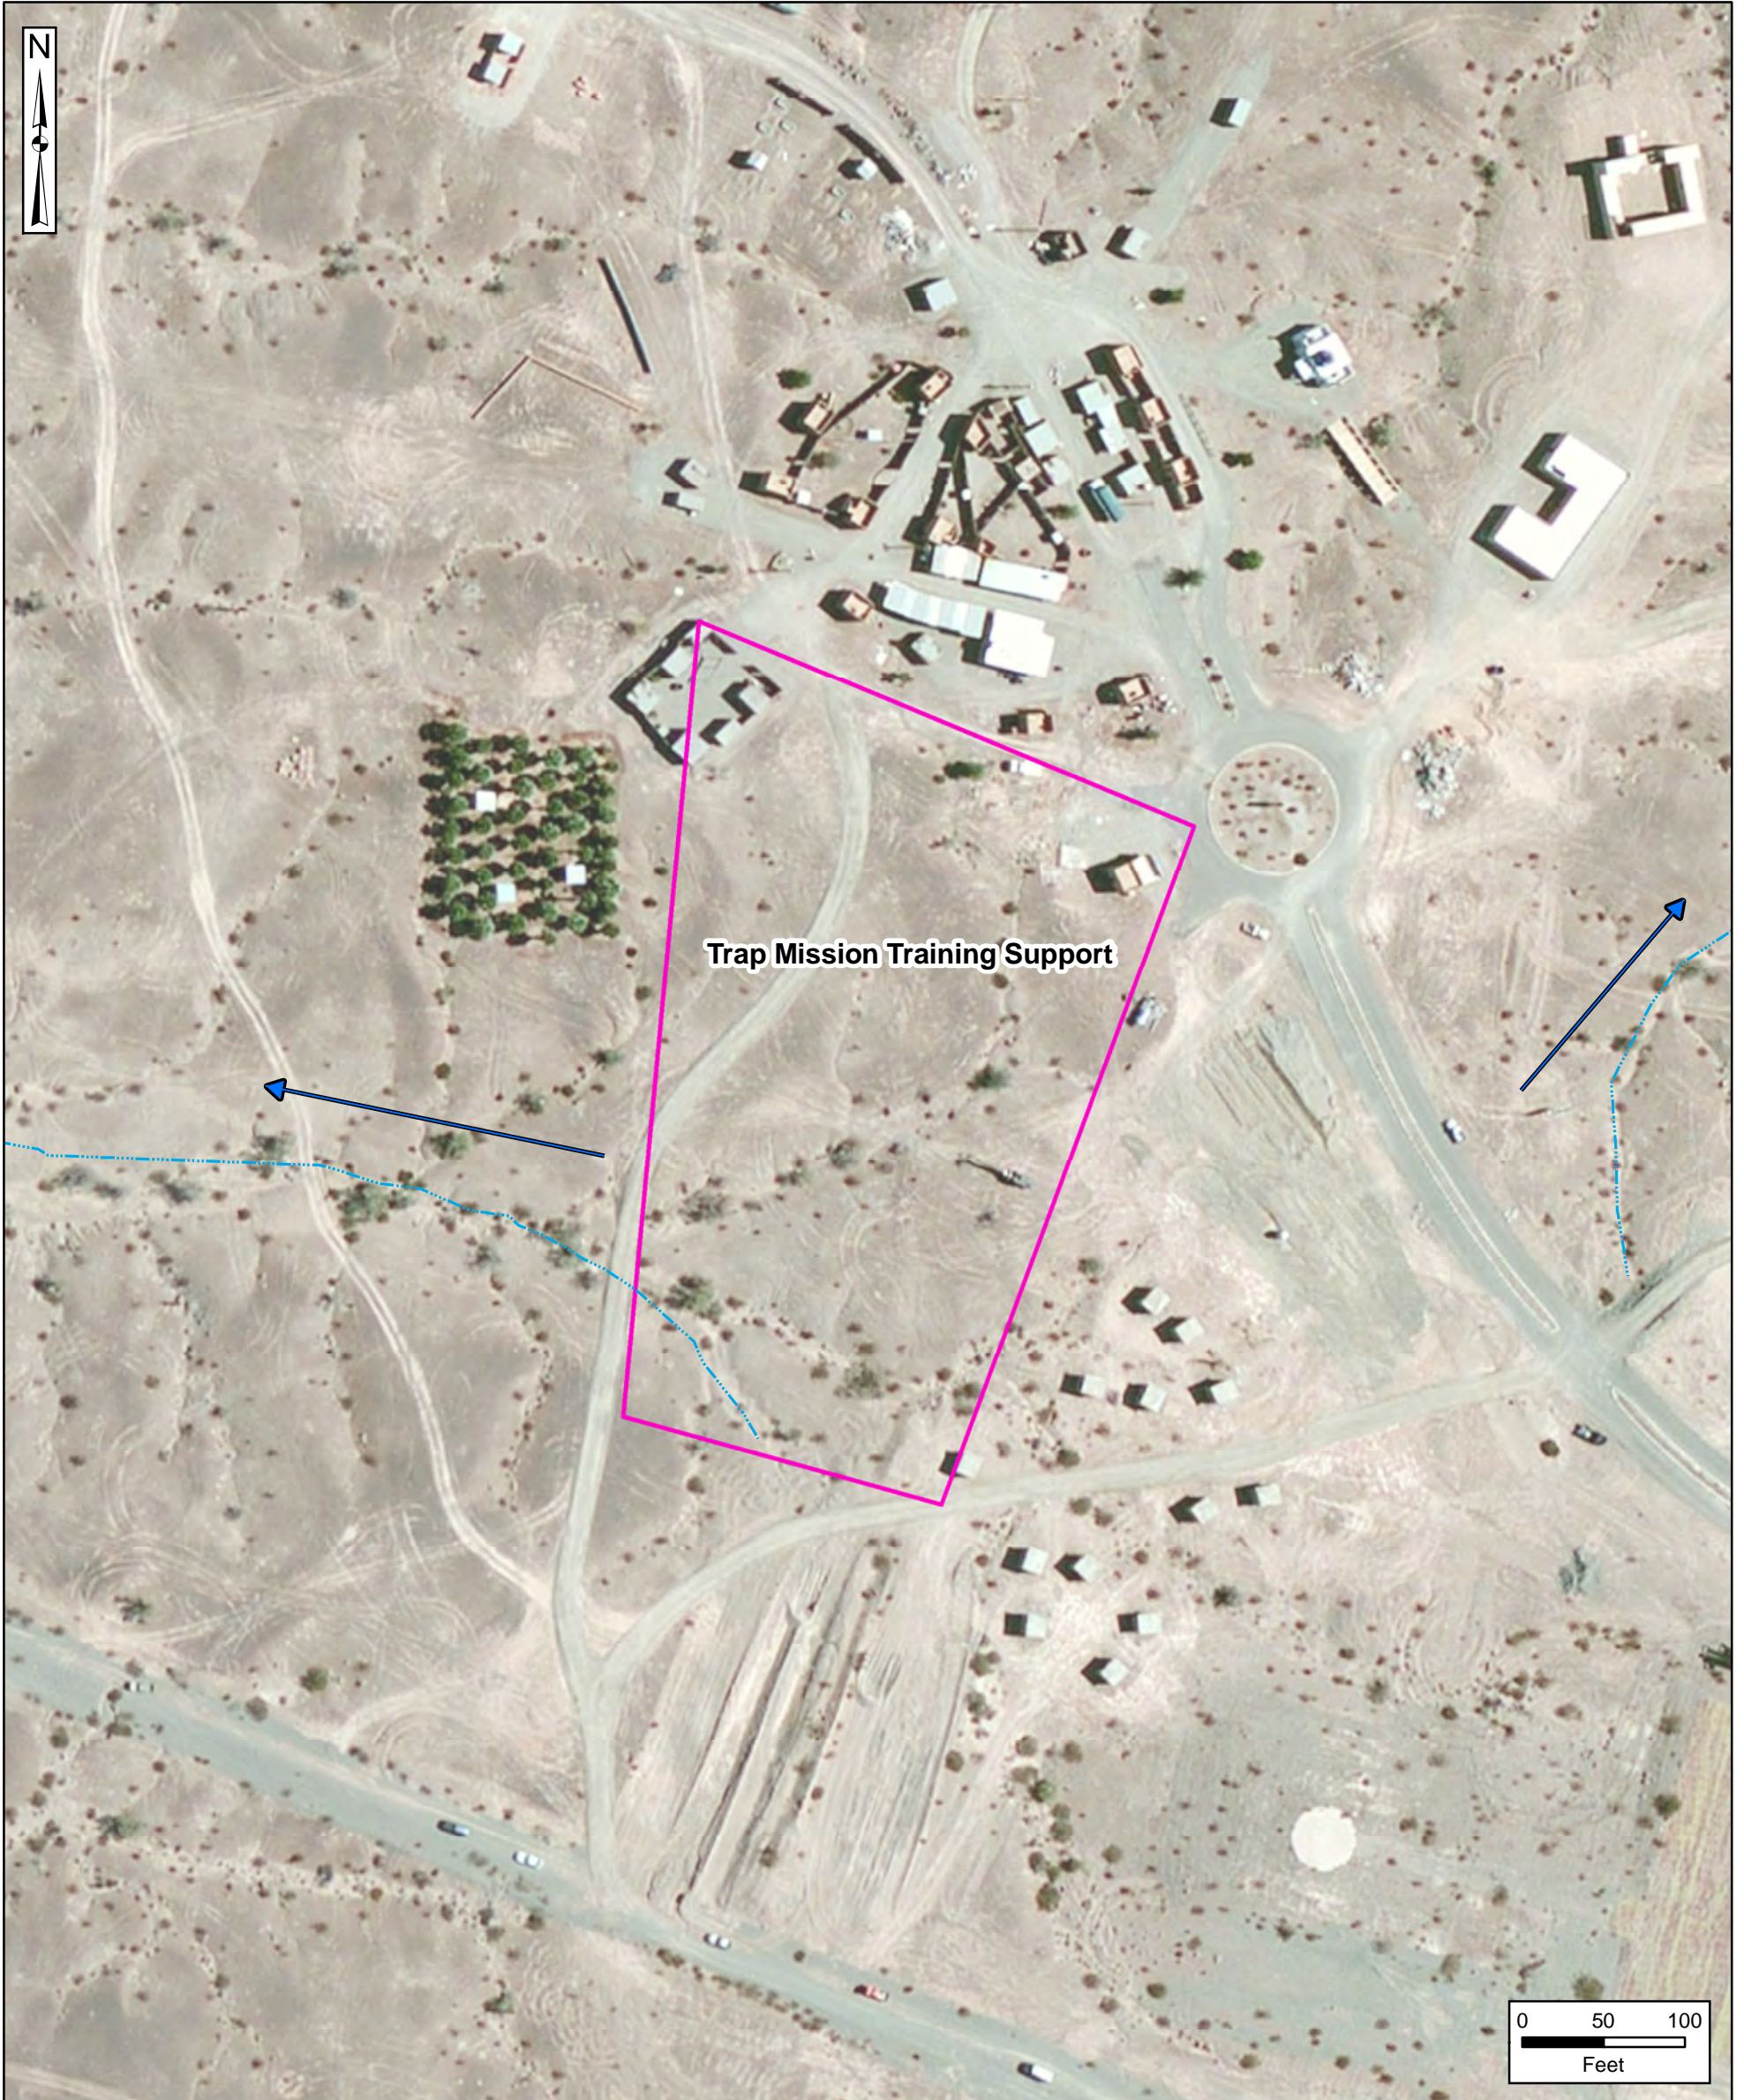
**Figure 5-5**  
**Aerial Photo of AOPI**  
**Trap Mission Training Support**

- **Trap Mission Training Support:** Shallow soil samples were collected at five locations where AFFF was deployed to the environment. Groundwater was not collected at this AOPI due to arid climate and depth to groundwater. In this type of environment, evaporation of precipitation is prevalent, net infiltration is minimal, and depth to groundwater is estimated to be greater than 200 ft bgs.

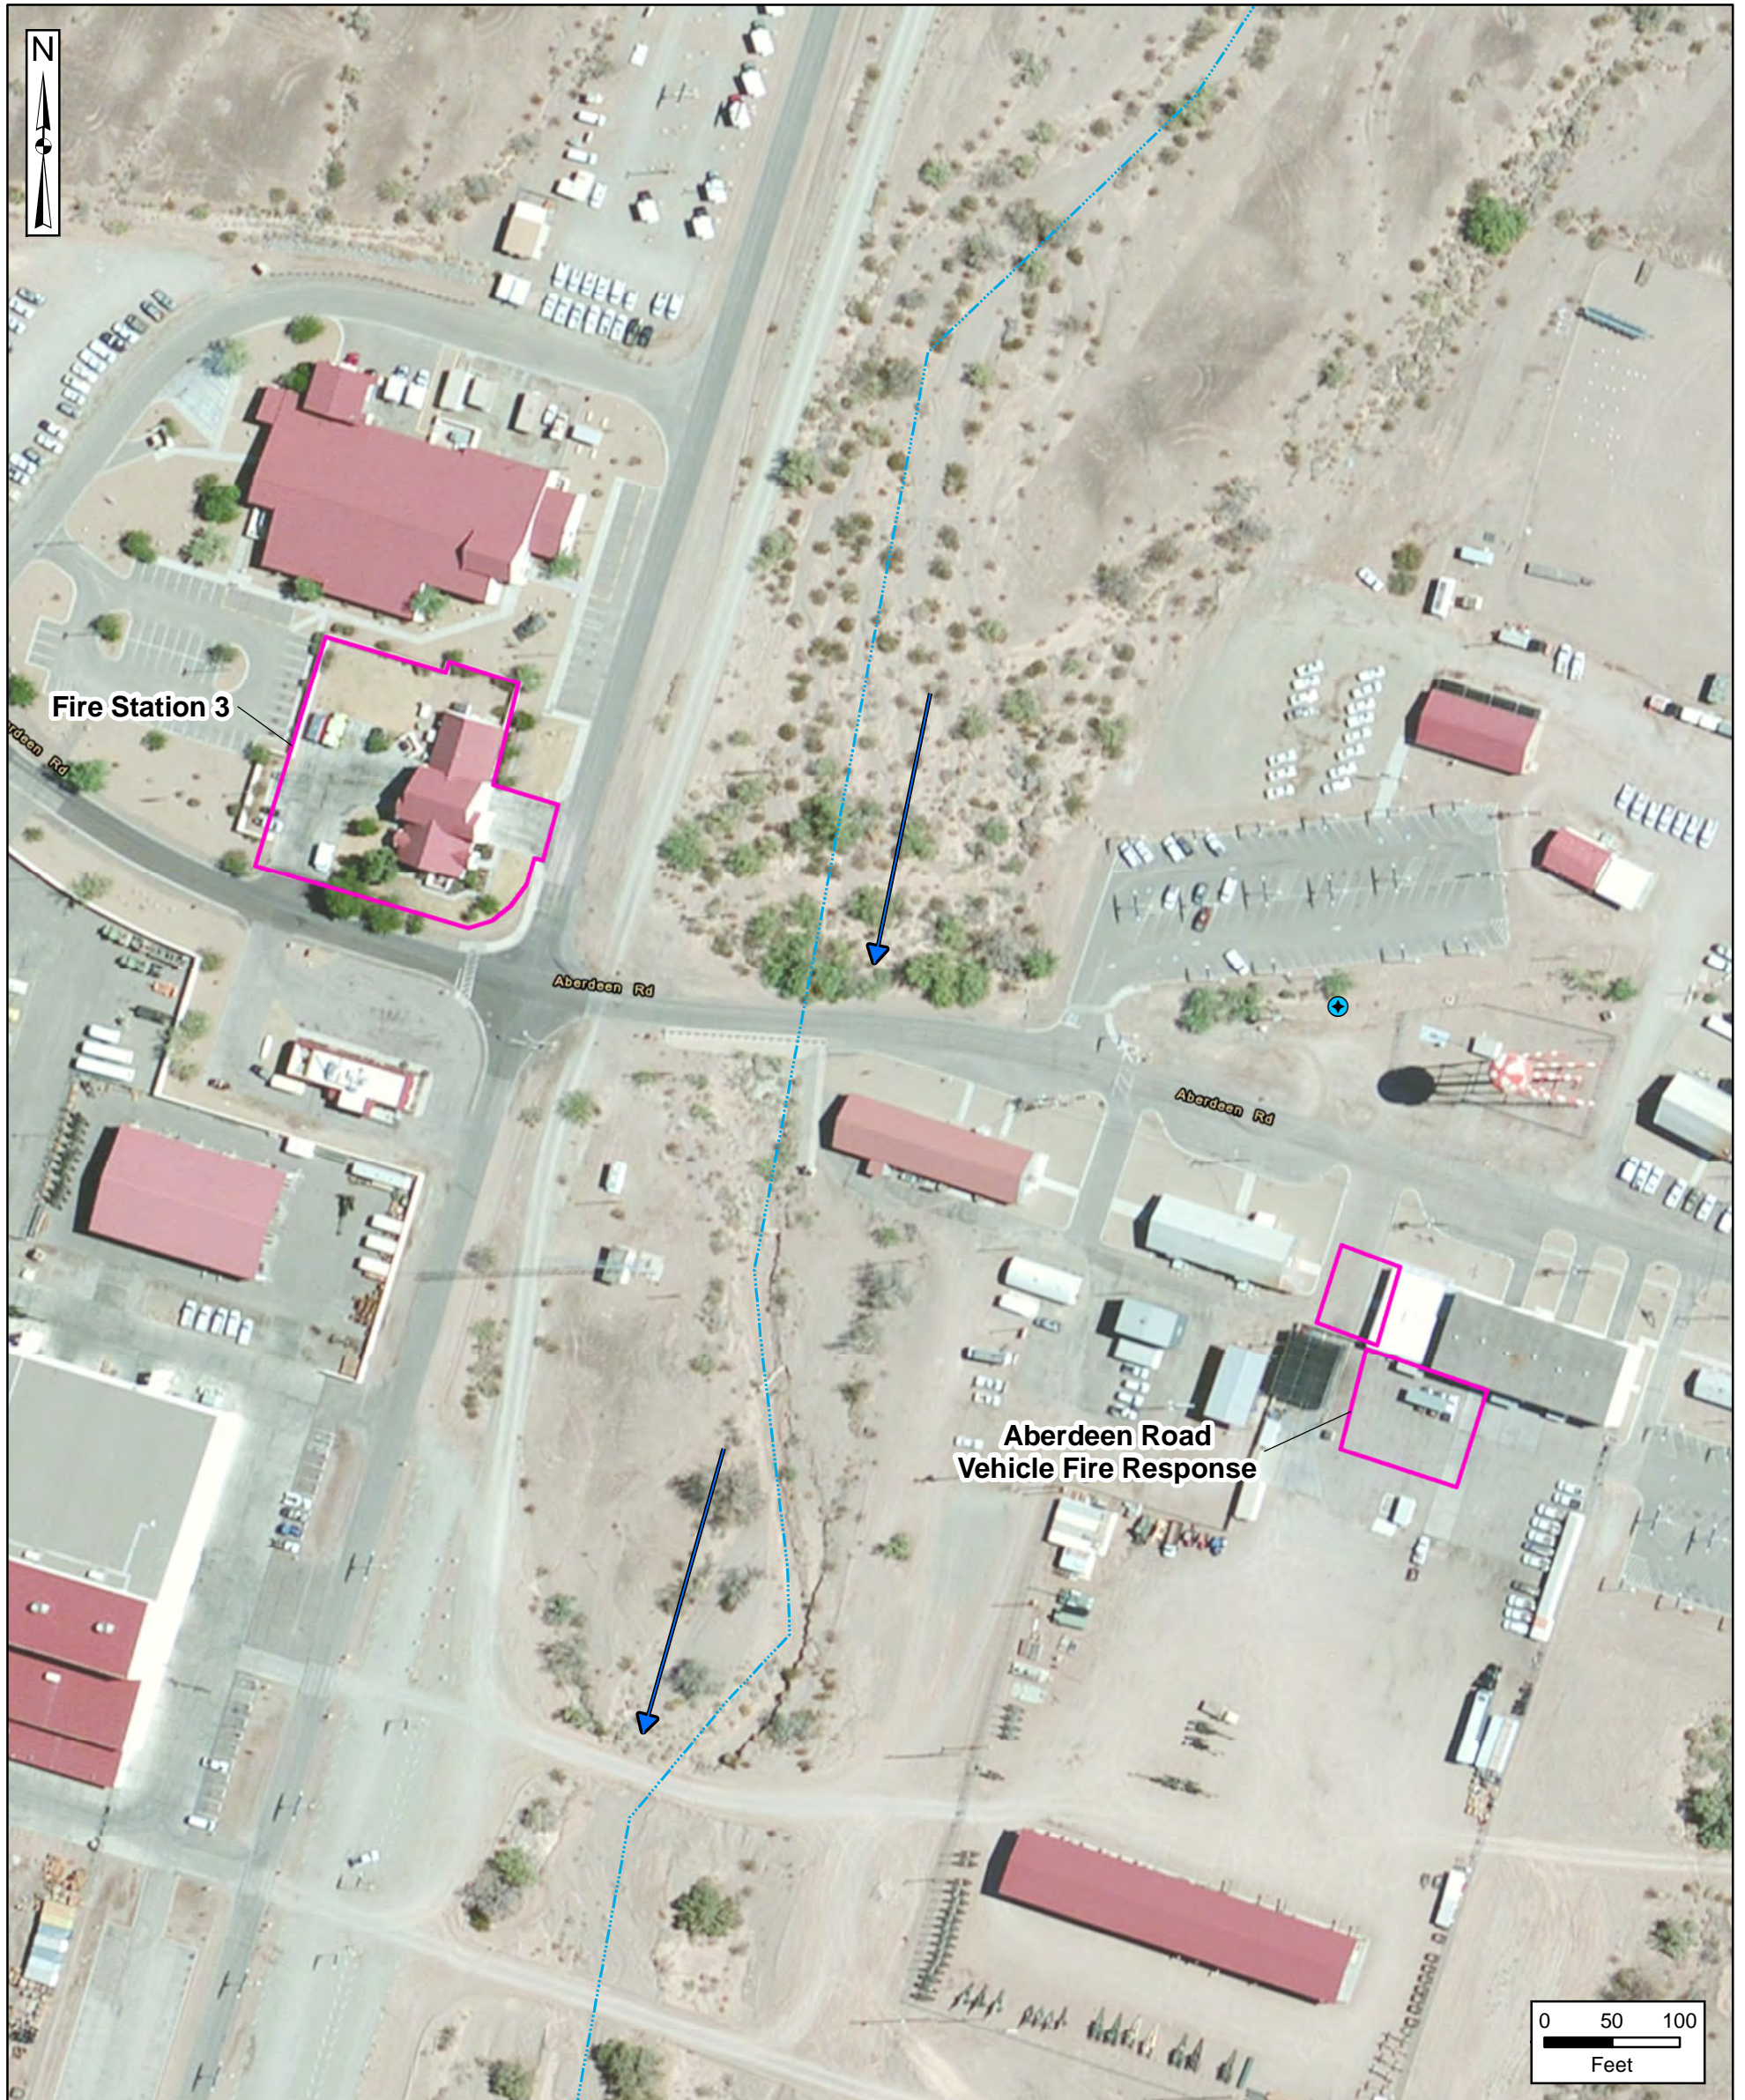
**Figure 5-6**  
**Aerial Photo of AOPIs**  
**Aberdeen Road Fire Response and Fire Station 3**

The Aberdeen Road Vehicle Fire Response, KFR, (**Figure 5-6**), is identified as an AOPI following activities potentially relevant to use, storage, and/or disposal of PFAS-containing materials at the Aberdeen Road Vehicle Fire Response that occurred on 2 September 2010 at KFR. A vehicle fire was extinguished with water but continued to reignite. Up to 50 gallons of AFFF were used to extinguish the fire in response. The fire response was either immediately west or south of nearby Building 3522 on a heavily cracked impervious surface.

- **Aberdeen Road Vehicle Fire Response:** Two shallow soil samples and one deep soil sample were collected where the paved surface meets soil. One shallow soil sample was collected from the drainage swale nearby. Groundwater was not collected at this AOPI due to arid climate and depth to groundwater. In this type of environment, evaporation of precipitation is prevalent, net infiltration is minimal, and depth to groundwater is estimated to be greater than 300 ft bgs.

- **Fire Station 3:** Two shallow soil samples and one deep soil sample were collected across the road from the east apron where any surface drainage would first meet soil. One shallow soil sample was collected where surface drainage from the west apron enters an earthen swale. Groundwater was not collected at this AOPI due to arid climate and depth to groundwater. In this type of environment, evaporation of precipitation is prevalent, net infiltration is minimal, and depth to groundwater is estimated to be greater than 300 ft bgs.

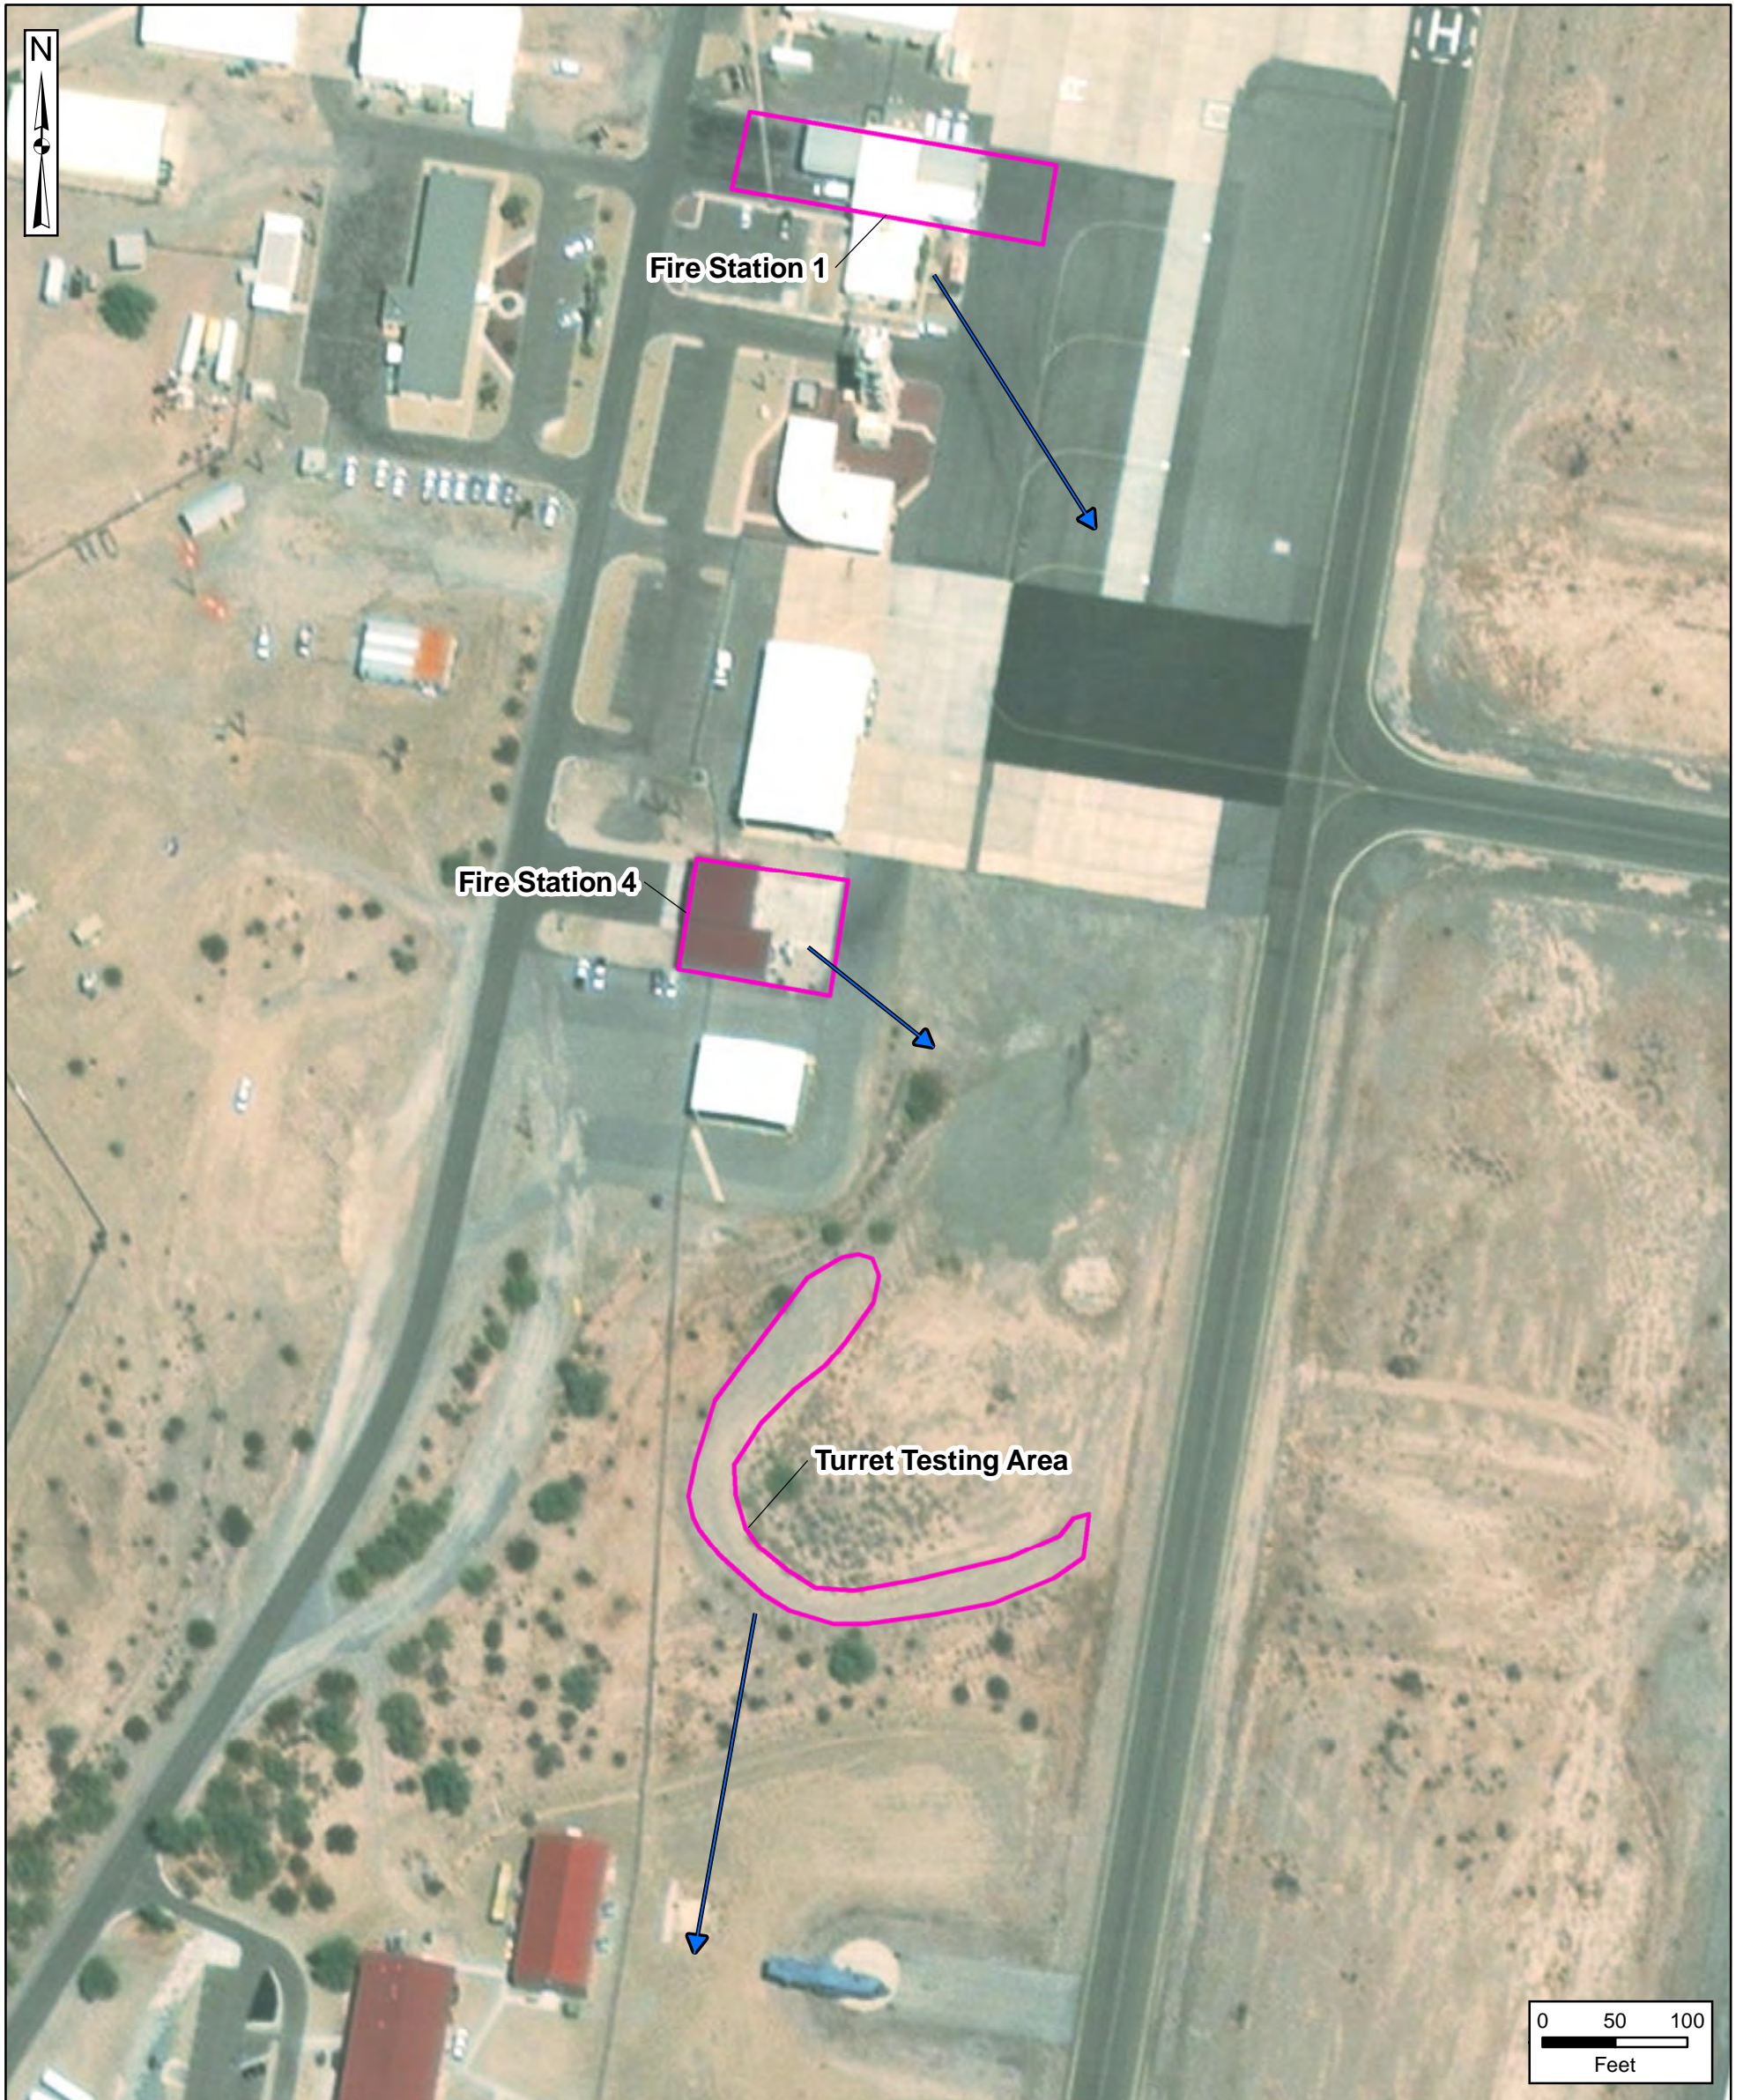
**Figure 5-8**  
**Aerial Photo of AOPIs Laguna Army Air Field,  
Fire Station 1, Fire Station 4, and Turret Testing Area**

The Fire Station 4, LAAF (**Figure 5-8**), is identified as an AOPI following activities potentially relevant to use, storage, and/or disposal of PFAS-containing materials at Fire Station 4 (Building 3034) that occurred from 2017 to present. Fire truck washing and annual hose pressure testing are conducted on the back apron. Incidental spills were confirmed on the fire station apron as well as a 0.5-gallon spill from a fire truck seam leak in early 2018.

- **Fire Station 1:** A shallow and one deep soil sample were taken from underneath the asphalt on the east apron. Groundwater was not collected at this AOPI due to arid climate and depth to groundwater. In this type of environment, evaporation of precipitation is prevalent, net infiltration is minimal, and depth to groundwater is estimated to be greater than 200 ft bgs.

- **Fire Station 4:** Shallow soil samples and one deep soil sample were collected where flow from the apron first meets soil and near the apron drainage outlet. Groundwater was not collected at this AOPI due to arid climate and depth to groundwater. In this type of environment, evaporation of precipitation is prevalent, net infiltration is minimal, and depth to groundwater is estimated to be greater than 200 ft bgs.

- **Turret Testing Area:** Five shallow soil samples and one deep soil sample were collected in the assumed spray path along the perimeter of the AOPI. Groundwater was not collected at this AOPI due to arid climate and depth to groundwater. In this type of environment, evaporation of precipitation is prevalent, net infiltration is minimal, and depth to groundwater is estimated to be greater than 200 ft bgs.

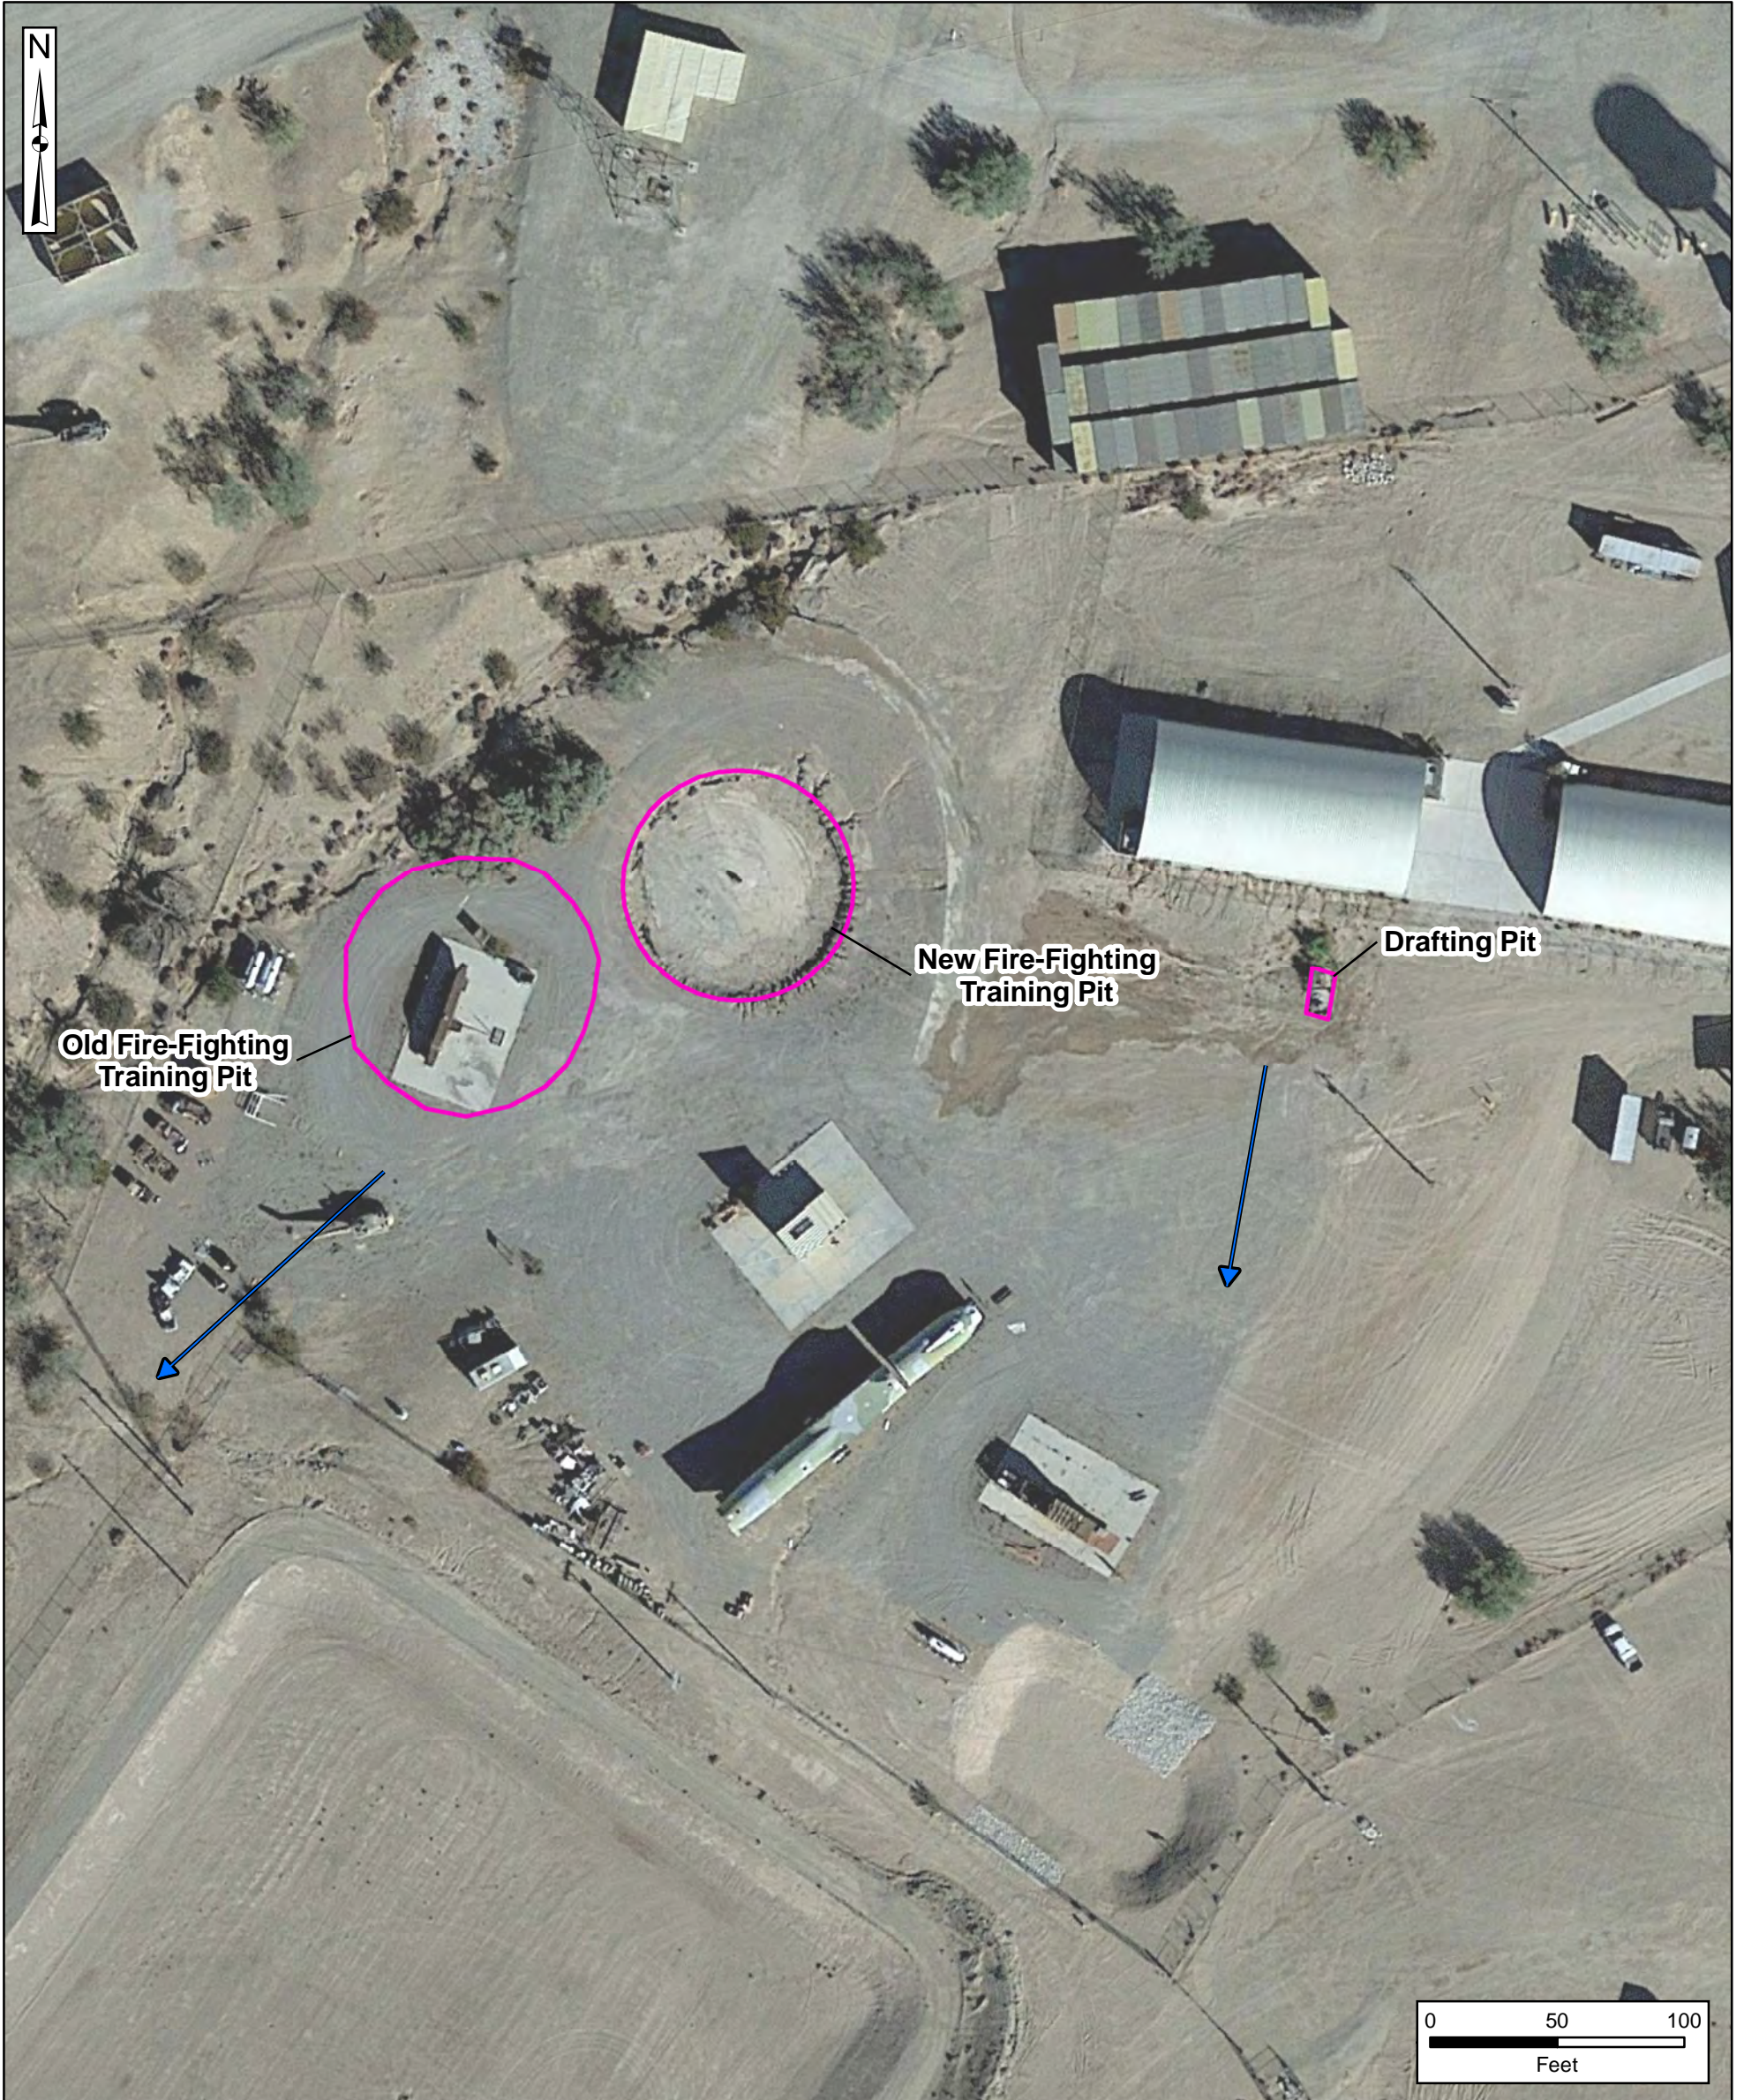
**Figure 5-9**  
**Aerial Photo of AOPIs**  
**Old Fire-Fighting Training Pit, New Fire-Fighting**  
**Training Pit, and Drafting Pit**

- **New FTP:** Two shallow soil samples and one deep soil sample were collected from the interior of the FTP. Groundwater was not collected at this AOPI due to arid climate and depth to groundwater. In this type of environment, evaporation of precipitation is prevalent, net infiltration is minimal, and depth to groundwater is estimated to be greater than 200 ft bgs.

- **Old FTP:** Shallow soil samples and one deep soil sample were collected from three locations surrounding the perimeter of the AOPI. Subsurface soil samples were collected from two of these locations due to potential soil disturbance from historical construction. Groundwater was not collected at this AOPI due to arid climate and depth to groundwater. In this type of environment, evaporation of precipitation is prevalent, net infiltration is minimal, and depth to groundwater is estimated to be greater than 200 ft bgs.

- **Drafting Pit:** Four shallow soil samples and one deep soil sample were collected near the bottom of the drafting pit. Groundwater was not collected at this AOPI due to arid climate and depth to groundwater. In this type of environment, evaporation of precipitation is prevalent, net infiltration is minimal, and depth to groundwater is estimated to be greater than 200 ft bgs.
