# FINAL PRELIMINARY ASSESSMENT AND SITE INSPECTION OF PER- AND POLYFLUOROALKYL SUBSTANCES

## Yuma Proving Ground, Arizona

Prepared For:  
U.S. Army Corps of Engineers, Baltimore District  
2 Hopkins Plaza  
Baltimore, MD 21201

PRELIMINARY ASSESSMENT/SITE INSPECTION OF PFAS AT YUMA PROVING GROUND, ARIZONA

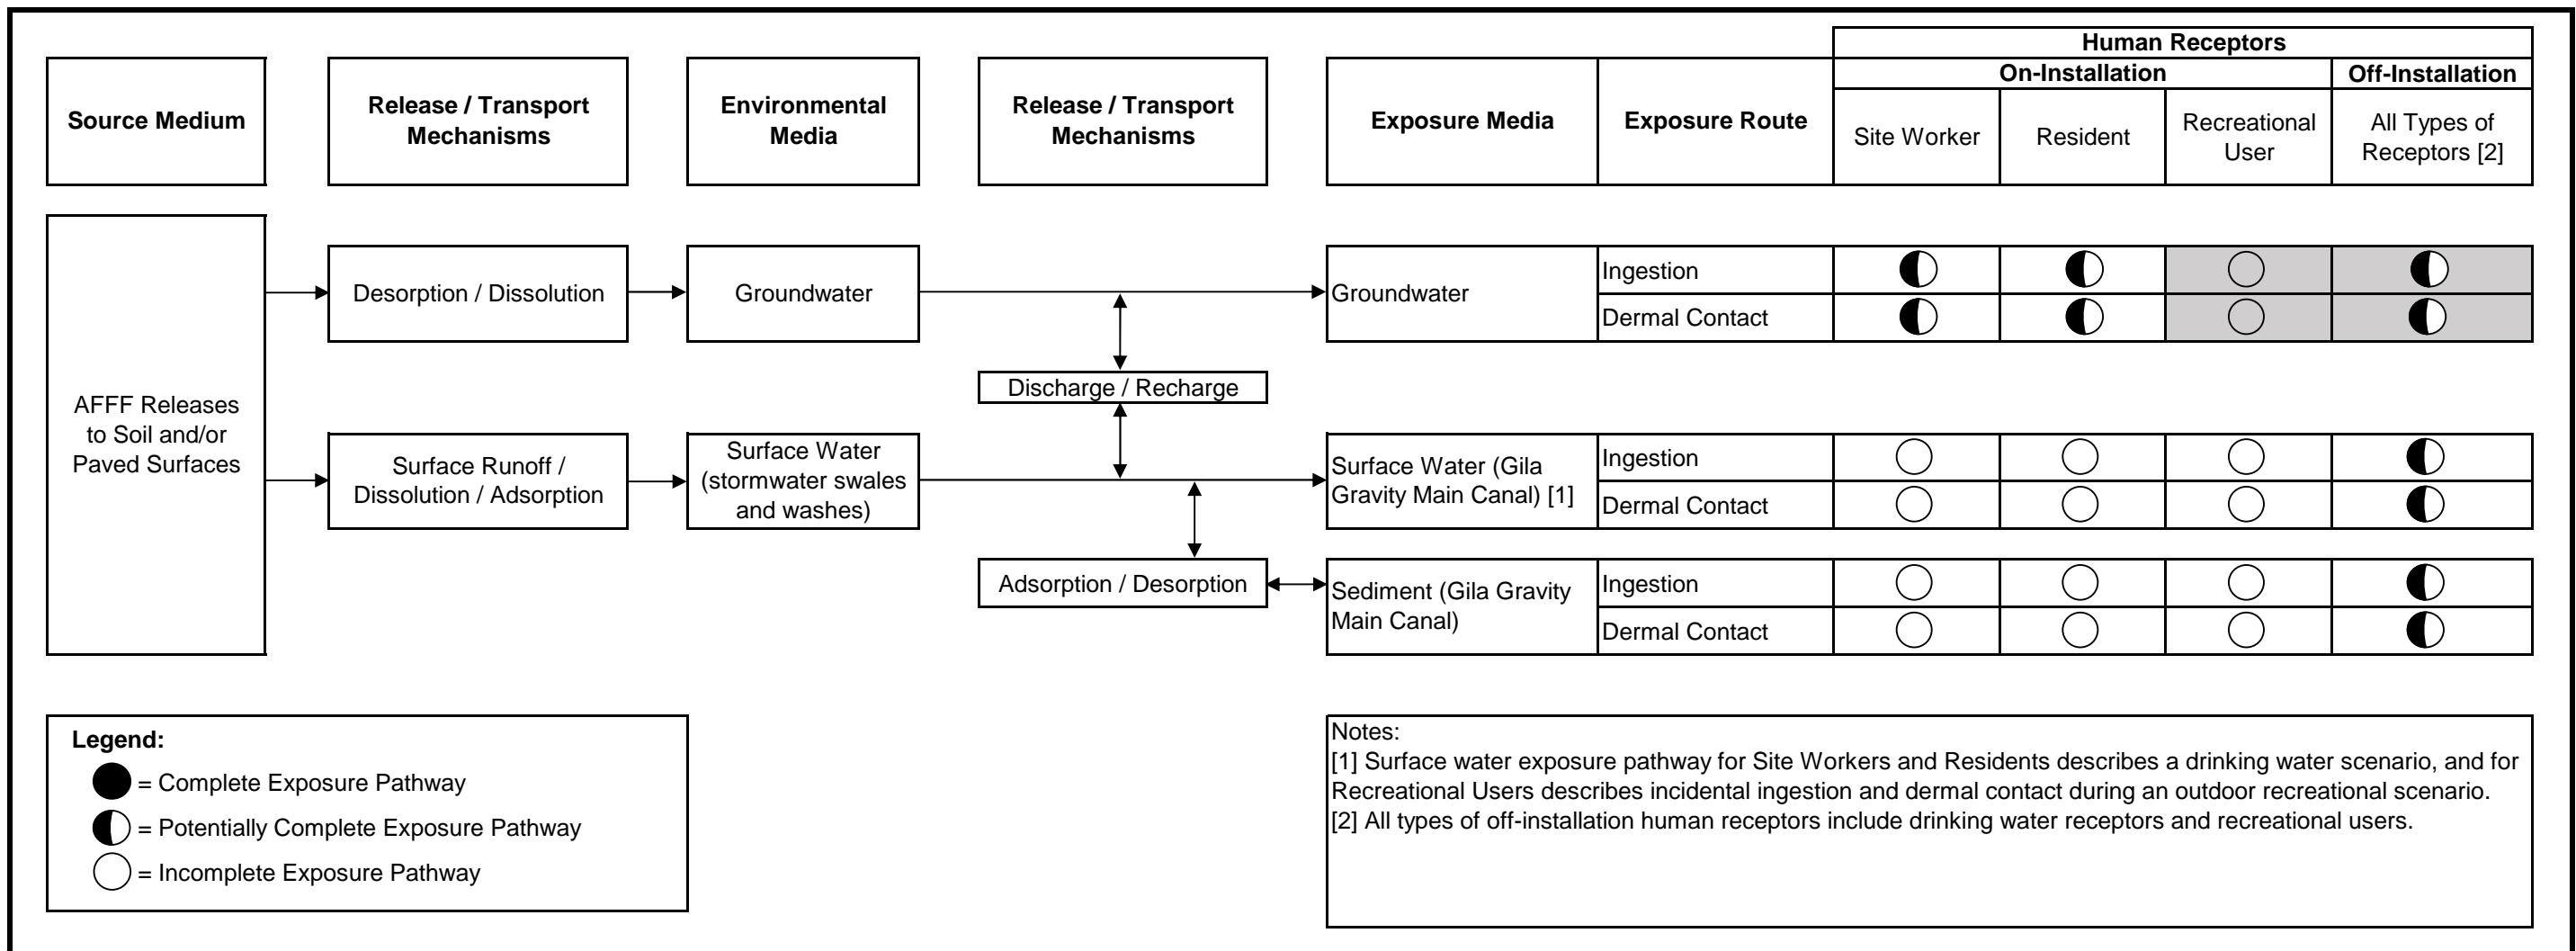
**Figure 7-12**

**Conceptual Site Model for AOP1 Grouping: Building 105**  
 USAEC PFAS Preliminary Assessment / Site Inspection  
 Yuma Proving Ground, Arizona
