Former Sunflower Army Ammunition Plant Restoration Advisory Board Meeting

22 May 2025

Characteristics of Site Wide Groundwater

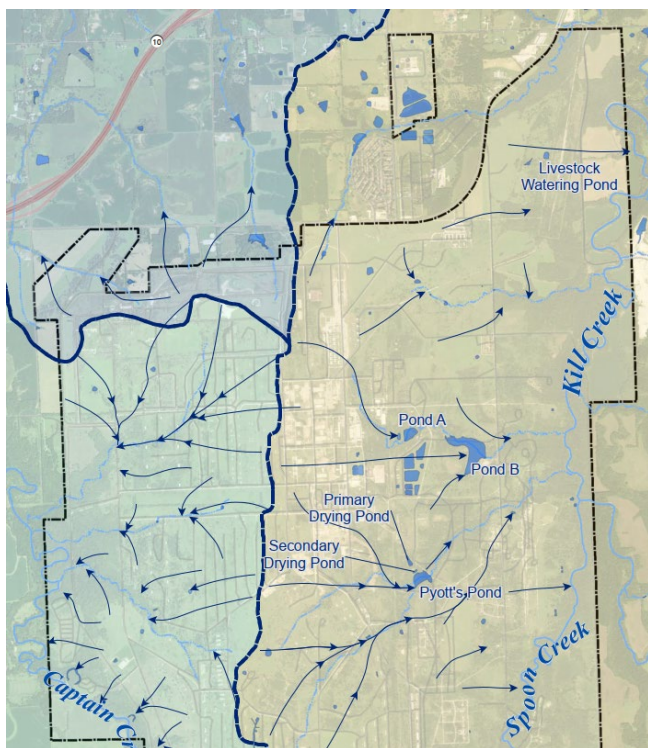
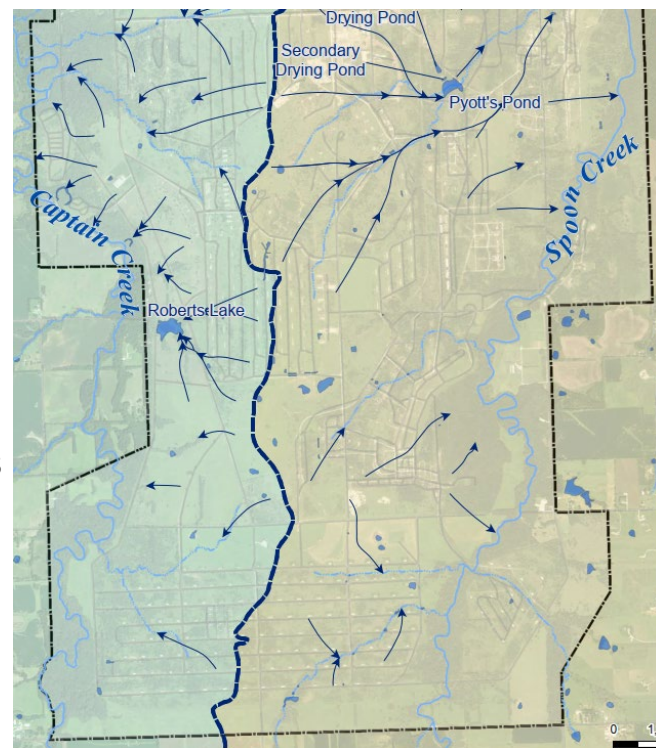
SWMU 66 – site wide stream study

- During operation, hazardous substances and contaminants were released to the environment
- Surface water runoff from operational areas received limited or no controls prior to clean water regulations enacted in the 1970s
- Potential contaminants from SWMUs and AOCs may have migrated to and impacted streams and creeks
 - Captain Creek – Western SAAP
 - Kill Creek – Northeast SAAP
 - Spoon Creek – Southeast SAAP

- Site wide stream study was completed in 2003 to determine whether historical activities at SAAP impacted sediment and surface water quality in major drainages (Captain, Kill and Spoon Creeks) that convey surface water runoff from the installation

- Metals (beryllium, cadmium, copper, lead, mercury, zinc) were detected in surface water at levels exceeding their respective surface water quality standards (SWQS)

- Eight pesticides were detected in surface water at levels exceeding their respective SWQS
 - Metals (arsenic, lead, manganese) were detected in sediment at levels exceeding the residential soil pathway

- One pesticide was detected in sediment at levels exceeding the residential soil pathway
- Interim Corrective Measure Actions have since been completed throughout SAAP

- Foundations, sewers, and soil removal actions
- This study will reassess potential impacts in drainages from these ICMs –
 - 34 co-located surface water and sediment locations.

- Analytes include TAL metals, mercury, chromium VI, VOCs, SVOCs, TPH (LRH/MRH/HRH), PCBs, pesticides, herbicides, explosives, nitrate, sulfate, perchlorate

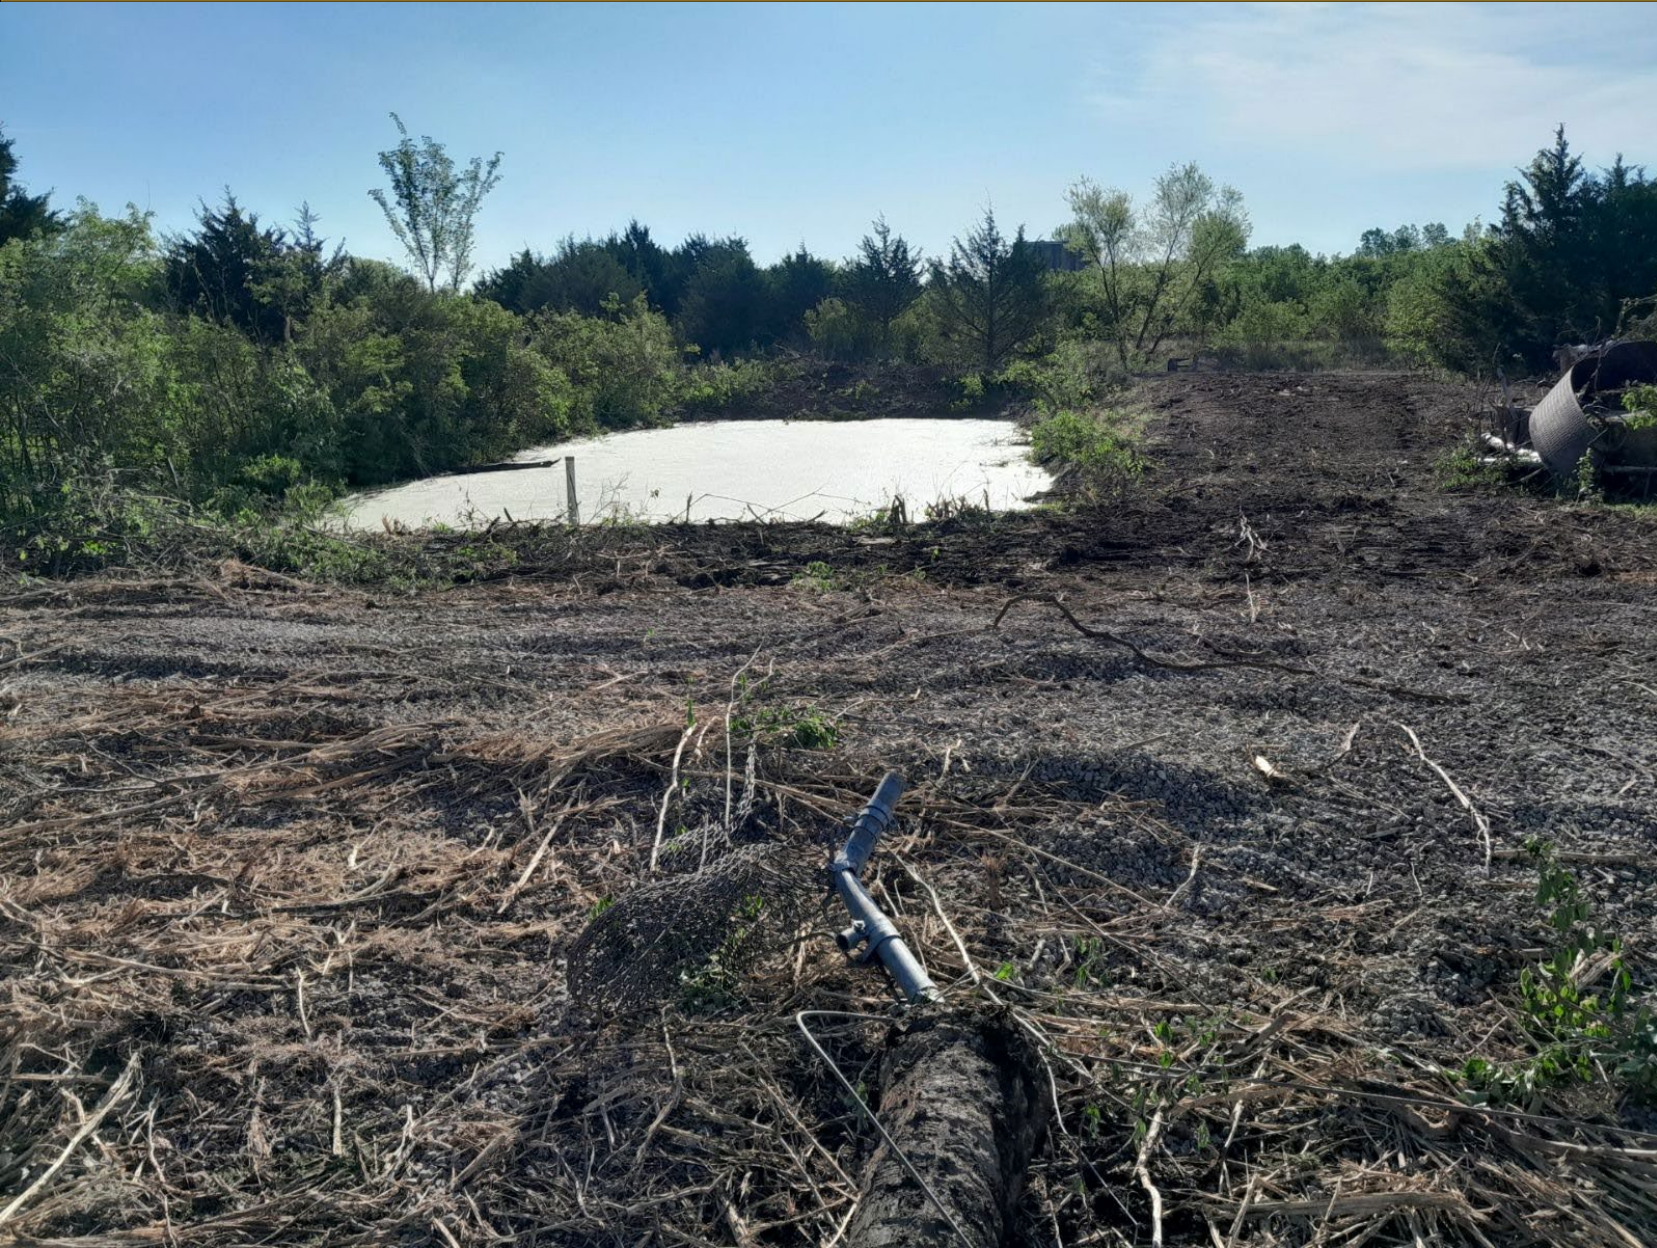
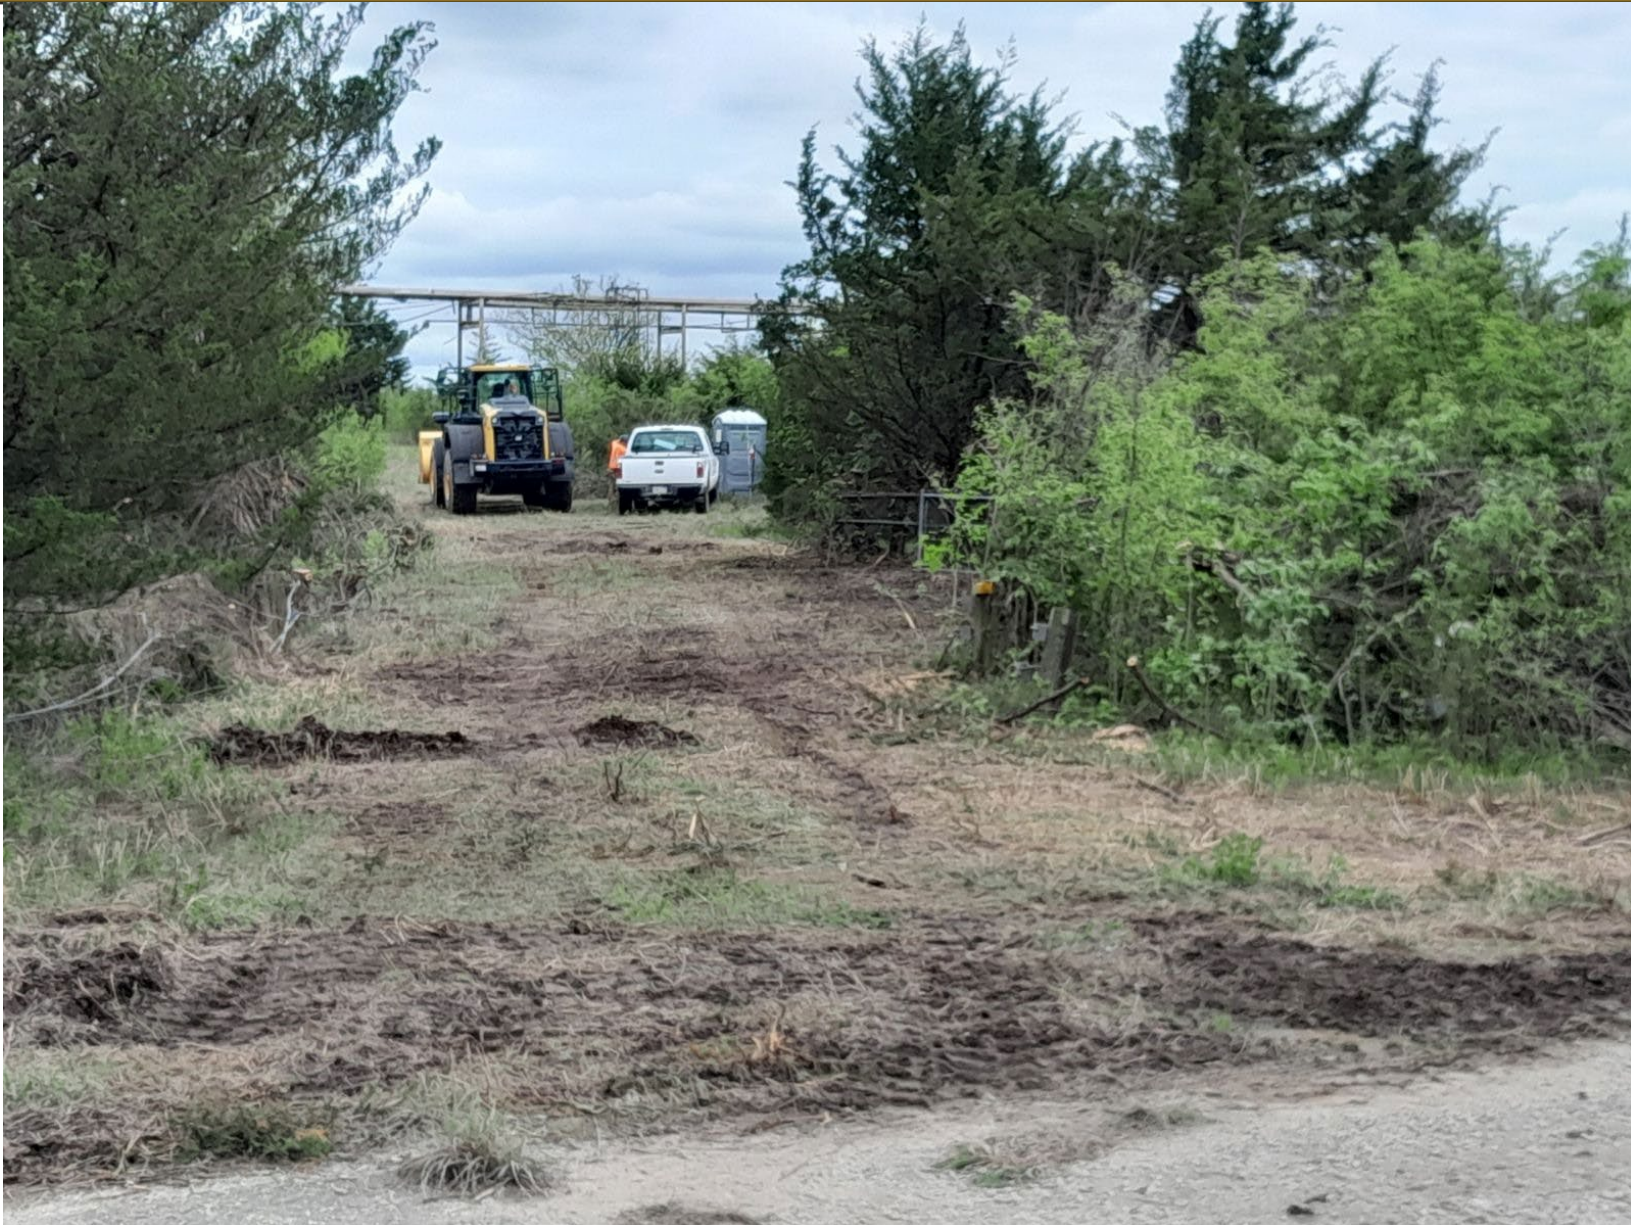
AOC 17 CMI

- The interim CMI includes removal of 20 sumps, including draining and cleaning the sumps, demolition and removal, excavation of potentially contaminated soil, confirmation sampling, backfill and site restoration, with the intent to achieve closure of the sumps and surrounding soils based on residential criteria.
- **Sumps: C928-1/2/3; 9040 B/G/I; B900-1; A900-2; D900-2 and 9041 C/E/G**
