US Army Corps  
of Engineers  
Construction Engineering  
Research Laboratories

USACERL Technical Report 98  
SFIM-AEC-ET-CR-98009  
July 1998

# Evaluation of Two Washrack Recycle Treatment Systems

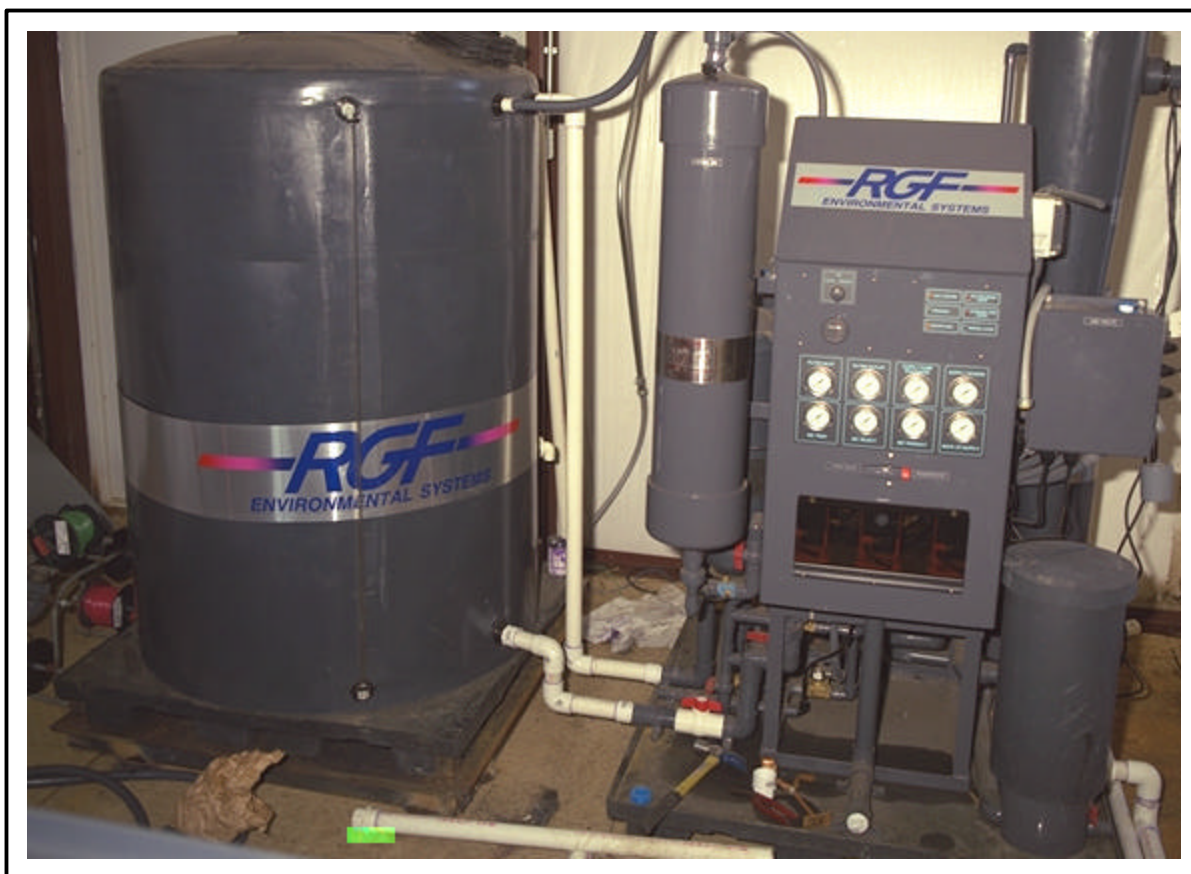
Figure 3. RGF system in Building 338 washrack, Aberdeen Test Center.

14. Figure 3 shows the RGF Model ST<sup>2</sup> installed at the Aberdeen Test Center Building 338 washrack. Figure 4 shows a schematic of the RGF system evaluated in this study.
